PORTLAND COMPANY COMPLEX GENERAL BUILDING CONDITION REPORT

PERFORMED FOR
CITY OF PORTLAND, MAINE PLANNING DEPARTMENT
389 CONGRESS STREET
PORTLAND, ME 04101

MARCH 26, 2015
SUPERSEDES REPORT DATED MARCH 11, 2015

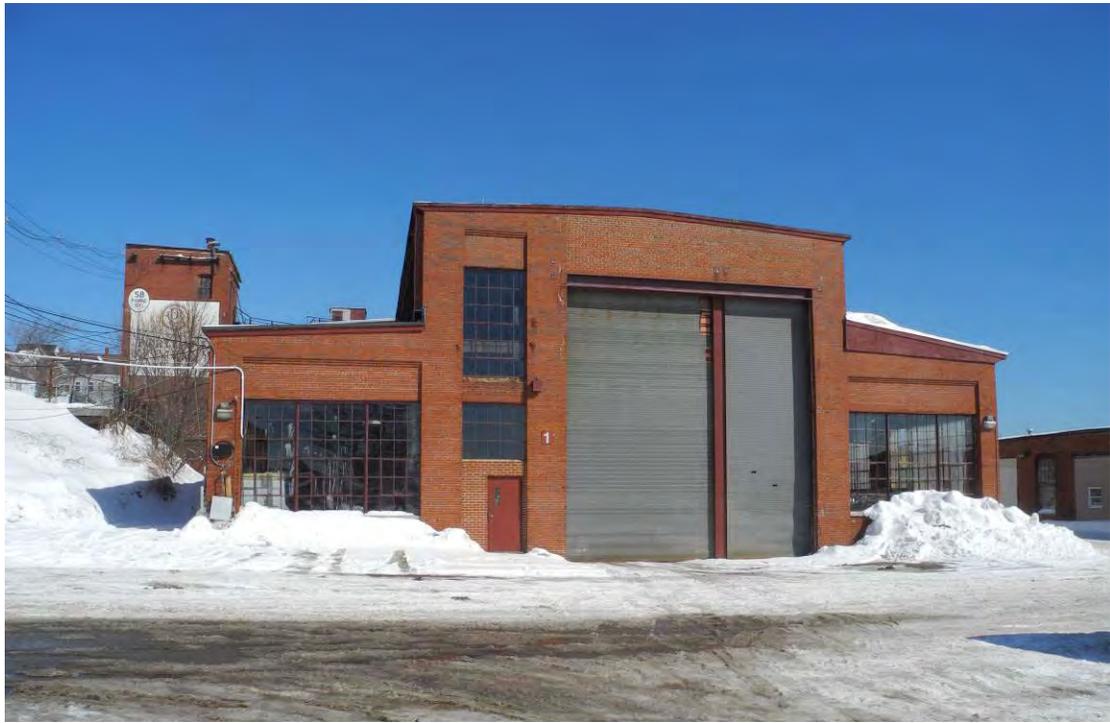
PHOTO
1.1
A 2 95.jpg

Building 1: View from west. Large, tall bay door has replaced original smaller overhead door and symmetrical high windows. Increased roof pitch at right side of photo appears to have been in place since late 1930s.

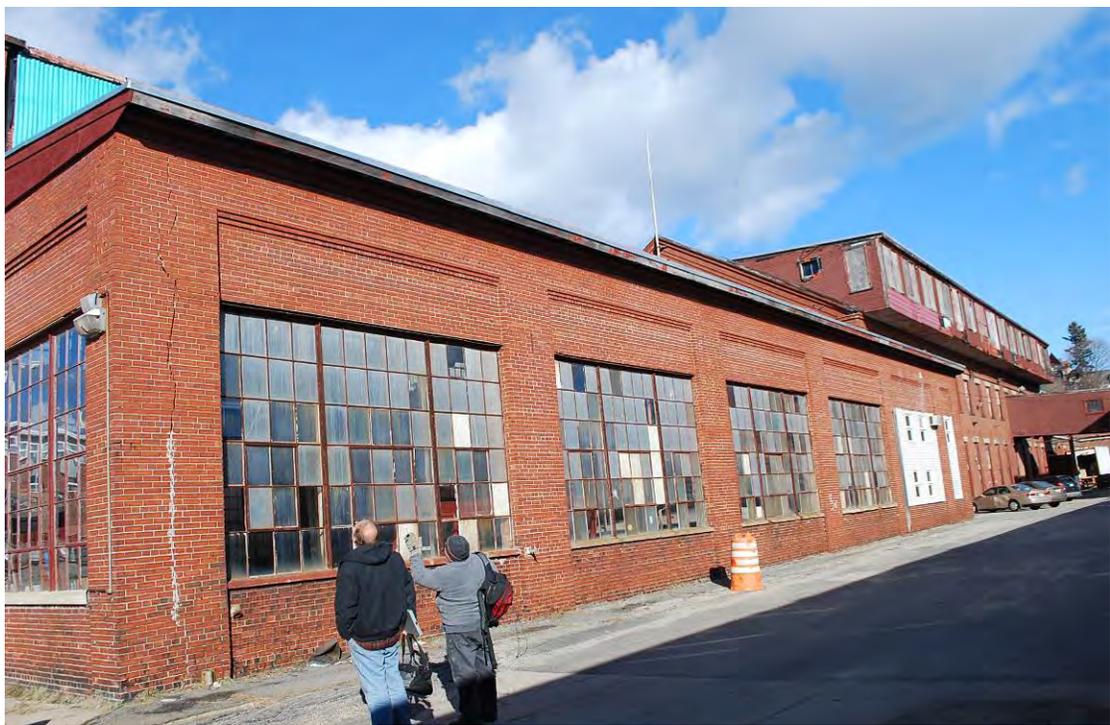
PHOTO
1.2
R 07.jpg

Building 1: View along south elevation looking toward Building 2, showing five bays of steel-framed windows and a small bay near Building 2. Note large crack at left, near joint with west wall.

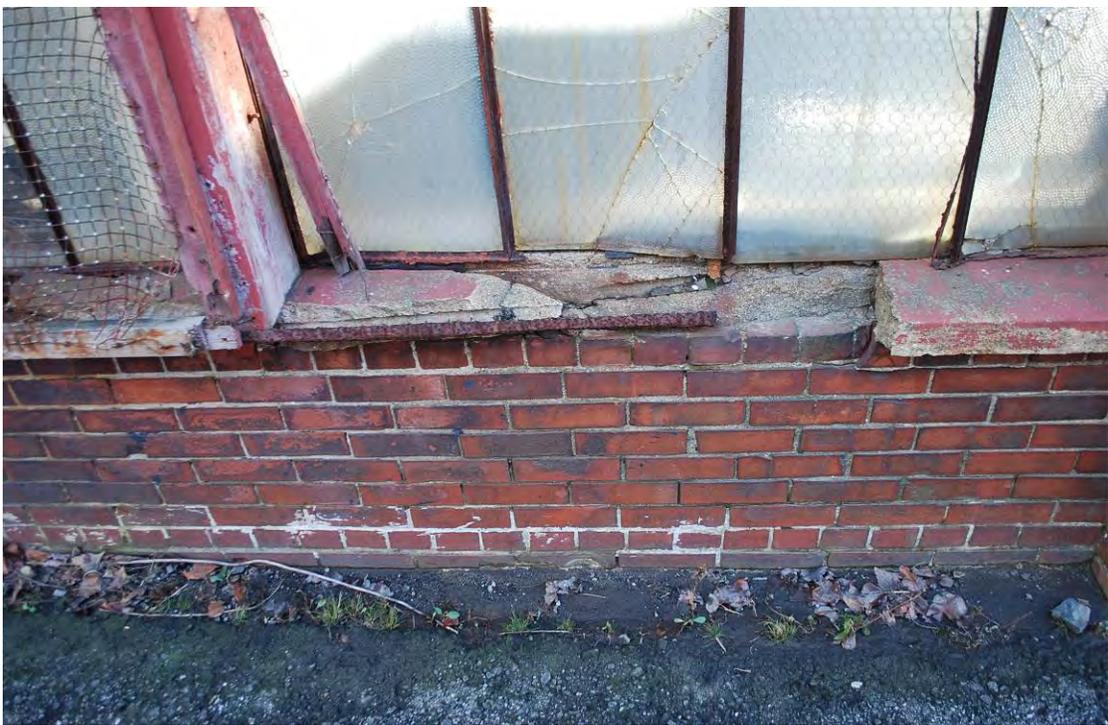
PHOTO
#1.6
R 32.jpg

Building 1: Rising damp at perimeter wall base, failed concrete sills, and significantly damaged steel-framed windows.

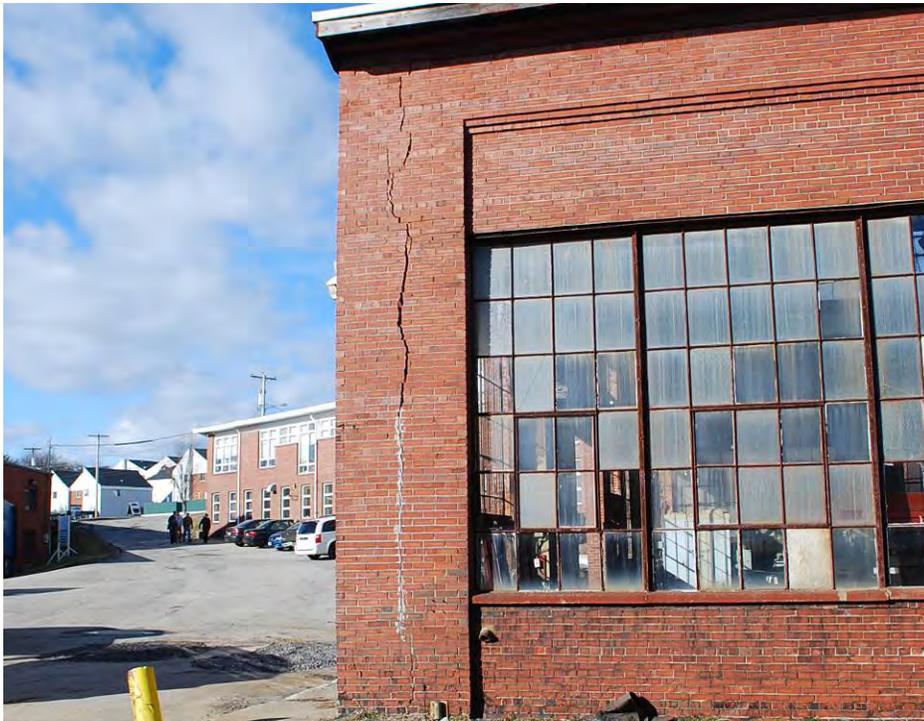
PHOTO
#1.7
 R 06.jpg

Building 1: Brick masonry crack, northwest corner of building. Rebuilding the west wall of the building and performing other masonry repairs can improve lateral stability of the building. .

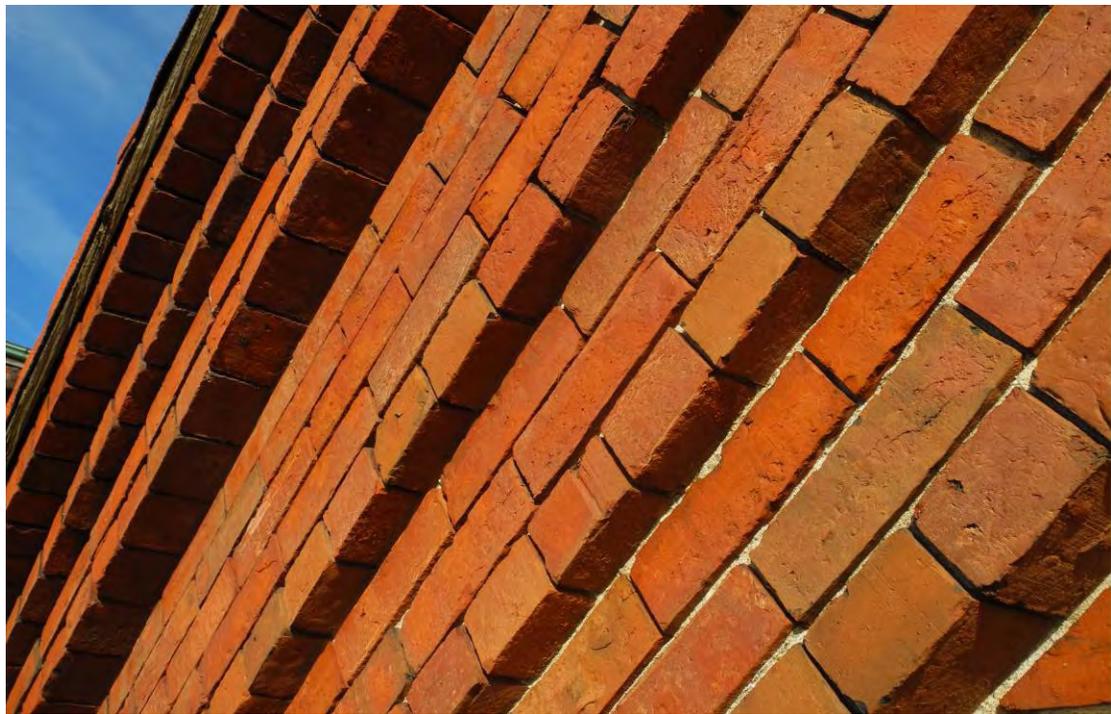
PHOTO
#2.8
A 30 68.jpg

Building 2: West Gable end rake (detail) comprised of 15 courses of brick masonry corbelling out over one foot beyond outside face of primary gable end wall. Repointing required, but otherwise in good condition.

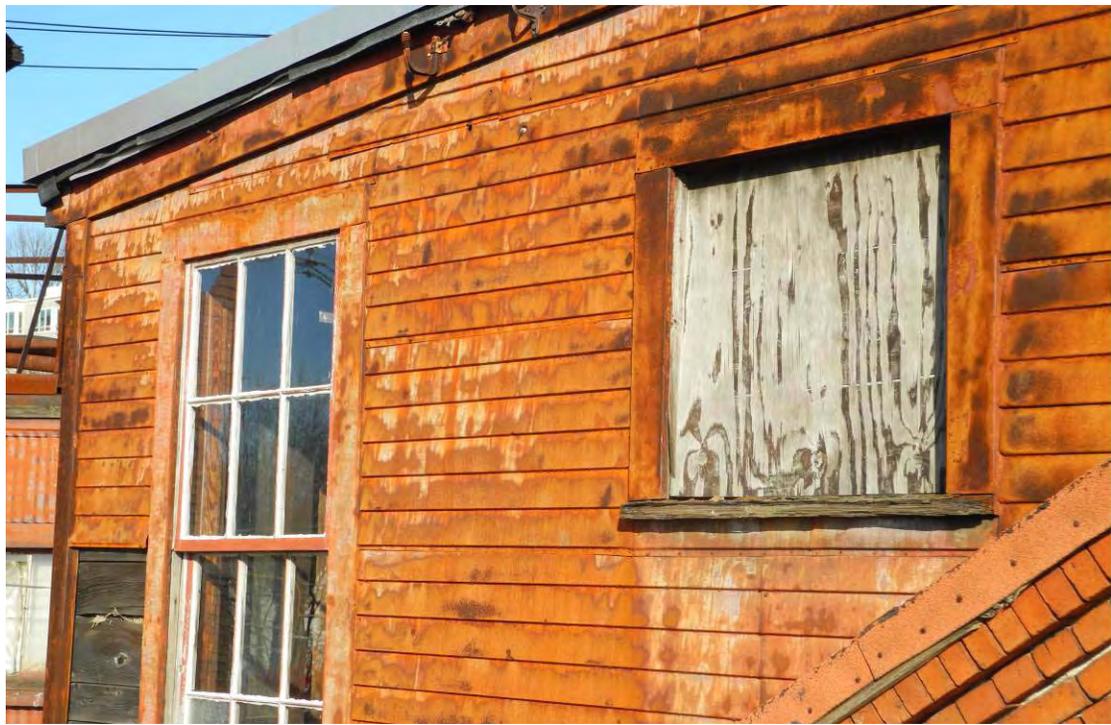
PHOTO
#2.9
A 30 95.jpg

Building 2: West end of north-facing third-floor dormer. Note corroded metal siding and missing siding. 6/6 window sash is likely original.

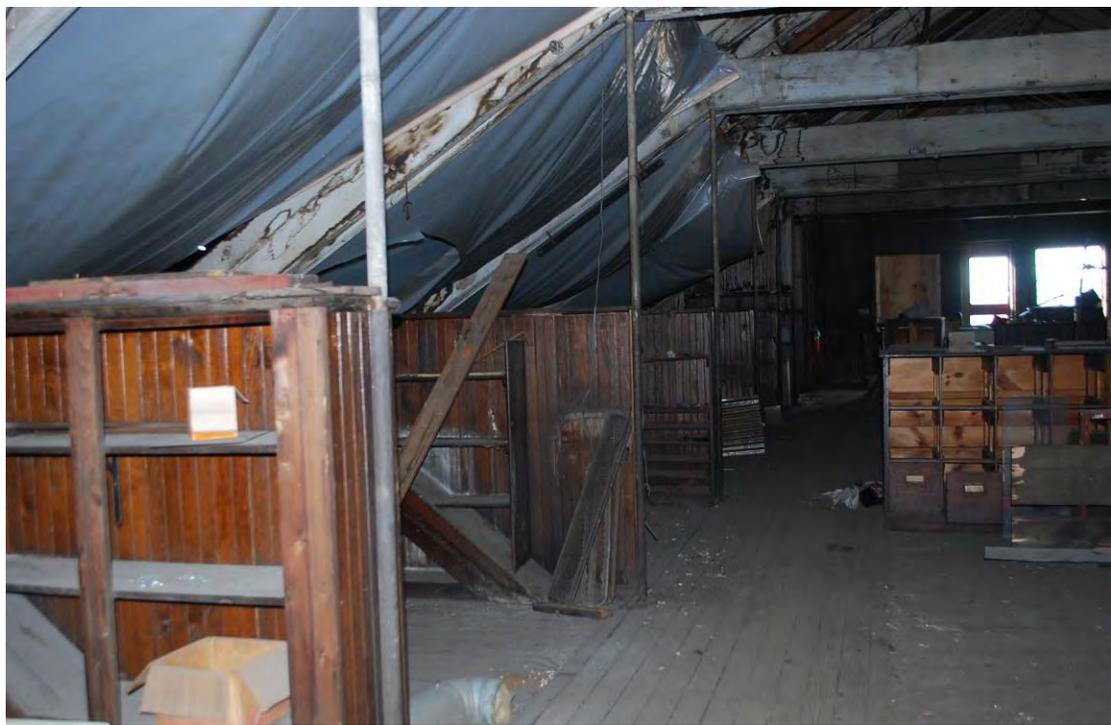
PHOTO
#2.10
R 169.jpg

Building 2: View from east end of third floor. Plastic sheeting has been used throughout to prevent roof leaks from reaching the assembly space below.

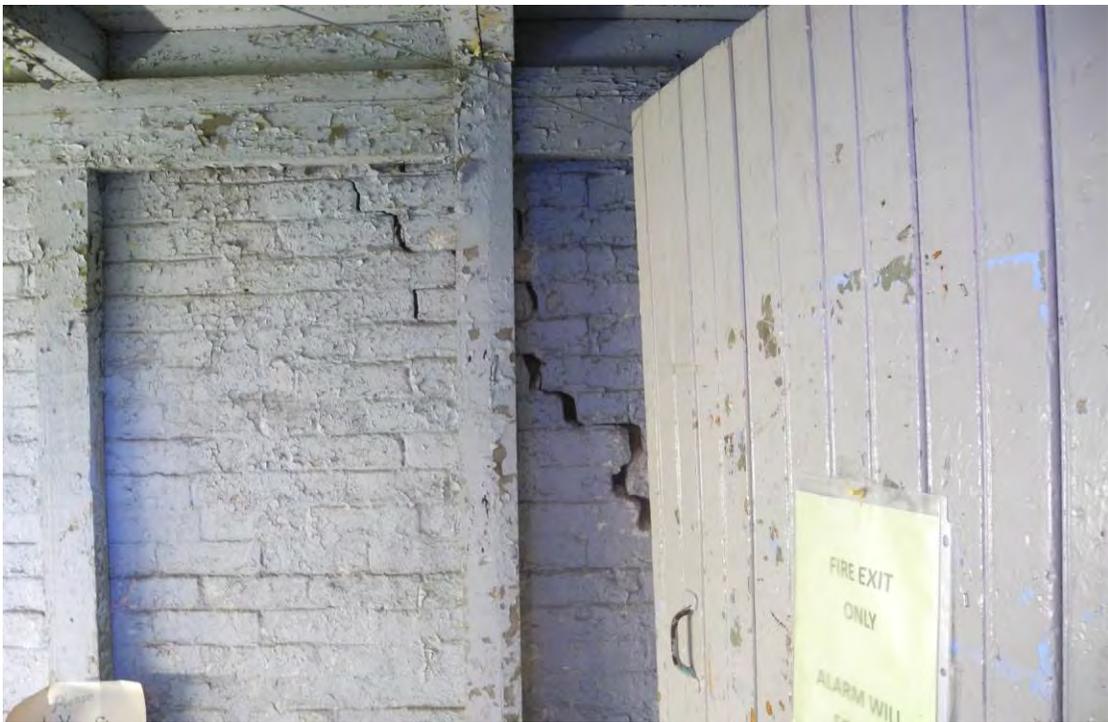
PHOTO
#2.16
A 3 37.jpg

Building 2: Common wall with Building 3: Extensive masonry crack near second floor south door.

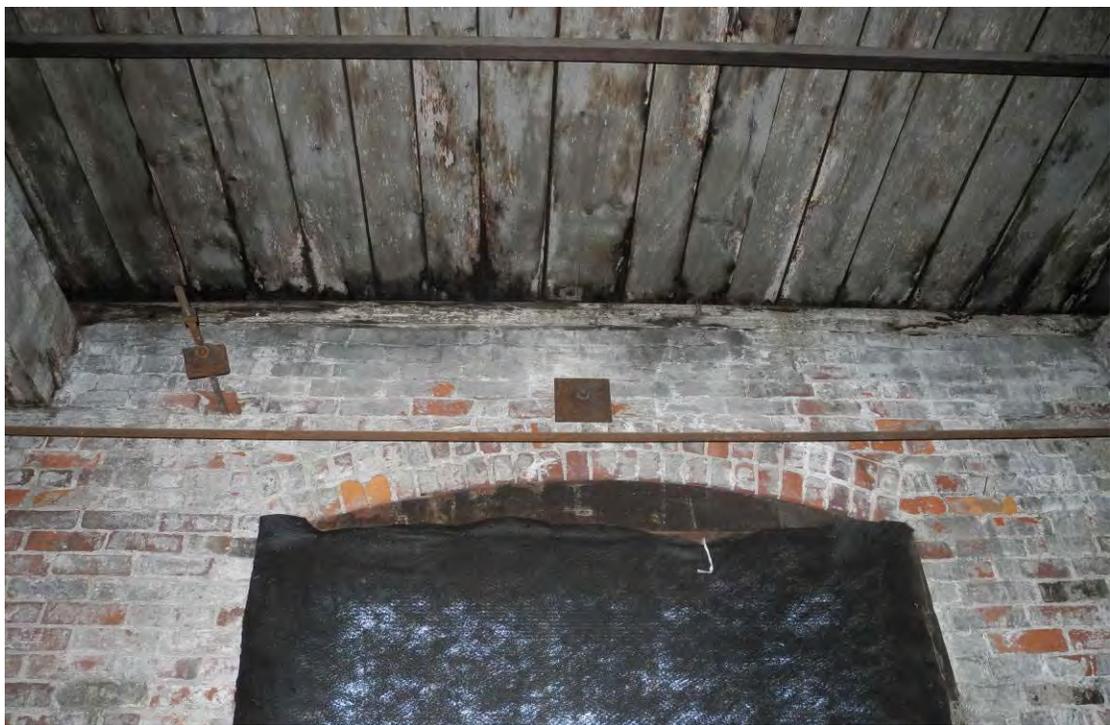
PHOTO
#3.8
A 3 31.jpg

Building 3: Potentially rotted sheathing at south eave. Closely examine ends of sheathing and eave plates for rot. Additional sheathing may be needed to create sufficient diaphragm action between roof edges and wall.

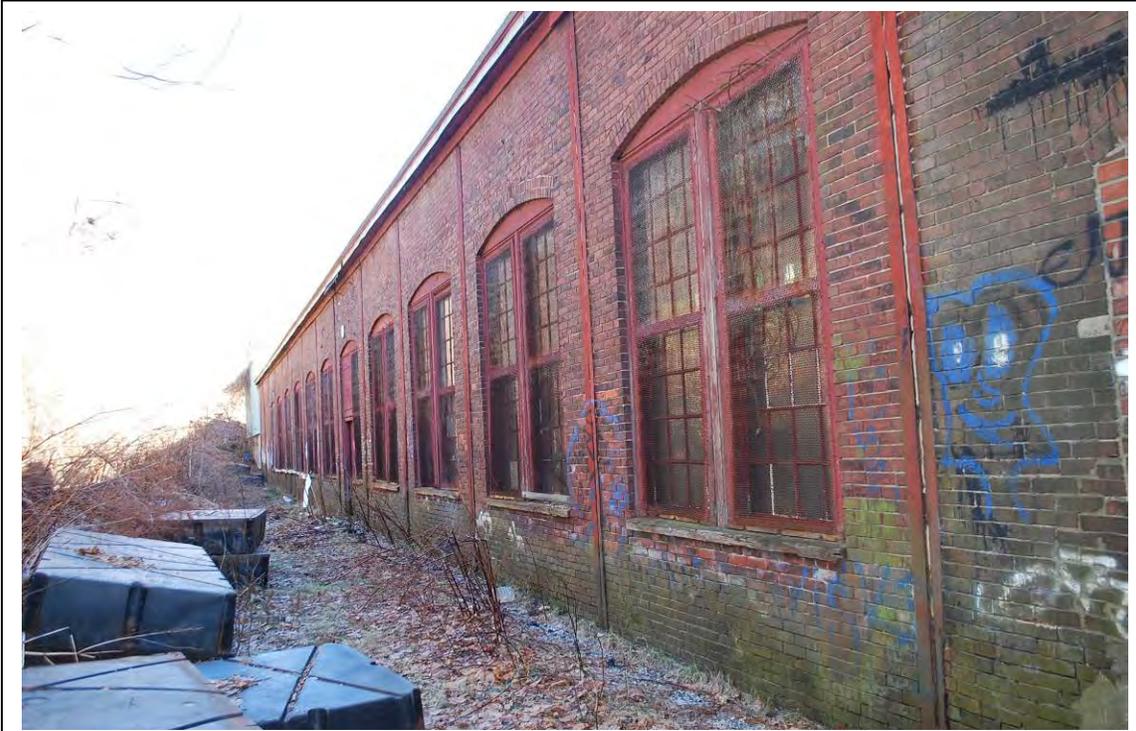
PHOTO
#4.1
R 61.jpg

Building 4: View from northwest, looking along north elevation. Hill descending from left drains substantial water toward the Building 4 foundation, and plant growth limits available sunlight in summer months.

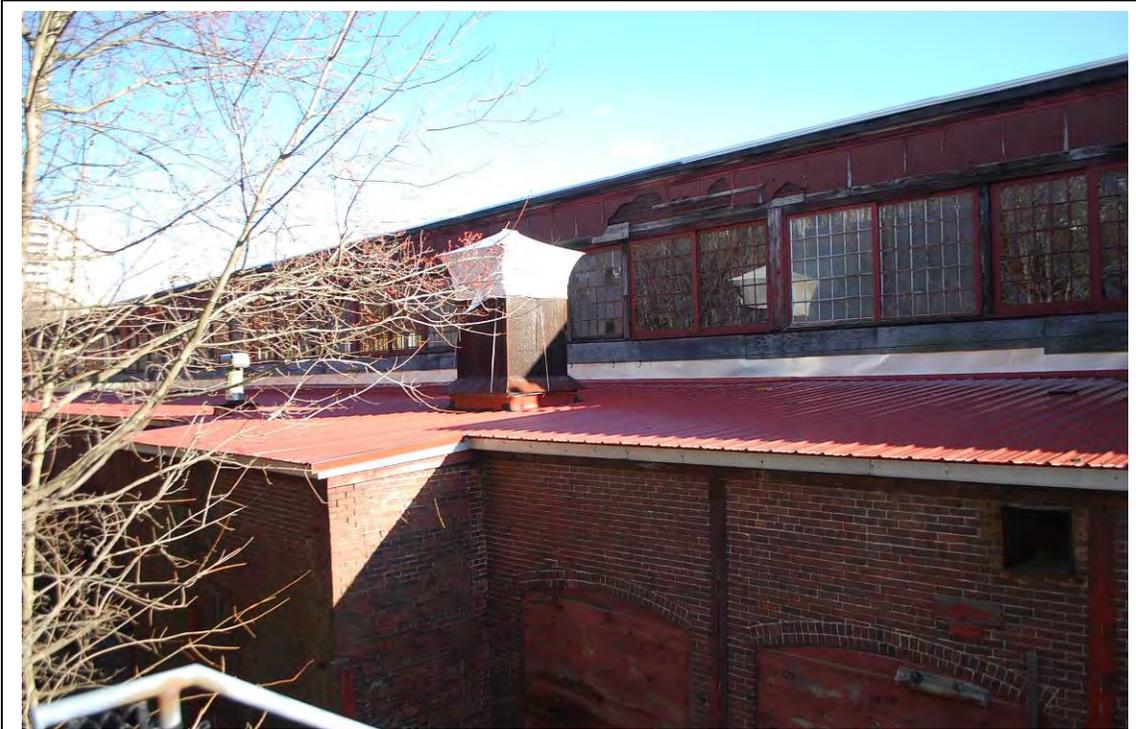
PHOTO
#4.2
R 65.jpg

Building 4: View looking east shows 30-light clerestory windows. As a foundry building, snow loads likely never accumulated on the roof while the foundry was operational. Since closing, snow loads can accumulate on roof.

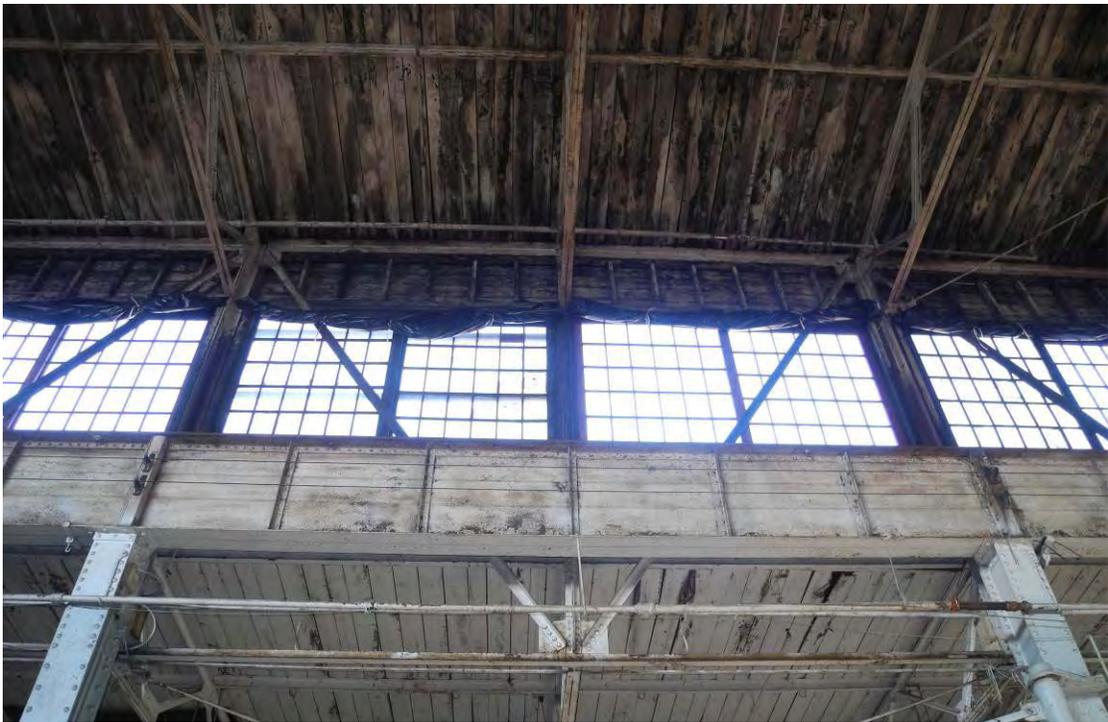
PHOTO
#4.8
A 30 109.jpg

Building 4: South-facing upper wall and clerestory roof, with significant wood staining and possible rot. Continuous crane rail is visible in the foreground.

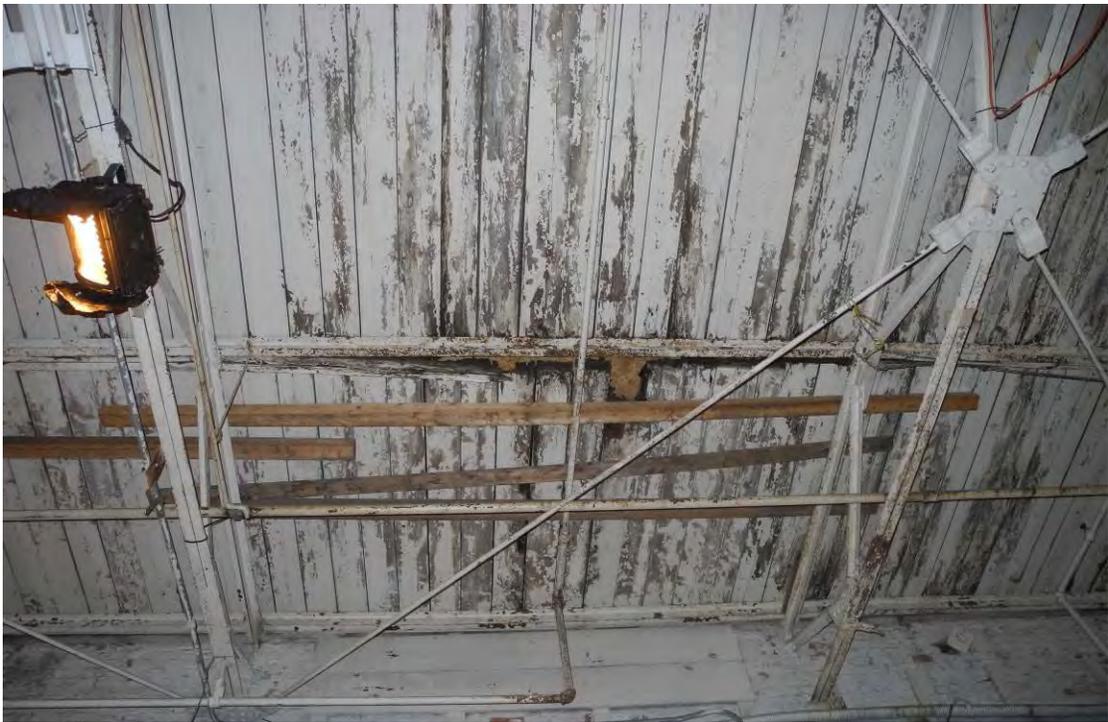
PHOTO
#4.10
A 3 40.jpg

Building 4: North bay roof decking: Local roof sheathing rot supported by multiple 2x framing members spanning between trusses.

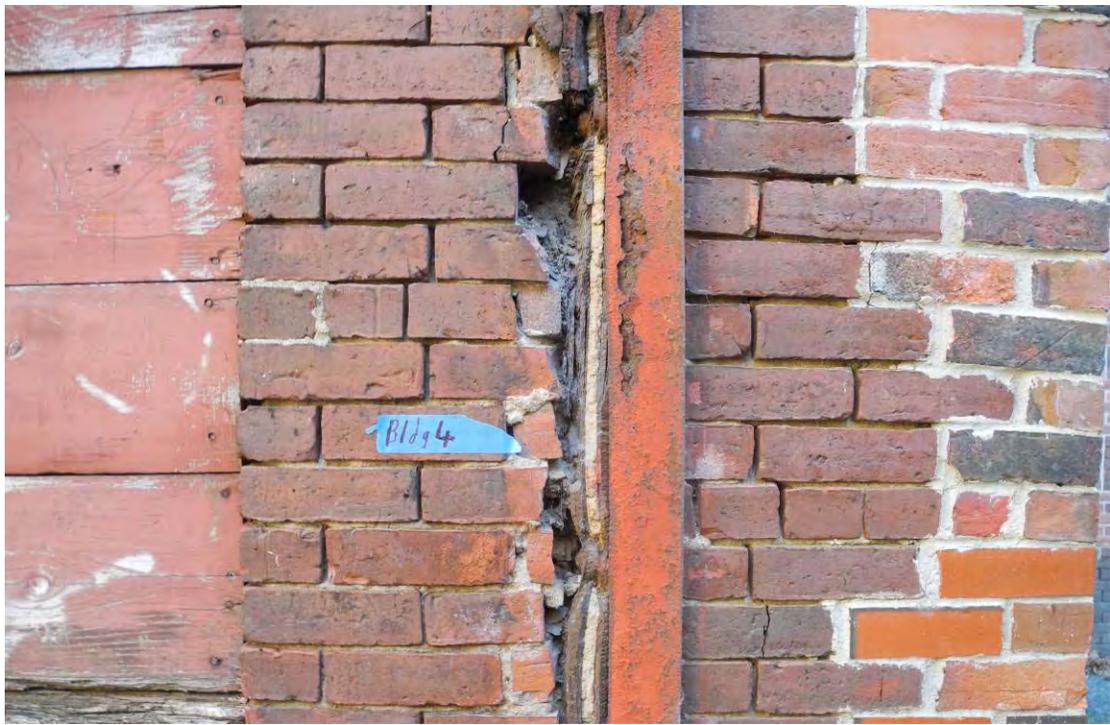
PHOTO
#4.11
A 29 49.jpg

Building 4: Significantly deteriorated built-up angle column. Constant exposure to a shoreline environment, along with inherent construction flaw, caused failure of these columns for several feet above the base.

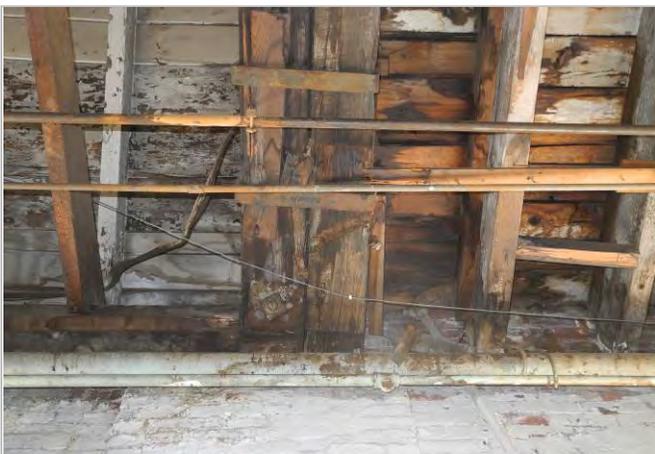
PHOTO #6B.5
A 30 02.jpg

Building #6B west end roof truss: Deteriorated south end of roof truss. Building #6A second floor visible at right. Provide temporary shoring beneath truss.

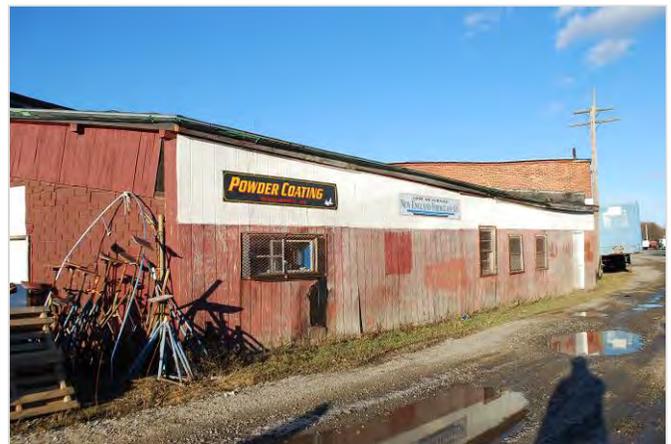
PHOTO #7.4
R 108.jpg

Building 7: Back shed addition, in very poor condition. Site pitches back toward the building immediately beneath eaves.

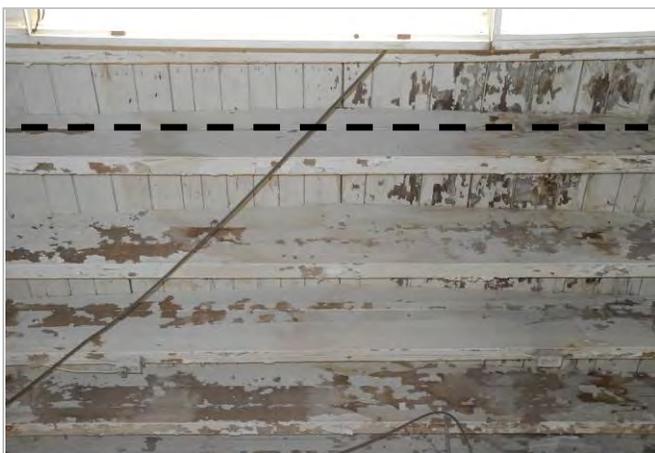
PHOTO #7.5
A 30 15 .jpg

East end unit: Conventional flat rafters with tapered shim on top provide roof pitch in this area. Rafters appear to be significantly undersized for span length.

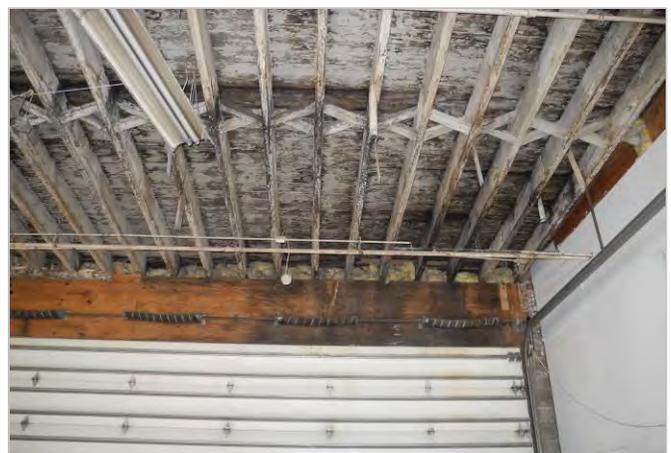
PHOTO #7.6
A 30 20.jpg

North wall overhead door opening: Roof leaking near eaves is possibly causing wall top plate rot and infiltration into masonry above steel header.

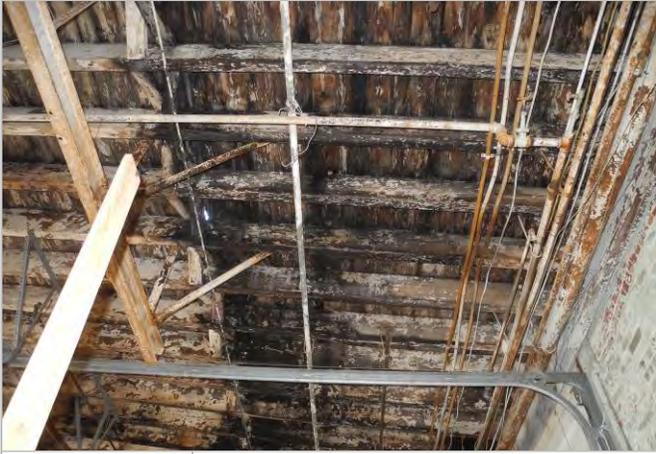
**PHOTO
#7.7**
A 30 21.jpg

Roof framing: Deteriorated rafters and sheathing at location of previous fire. North bearing wall is visible at right of photo.

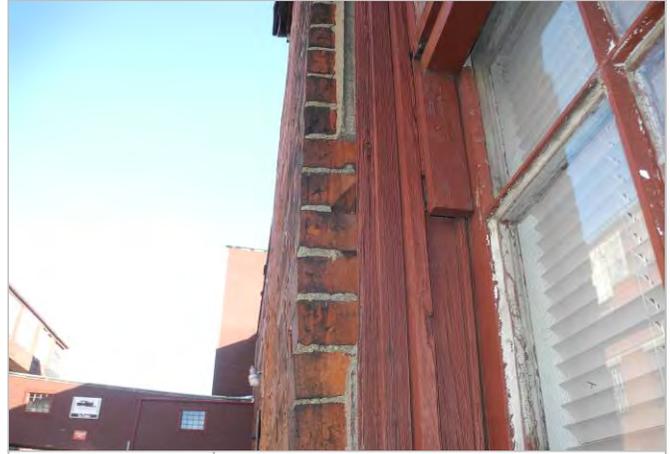
**PHOTO
#7.8**
A 30 23.jpg

North wall: Masonry suffers from significant bowing throughout and will likely need to be rebuilt, as opposed to stabilized.

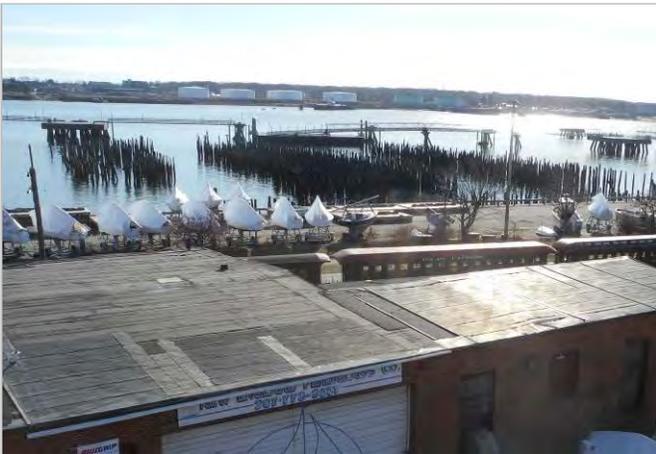
**PHOTO
#7.9**
A 30 89.jpg

Roof surfacing: Built-up asphalt roof exhibits many repairs. Open areas of the roof were visible toward the west end of the building.

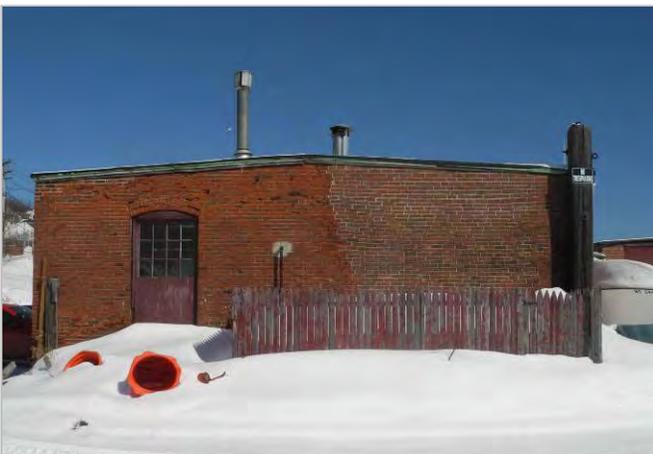
PHOTO # 10.3
A 2 93.jpg

Building 10: West elevation wall showing unstable rebuilt south half (right) and deteriorated north section (left). Original window remains at south half.

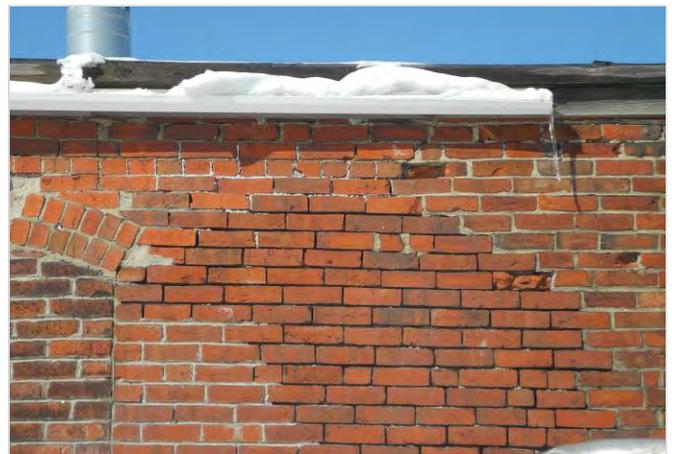
PHOTO # 10.4
A 2 92.jpg

Building 10: Loose mortar and deteriorated masonry on South elevation near infilled window. Building likely retains few of its original windows.

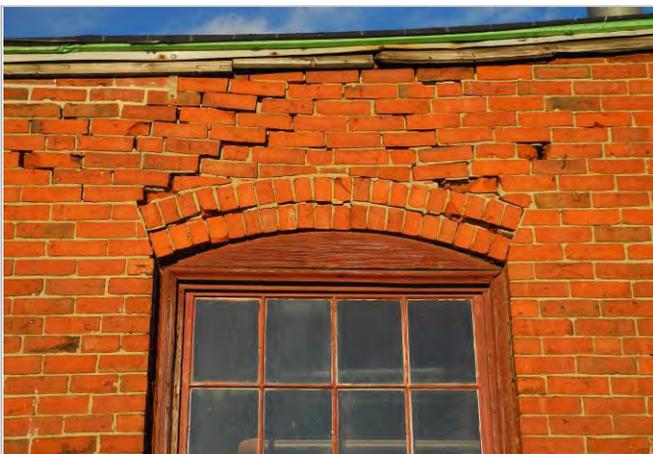
PHOTO # 10.5
A 29 114.jpg

West elevation window: Significant bow in masonry wall and failed brick. Potential exists for significant water infiltration from driven rain.

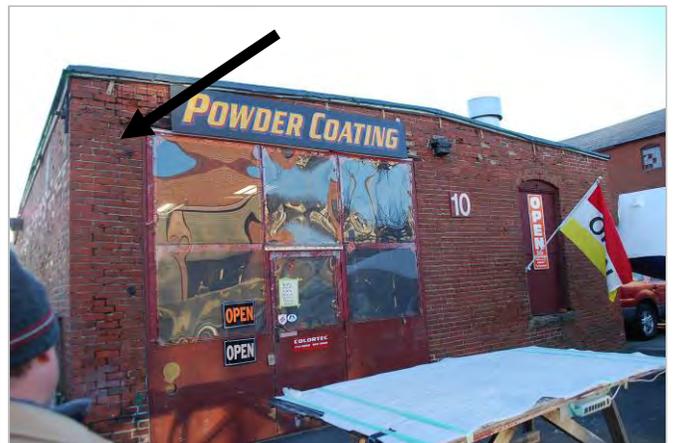
PHOTO # 10.6
R 129.jpg

East elevation (detail): Contemporary door infill. Note badly deteriorated mortar visible at left side of door and along upper roof (arrow).

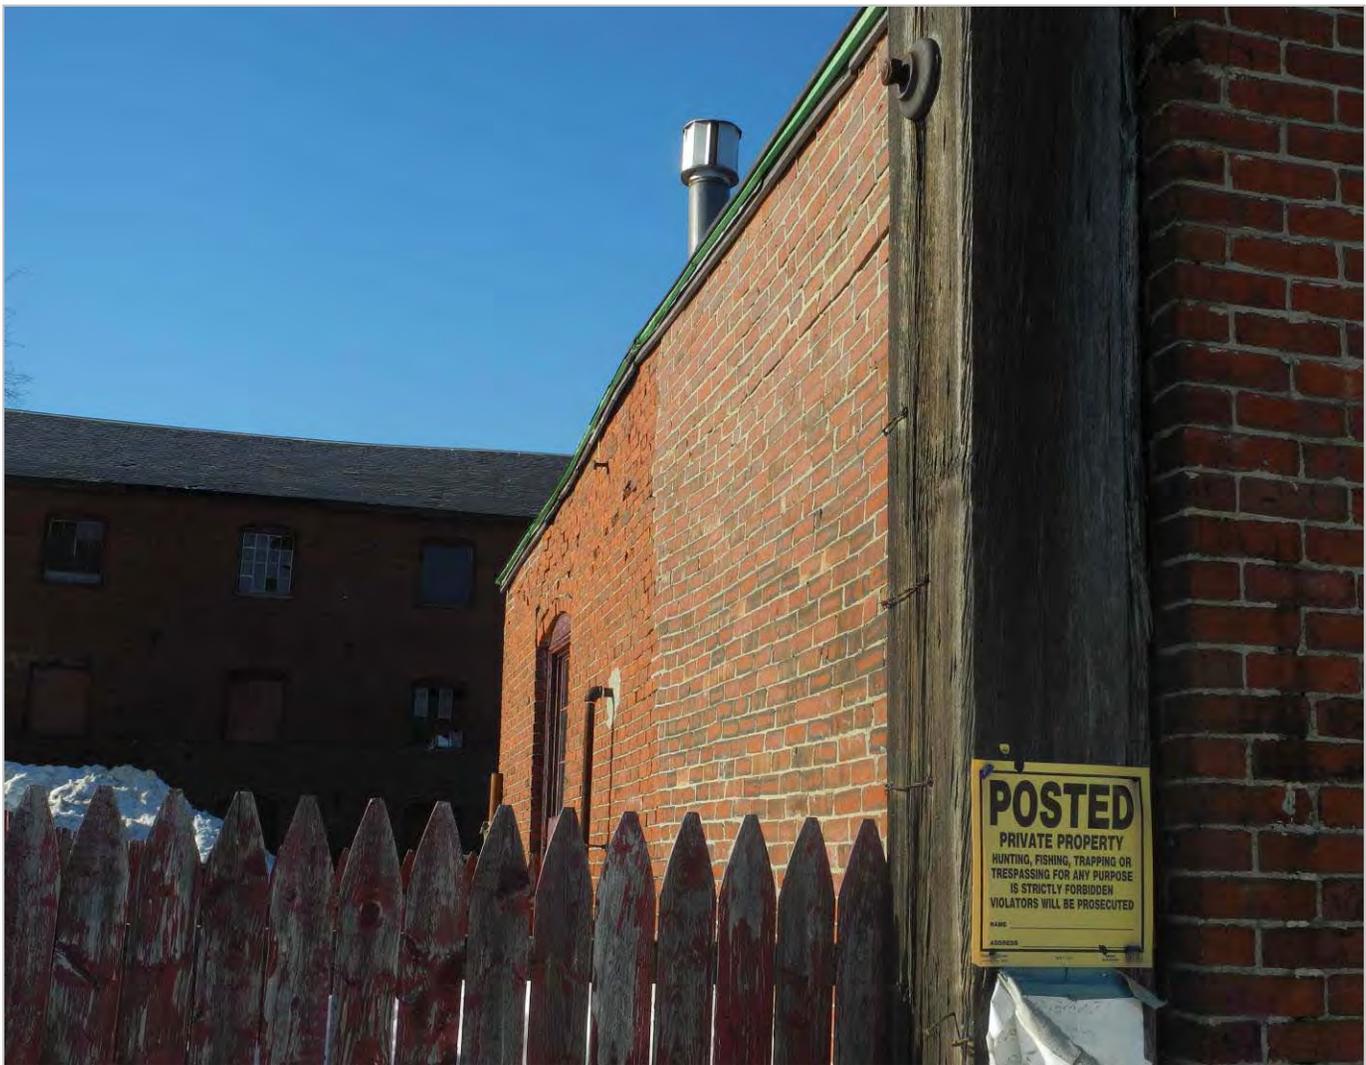
**PHOTO
10.9**
A 3 5.jpg

West elevation, viewed from south: Significantly bowed masonry at south half of wall is unstable. Upper masonry at north half of wall is in poor condition (see Photo #10.5) We concur with the BSE report that the building should not be occupied.

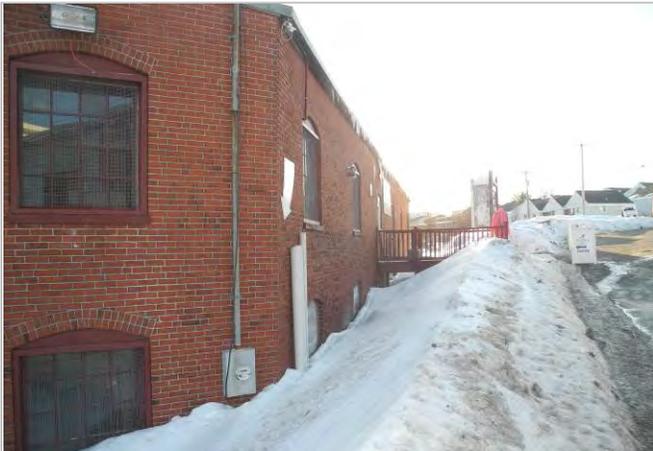
PHOTO #11.3
A 3 81.jpg

Building 11: North elevation along driveway. Snow and water accumulations lead to infiltration, mortar erosion, lateral pressures and wall failure.

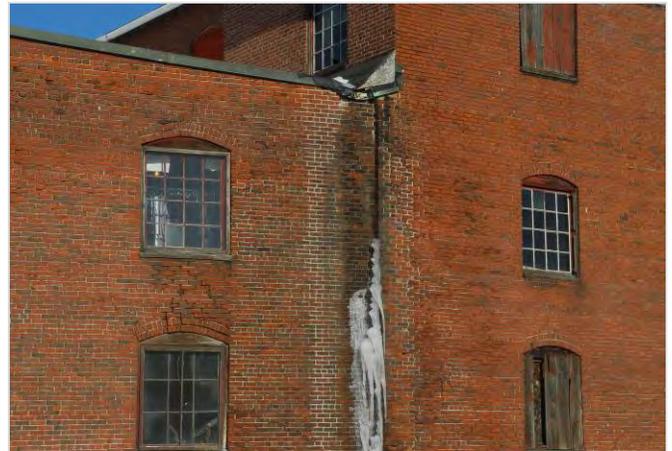
PHOTO #11.4
A 3 2.jpg

Building 11: Ice and water runoff at west wall junction between Building 11 and Building 12. Masonry repointing cured symptoms of damage, but not cause.

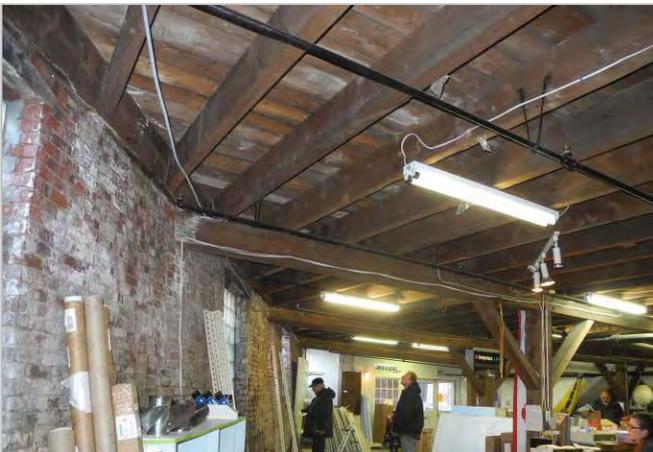
PHOTO #11.5
A 30 30.jpg

Ground floor north wall: Significant bow in masonry wall caused by lateral earth pressure and potential local rot beneath floor.

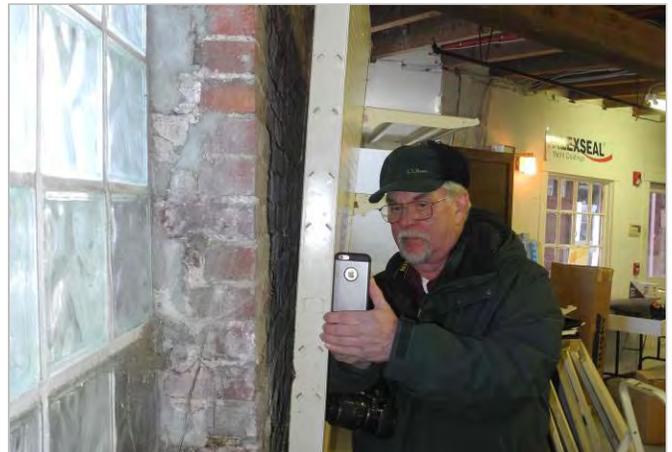
PHOTO #11.6
A 30 32.jpg

Ground floor north wall (detail): Significant bow in unstable masonry wall, caused by lateral earth pressure. Wall is bowed several inches out of plumb over four feet.

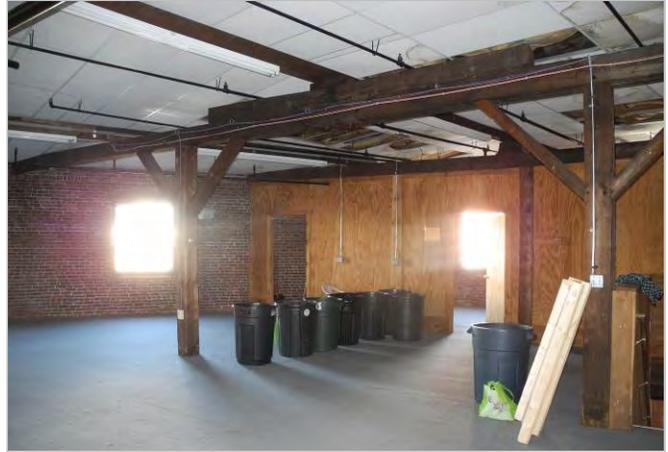
**PHOTO
#11.8**
A 30 45.jpg

Second floor assembly space, east end: Barrels beneath multiple active roof leaks.

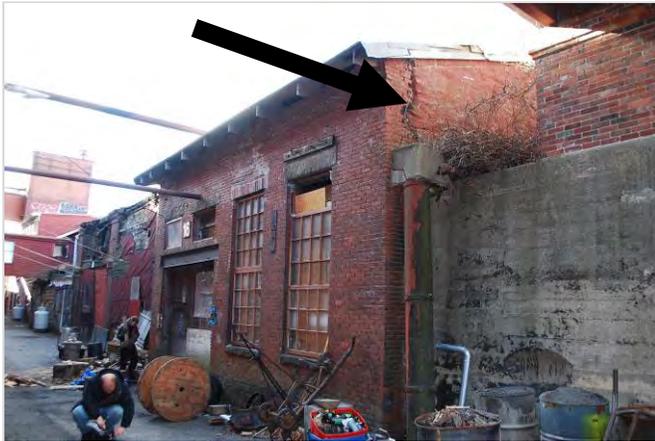
PHOTO #16.1
R 57.jpg

Building 16: View from southeast from alleyway. Note masonry wall return cracks on east elevation (arrow).
