Capisic Pond Habitat Restoration and Enhancement Project

Capisic Pond Park in Portland, Maine

Year Three Post Construction Monitoring Report

DECEMBER 2019

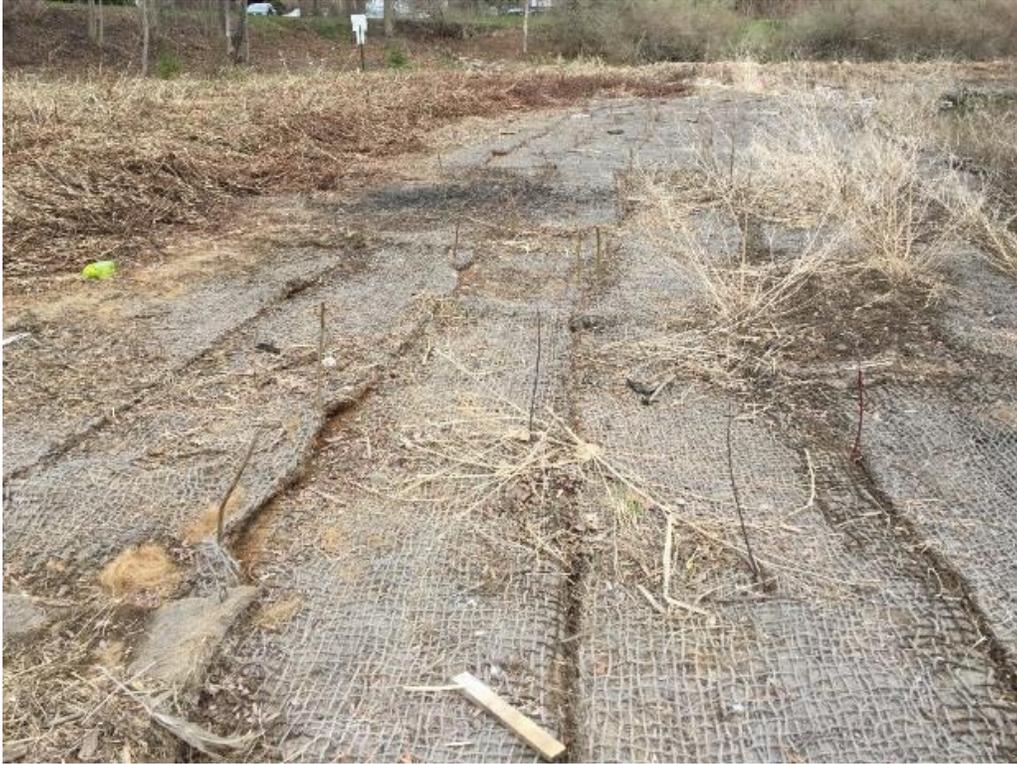
Photo 1: Live stake plantings on western bank, facing north (May 2018).

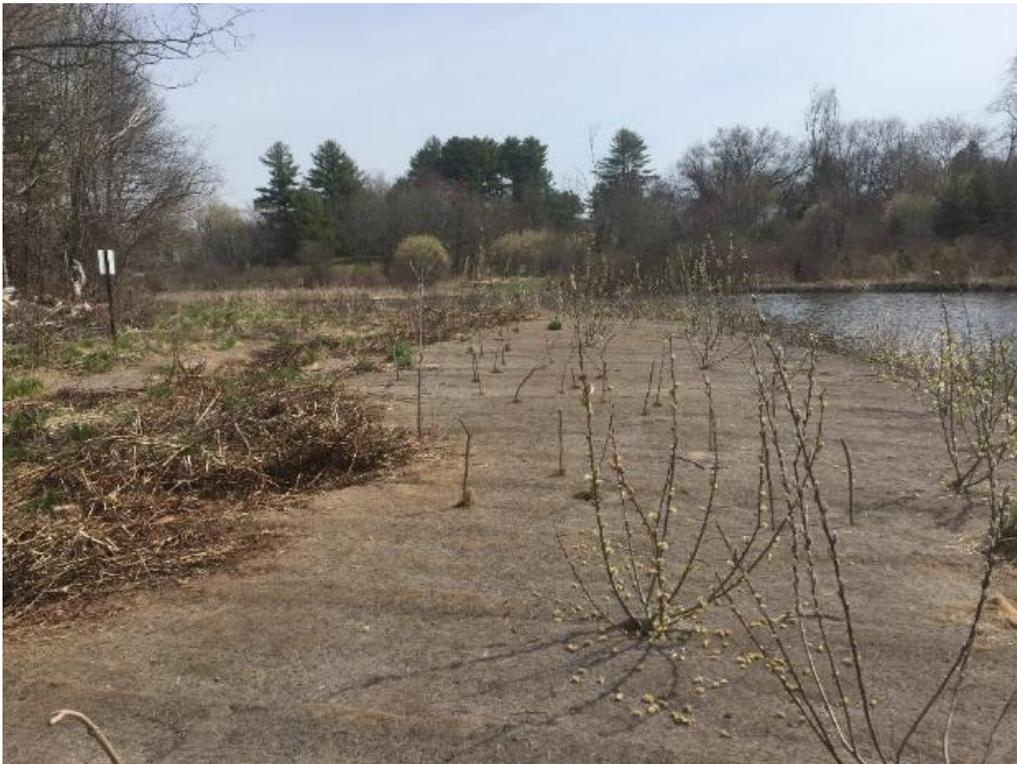
Photo 2: Pussy willow shrubs thriving on northern bank, facing east (May 2018).

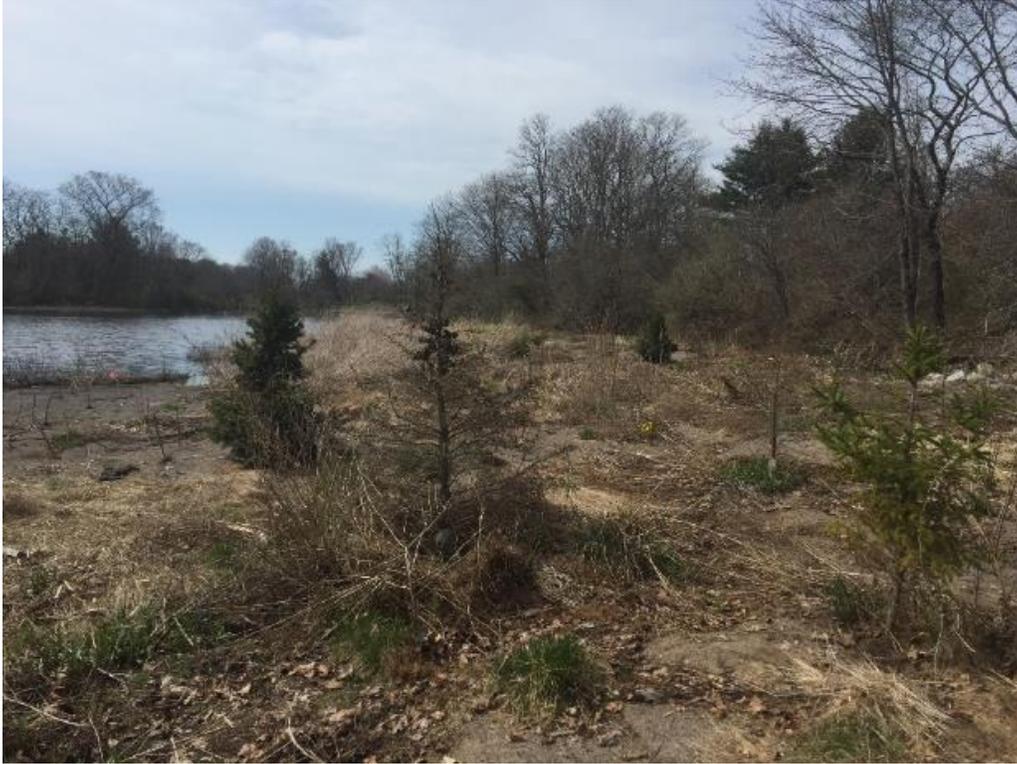
Photo 3: Dead evergreens were replaced on western bank (May 2018).

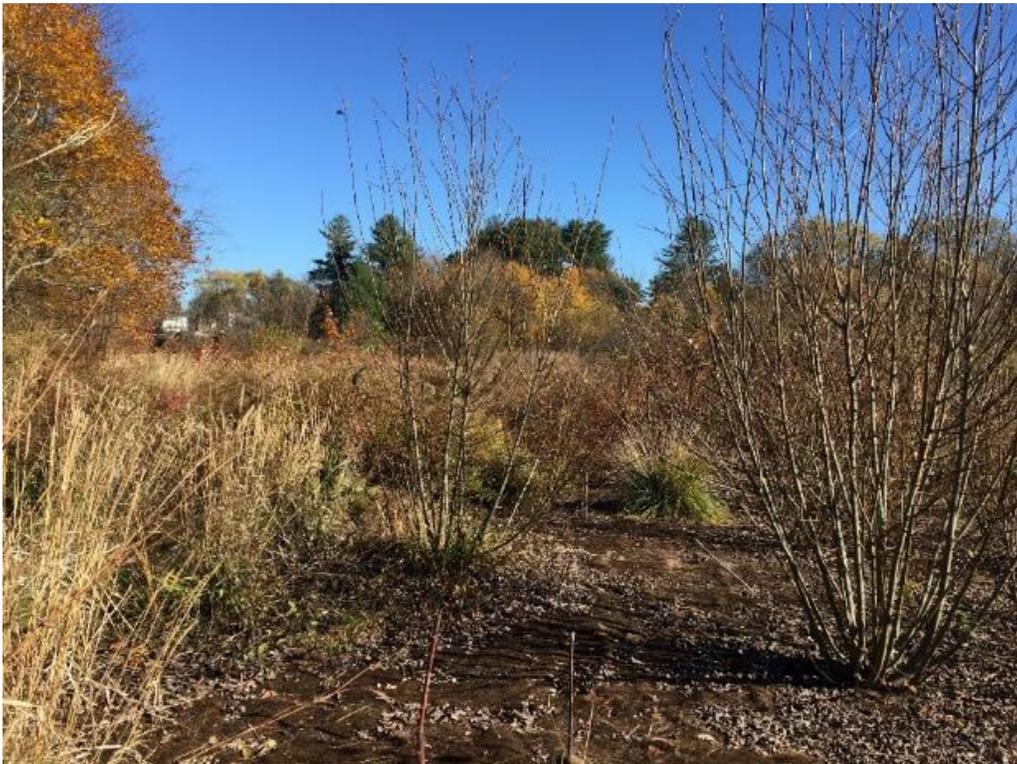
Photo 4: Significant growth in height of pussy willow shrubs (Nov 2018).

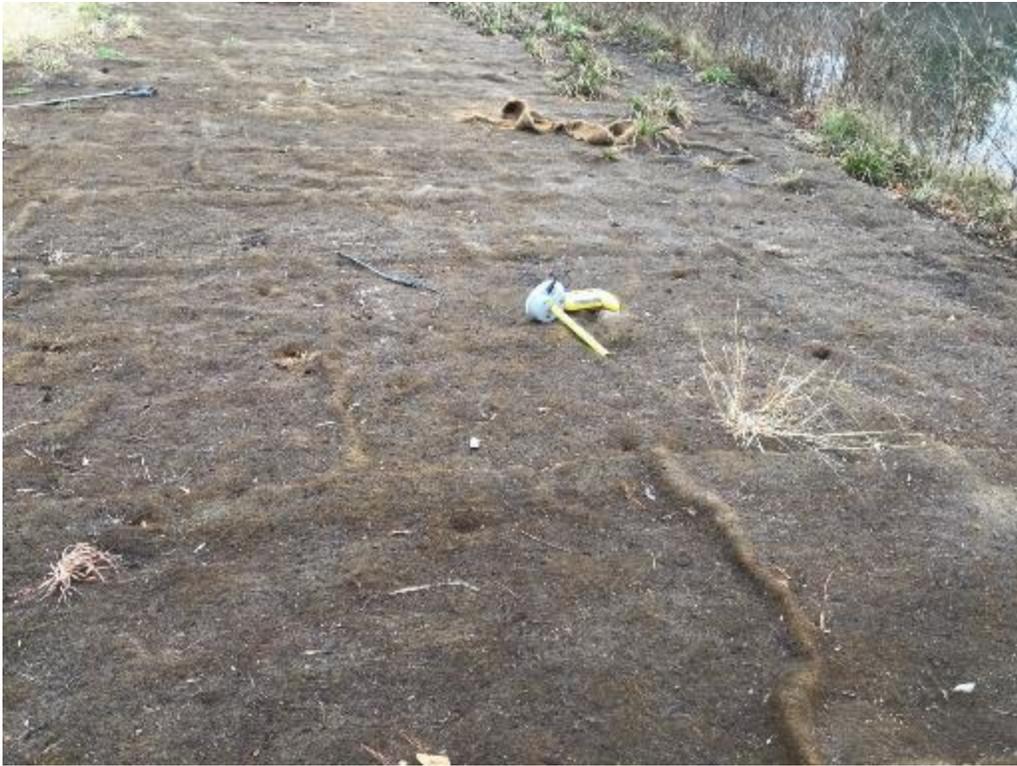
Photo 5: Plot H-1 (herbaceous, square plot, year 1). View of riparian planting area, facing northeast (12/1/2017).

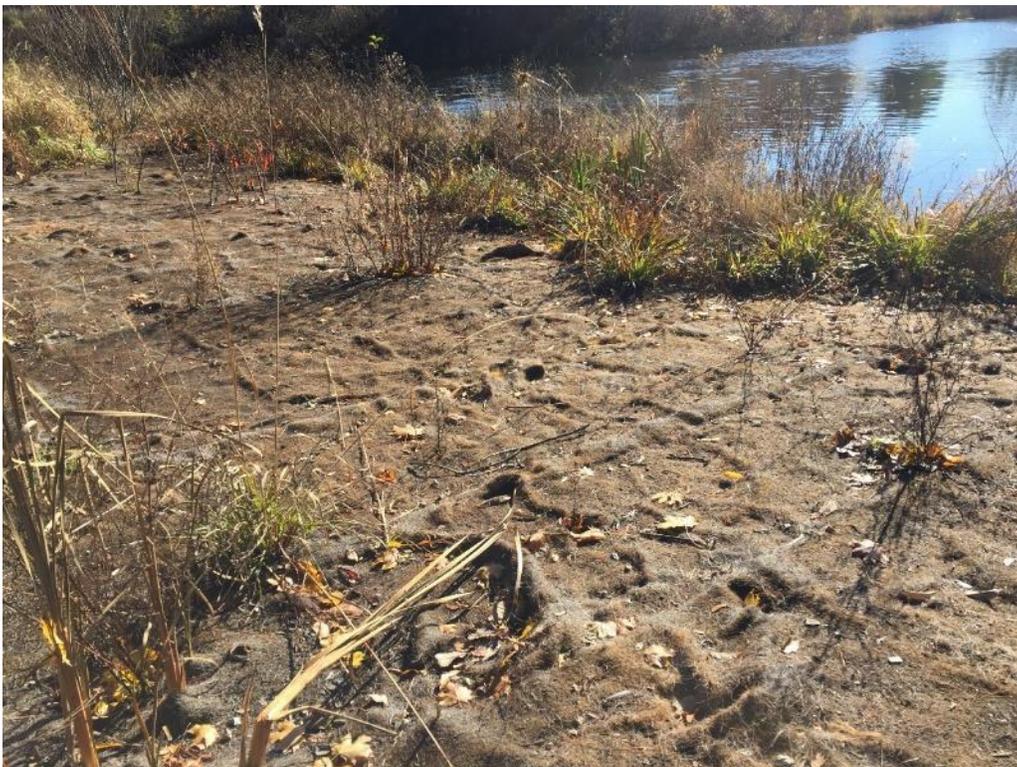
Photo 6: Plot H-1 (year 2). Facing southeast. Cattail growth has increased to the north (11/7/2018).

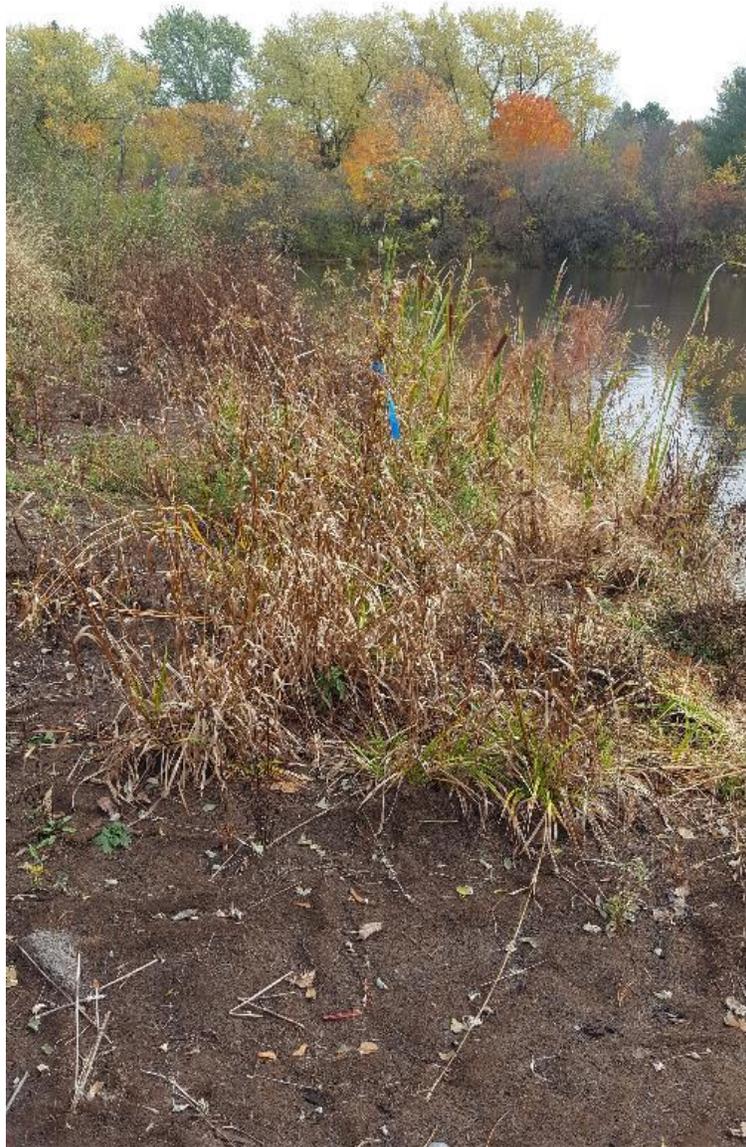
Photo 7: Plot H-1 (year 3). Volunteer vegetation is beginning to spread into plot. View facing northeast (10/23/19).

Monitors recommend installing approximately 200 willow and dogwood whips and/or live stakes to the area around plot H-1. Willow whips could be harvested onsite prior to bud burst in the

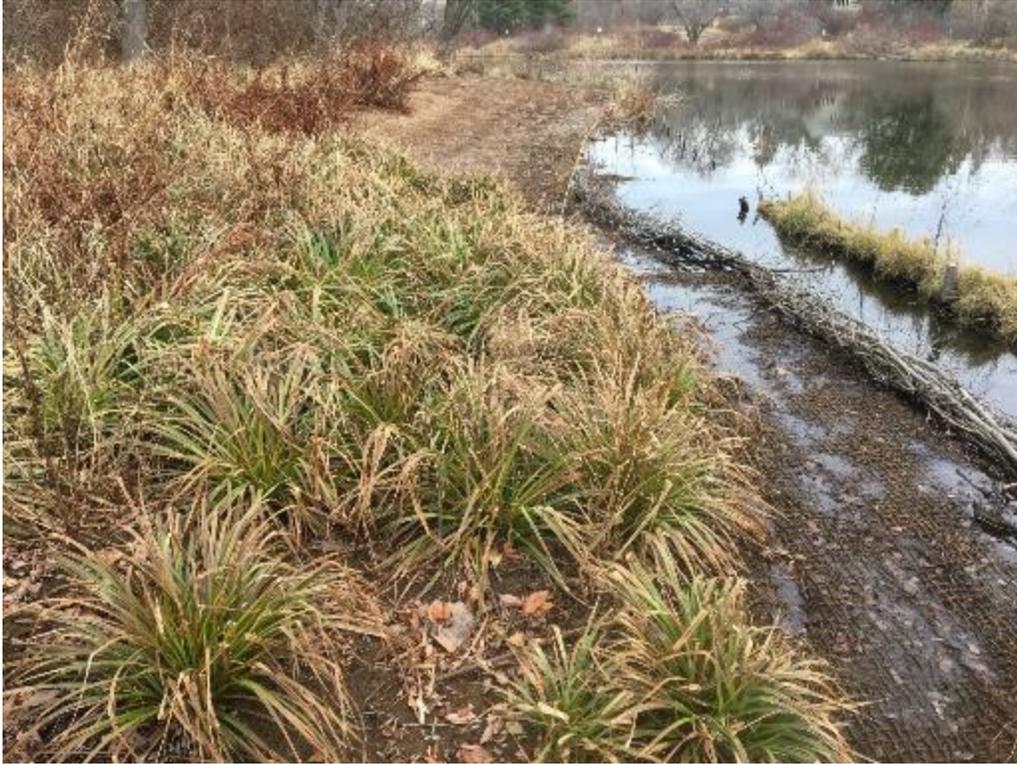
Photo 8: Plot H-2 (herbaceous plot, year 1). View along edge of pond, facing northeast (12/1/2017).

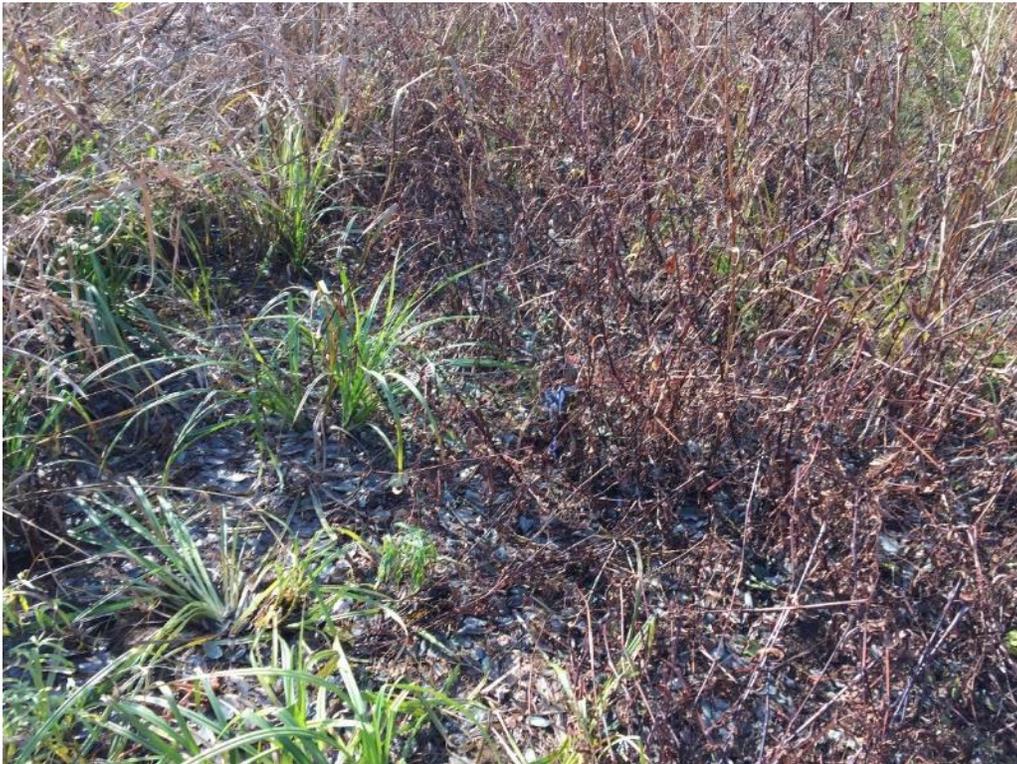
Photo 9: Plot H-2 (year 2). View of plants along the edge of pond (11/7/2018).

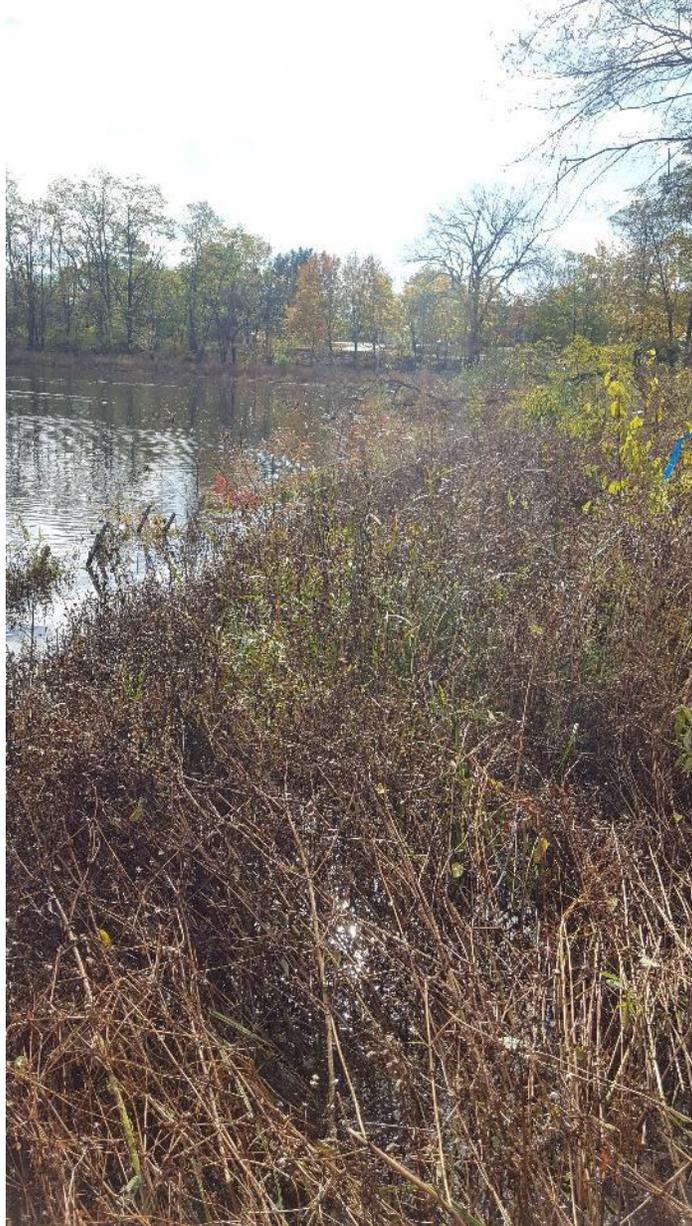
Photo 10: Plot H-2 (year 3). View facing south (10/23/2019).

Herbaceous Plot 2: Only a small area (~ 4 x 3 m) remains without vegetation due to coir fiber matting. It is recommended that approximately 100 willow and dogwood whips are installed here to help shade out and prevent colonization by invasive plants as the coir fabric begins to degrade.

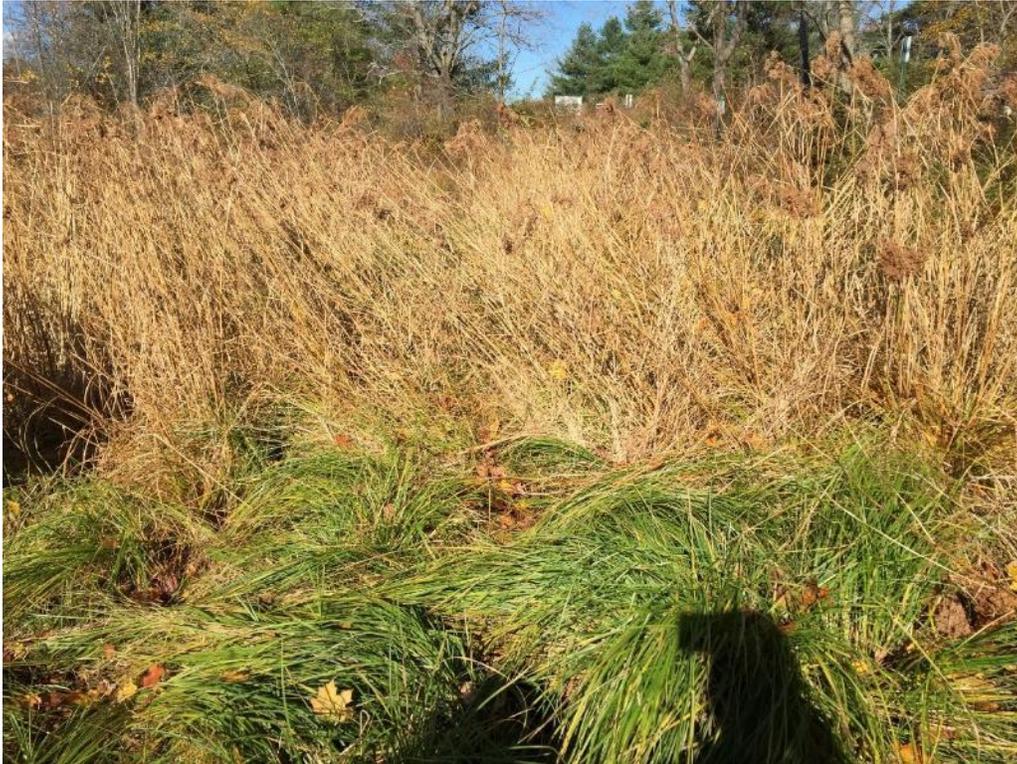
Photo 12: Plot H-3 (year 2). View of sedges that have filled and are flourishing in plot (11/7/2018).

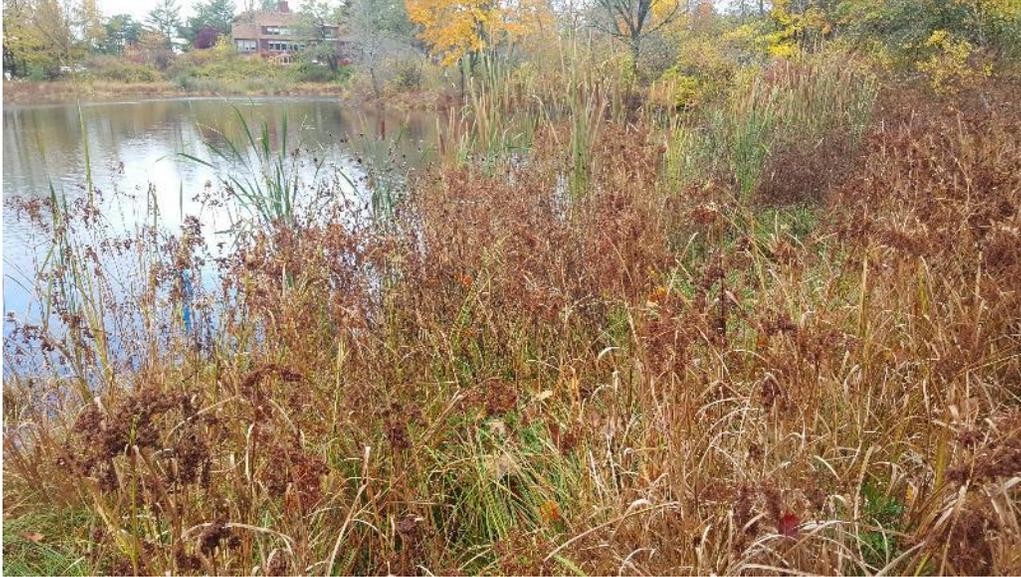
Photo 13: Plot H-3 (year 3). View of sedges and a few cattails, looking north (10/23/2019).

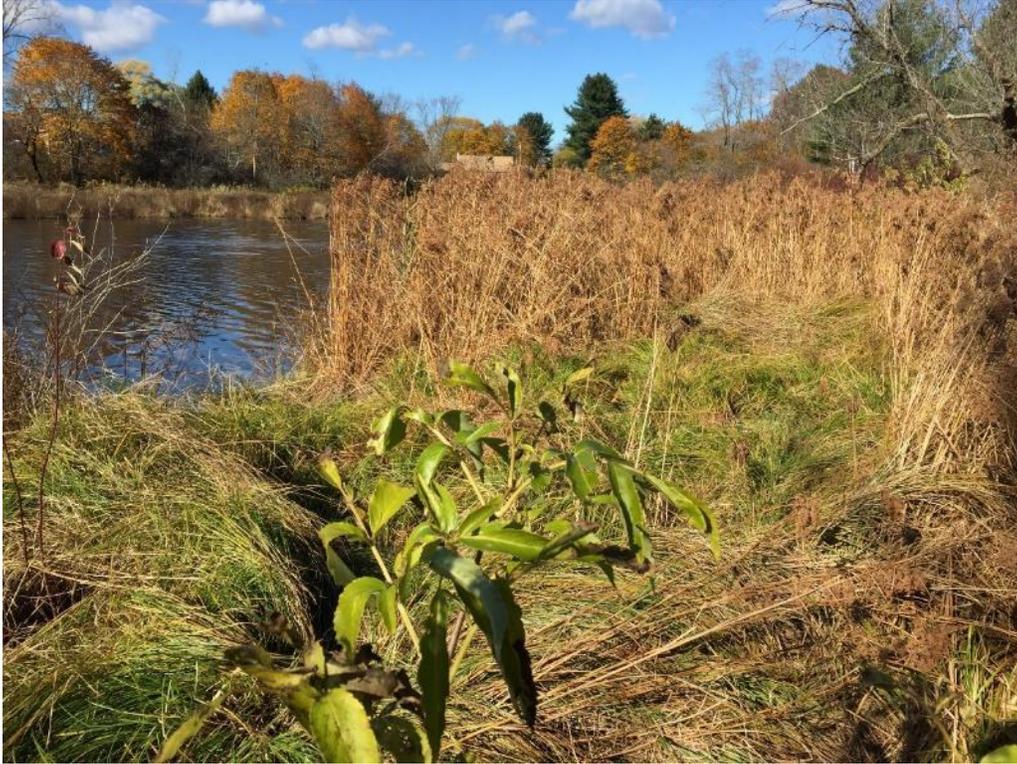
Photo 15: Plot H-4 (year 2). View of robust vegetation, facing north (11/7/2018).

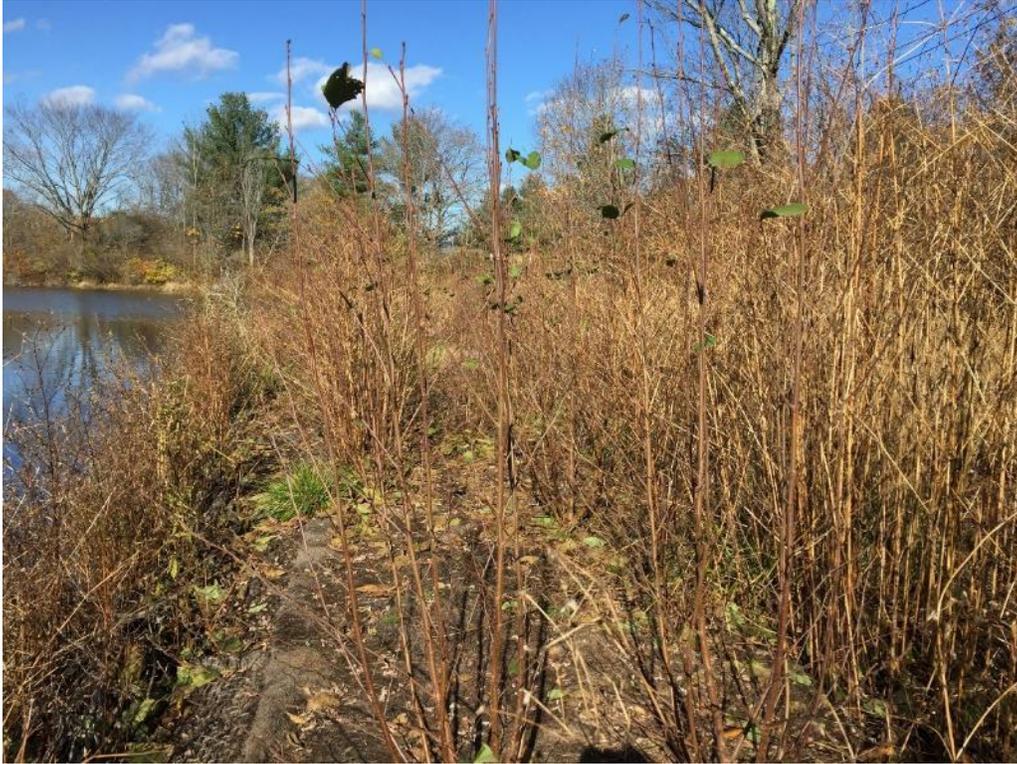
Photo 18: Plot 1 (year 2). Picture shows extensive shrub and herbaceous growth. View facing north (11/7/2018).

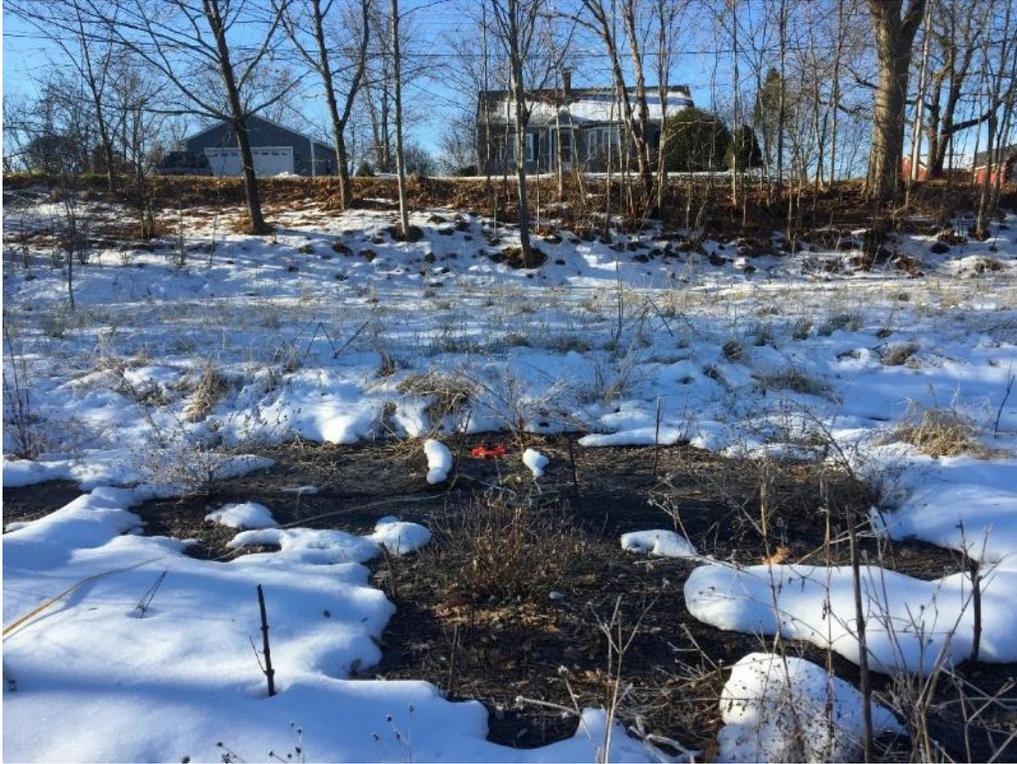
Photo 25: Plot 3 (year 2). View of new live stake plantings (11/30/2018).

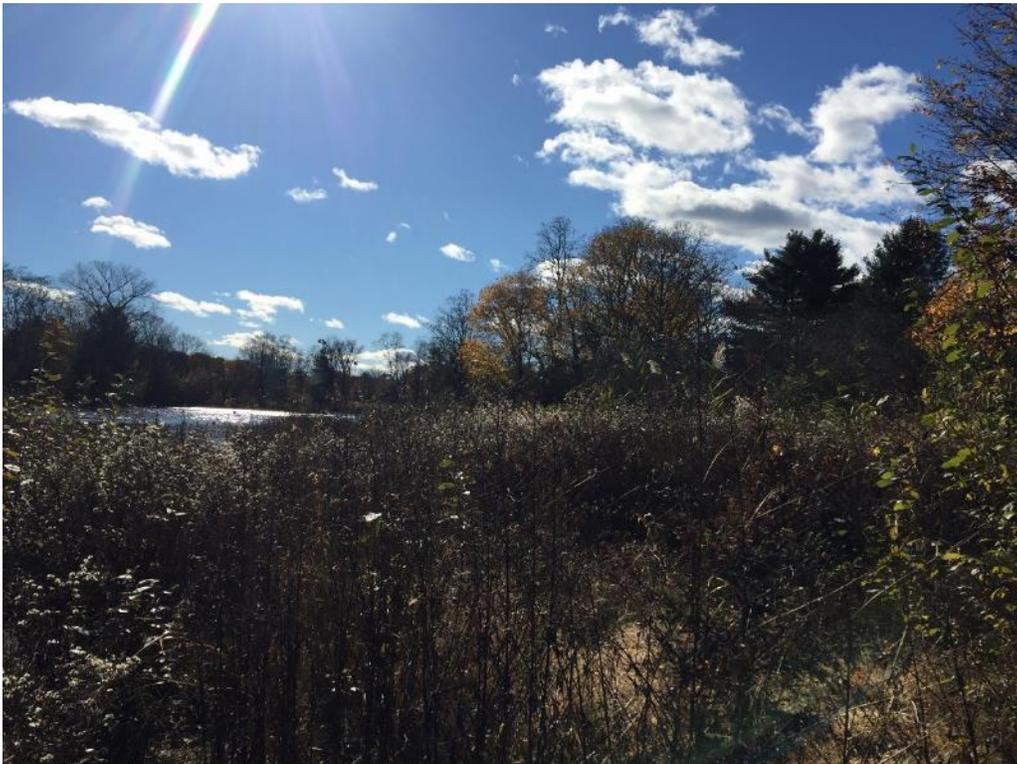
Photo 28: Transect 4 (year 2). View of heavy vegetative growth, facing south (11/7/2018).

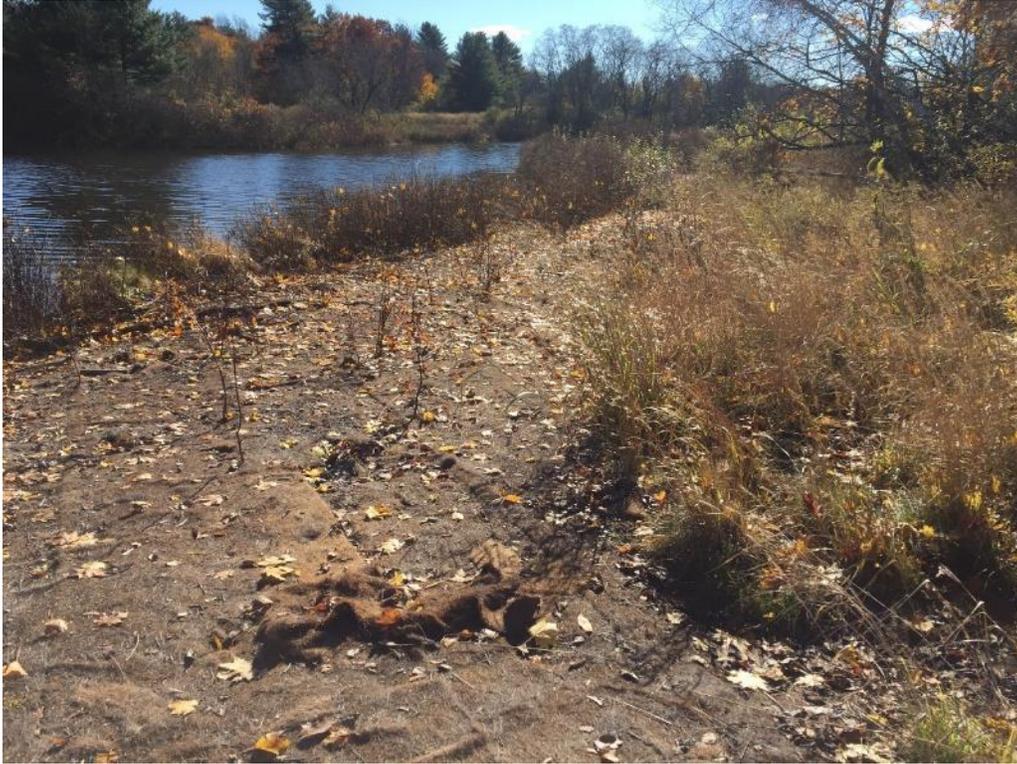
Photo 31: Plot 5 (year 2). View showing sparse growth even with new live stake plantings (11/7/2018).

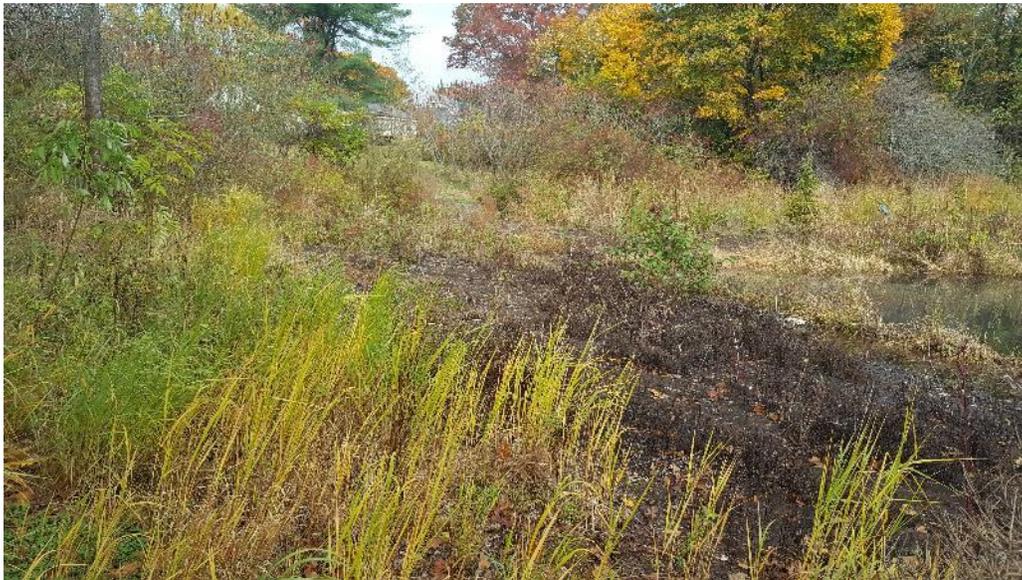
Photo 32: Plot 5 (year 3). View showing new growth meeting sparse area (10/23/19).
