CITY OF PORTLAND, MAINE
HISTORIC PRESERVATION BOARD

HISTORIC PRESERVATION BOARD AGENDA
April 4, 2018 at 5:00 p.m.
Room 209, City Hall, 389 Congress Street

**PUBLIC HEARING
61 INDIA STREET**

61 INDIA STREET - PORTLAND, MAINE MASONRY REPAIR, REPLACEMENT WINDOWS AND PROPOSED SIGNAGE MASTER PLAN

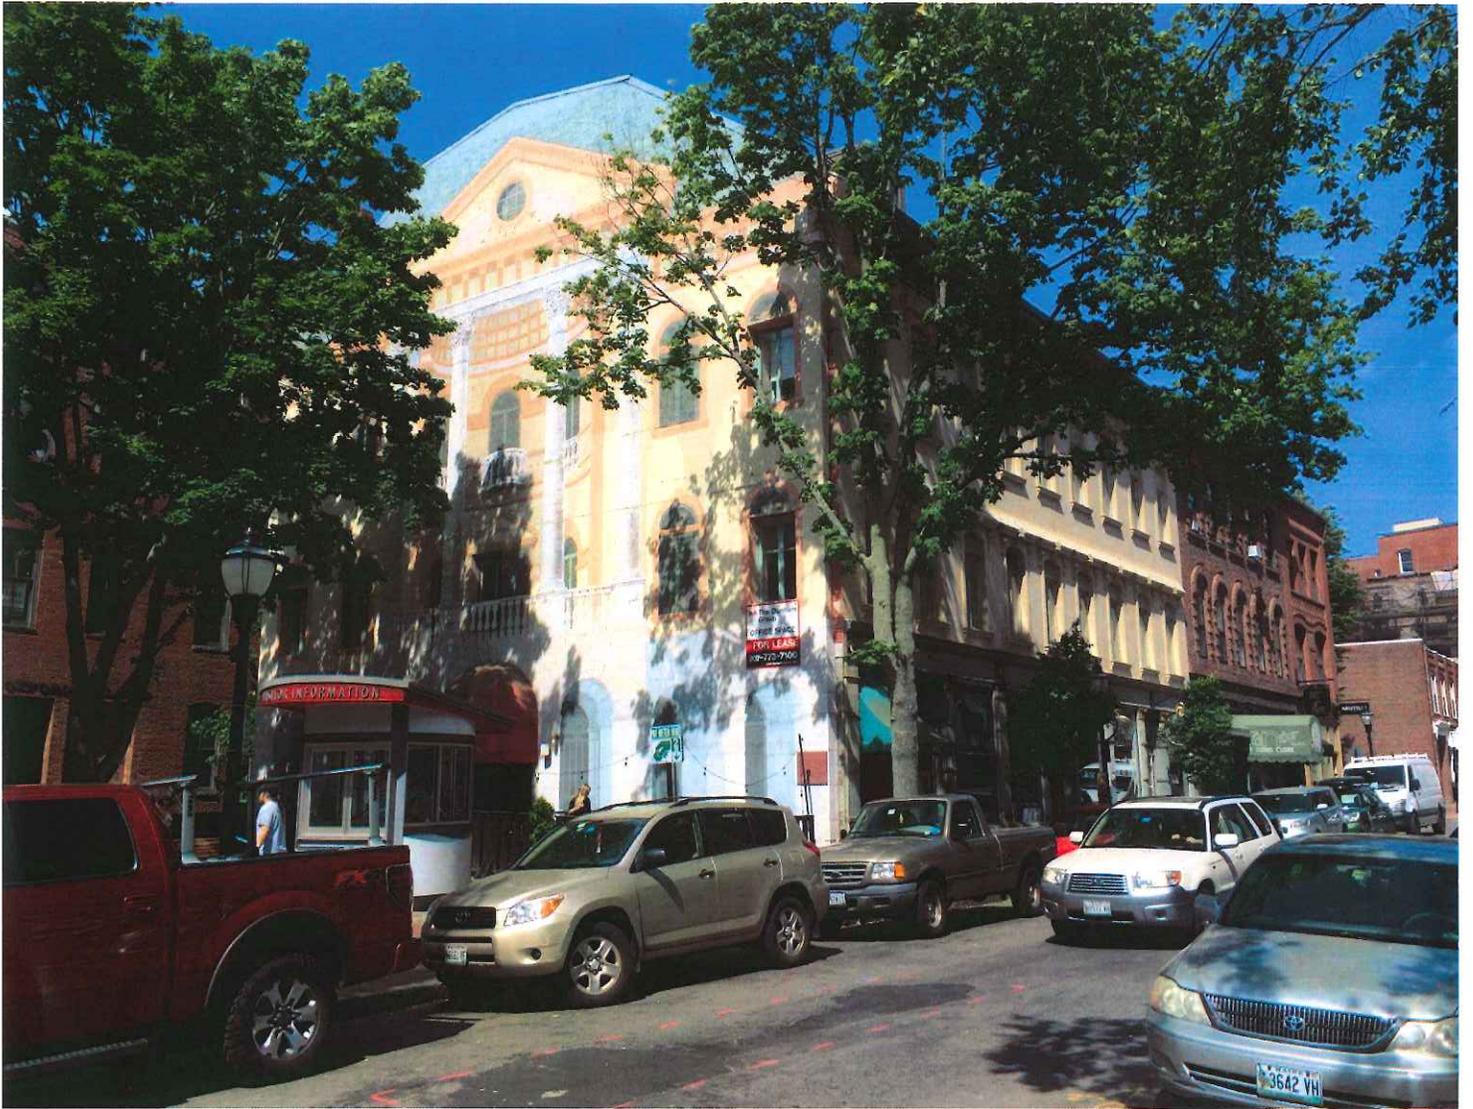
1. Photo of existing mural
2. Elevation with notes regarding proposed repairs and added window openings

This communication is to confirm that the project scope of work has been expanded to include repairs to the south wall and future replacement of the mural. Given the prominence of the mural within the Old Port Historic District, staff thought it would be appropriate for the applicant to apprise the Board of their plans for replacement of the mural—the process for selection of an artist, an estimate of how long the wall will likely be without a mural, etc. Jim Brady, a partner in 80 Exchange Street LLC, will attend Wednesday's meeting to describe this aspect of the project and how it will be approached. The final design of the mural will be subject to review and approval by the Board.

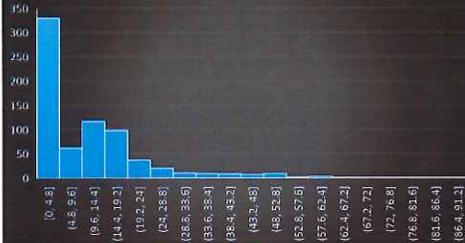
Left Side Setbacks (feet)

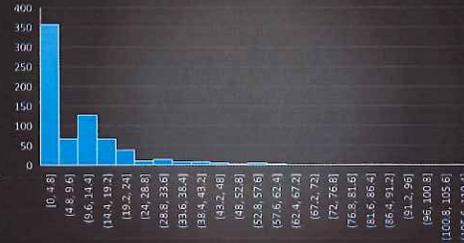
Right Side Setbacks (feet)

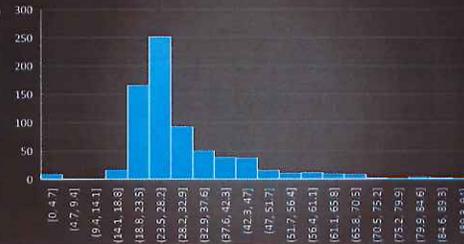
Building Widths (feet)

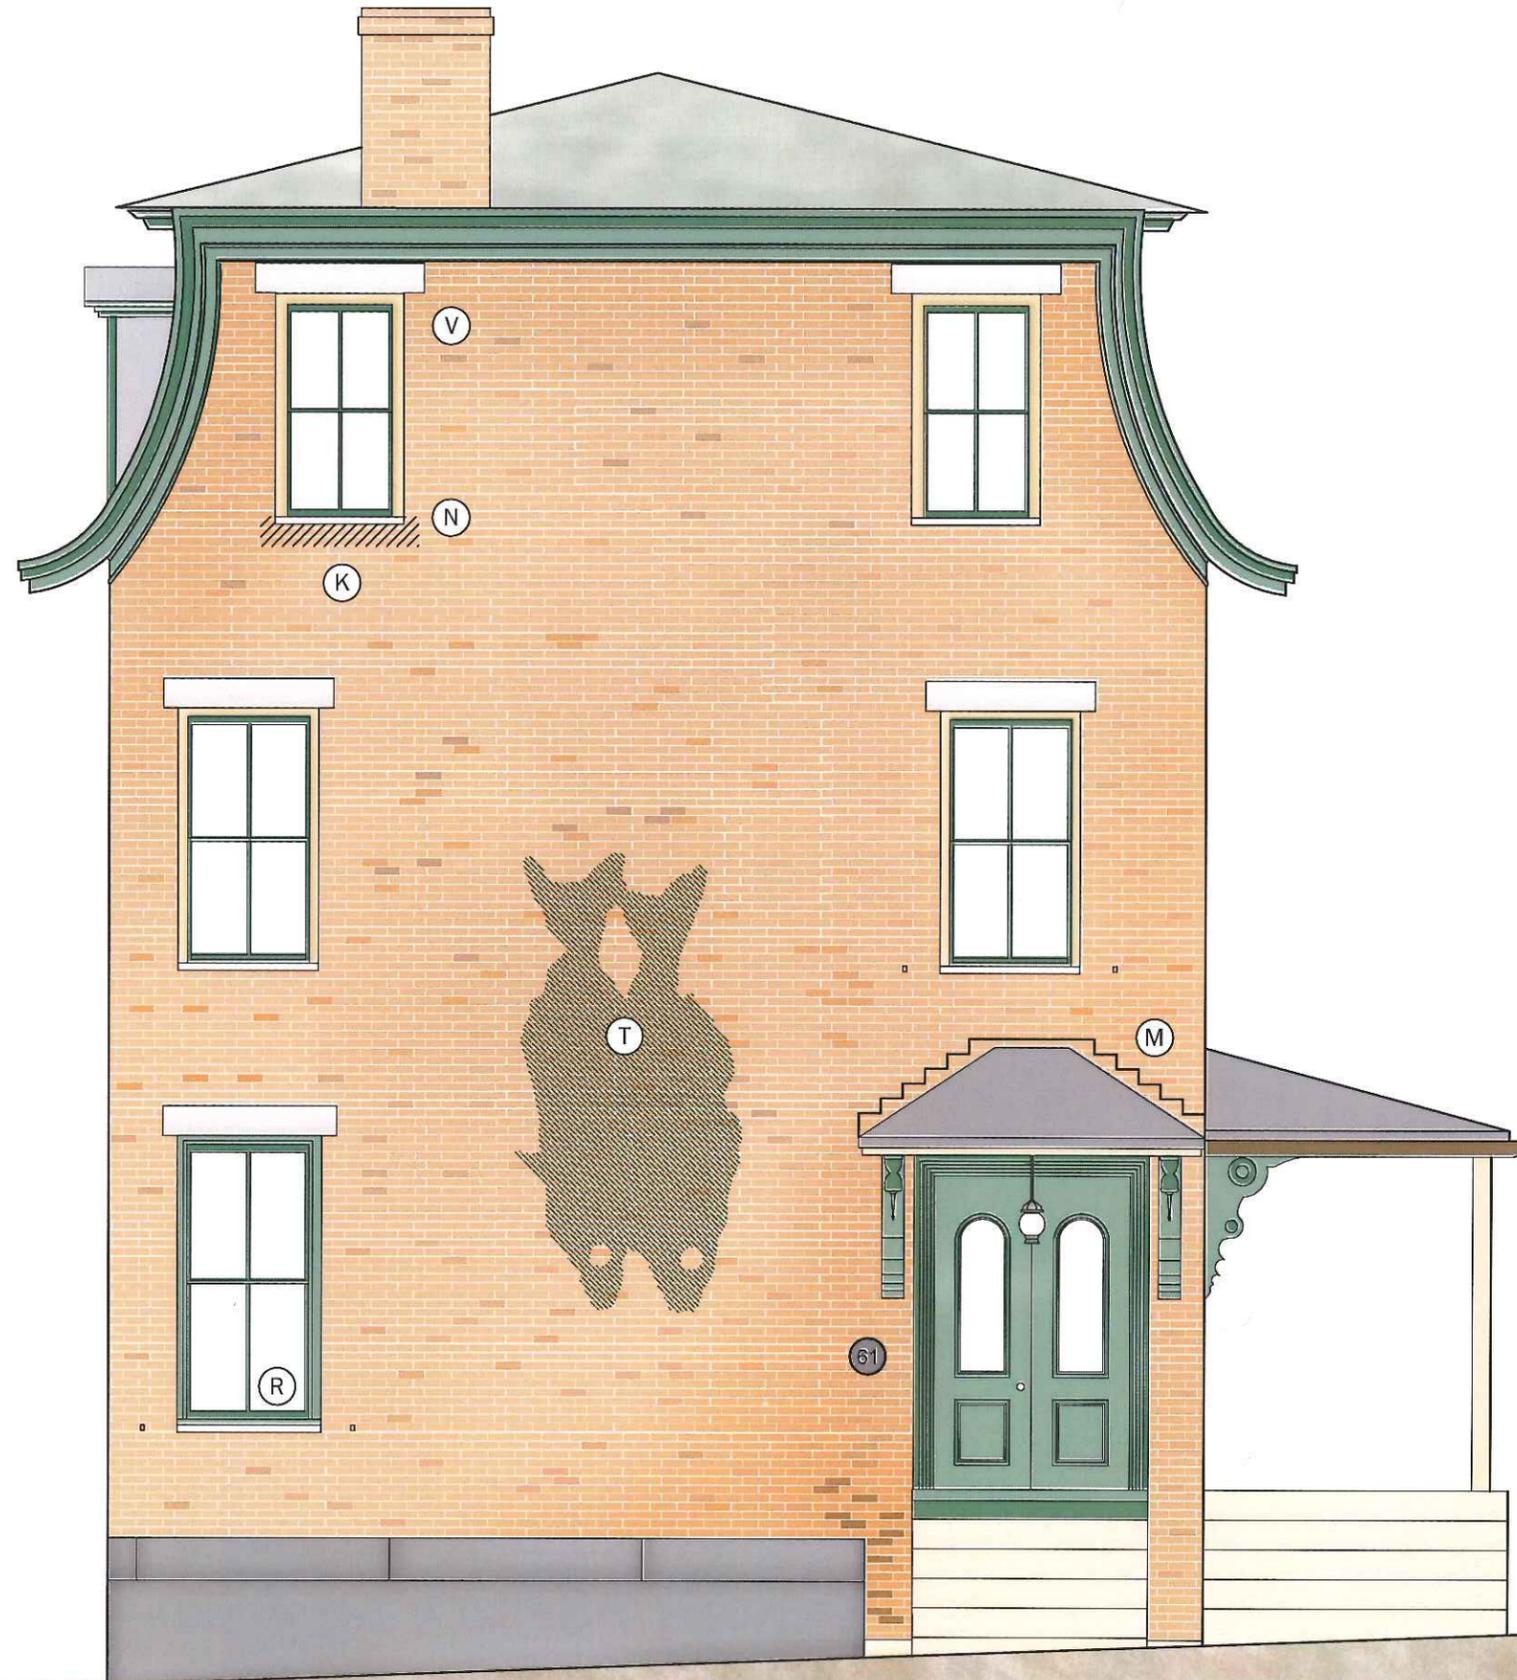
SIDE ELEVATION

- (A) DISASSEMBLE 13 CORNER BRICKS. SALVAGE 5 BRICKS. REPLACE WITH 8 MATCHING BRICKS. REBUILD. (PHOTO 6)
- (B) DISASSEMBLE 5 JAMB BRICKS. REBUILD WITH 5 MATCHING BRICKS. (PHOTO 11)

- (K) CUT AND REPOINT MORTAR JOINT WITH RESTORATION MORTAR. TYPE O, 1:2:9 TO MATCH.
- (L) REMOVE EXISTING BROWNSTONE LINTEL. REPLACE WITH GRANITE LINTEL TO MATCH SIDE FACADE.

- (R) REMOVE EXISTING, DECAYED WOOD WINDOW AND SURROUND. INSTALL NEW PELLA UNIT REPLACEMENT WITH INTEGRAL BRICKMOULD TO MATCH EXISTING REPLACEMENT UNITS.

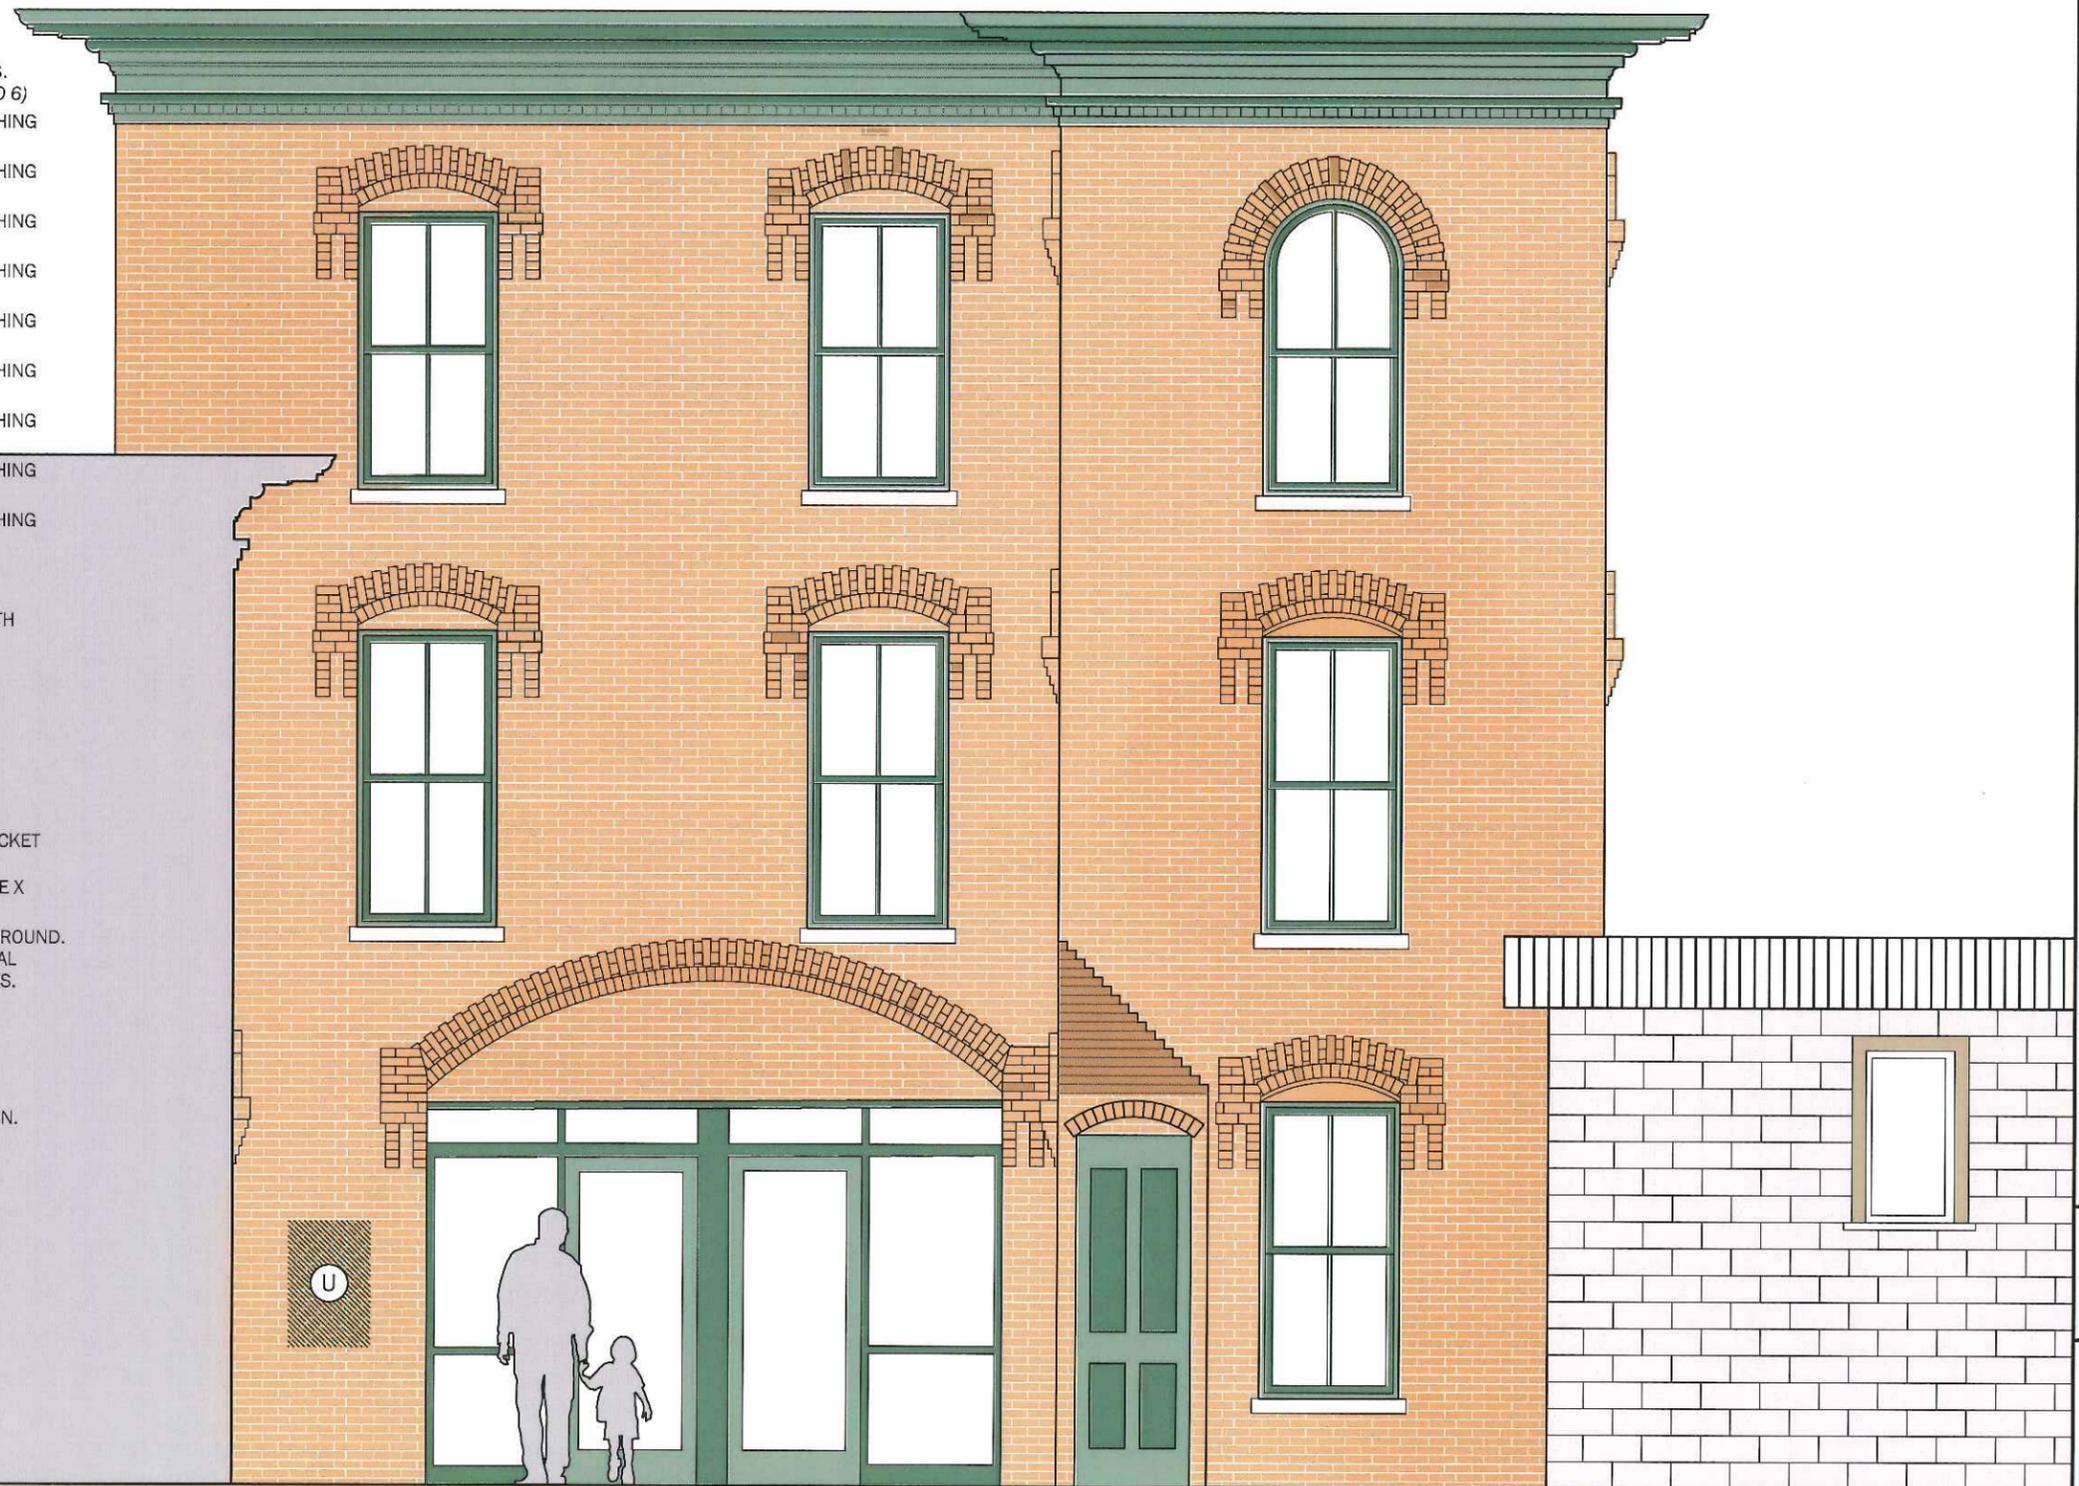
REAR ELEVATION

- (A) DISASSEMBLE 13 CORNER BRICKS. SALVAGE 5 BRICKS. REPLACE WITH 8 MATCHING BRICKS. REBUILD. (PHOTO 6)
- (B) DISASSEMBLE 5 JAMB BRICKS. REBUILD WITH 5 MATCHING BRICKS. (PHOTO 11)

- (K) CUT AND REPOINT MORTAR JOINT WITH RESTORATION MORTAR. TYPE O, 1:2:9 TO MATCH.
- (L) REMOVE EXISTING BROWNSTONE LINTEL. REPLACE WITH GRANITE LINTEL TO MATCH SIDE FACADE.

- (R) REMOVE EXISTING, DECAYED WOOD WINDOW AND SURROUND. INSTALL NEW PELLA UNIT REPLACEMENT WITH INTEGRAL BRICKMOULD TO MATCH EXISTING REPLACEMENT UNITS.

- (S) RESERVED ZONE FOR FUTURE CUSTOM SIGN BOARD. 12 FEET SQ.
- (T) RESERVED ZONE FOR FUTURE CUSTOM SIGN BOARD. 30 FEET SQ.
- (U) RESERVED ZONE FOR FUTURE CUSTOM DIRECTORY SIGN. 6 FEET SQ.

- (V) REMOVE EXISTING SIGN BRACKET. PATCH HOLES WITH RESTORATION MORTAR.

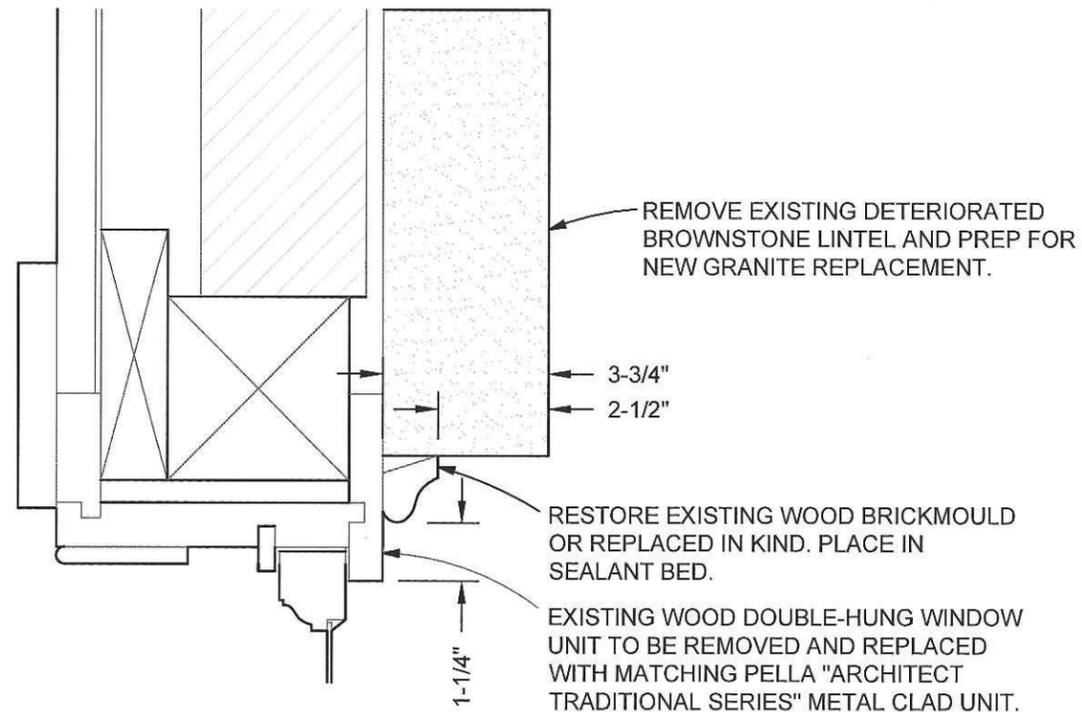
1
A1.4 EXISTING WINDOW HEAD CONDITION
3" = 1'-0" (ON 22 X 34 SHEET)

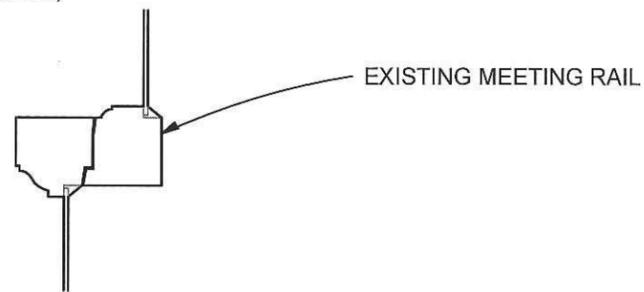
2
A1.4 EXISTING MEETING RAIL CONDITION
3" = 1'-0" (ON 22 X 34 SHEET)

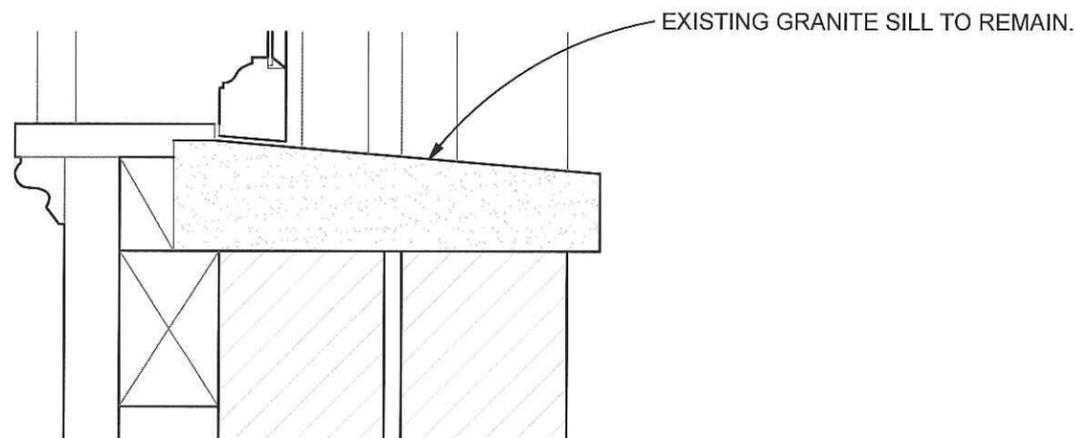
3
A1.4 EXISTING WINDOW SILL CONDITION
3" = 1'-0" (ON 22 X 34 SHEET)

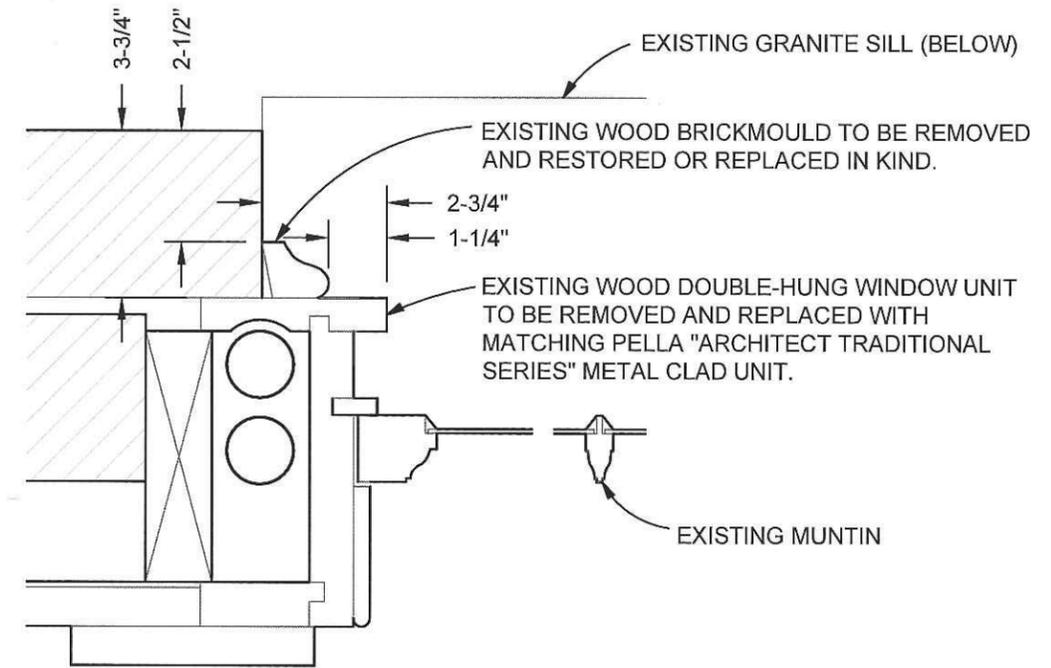
4
A1.4 EXISTING WINDOW JAMB CONDITION
3" = 1'-0" (ON 22 X 34 SHEET)

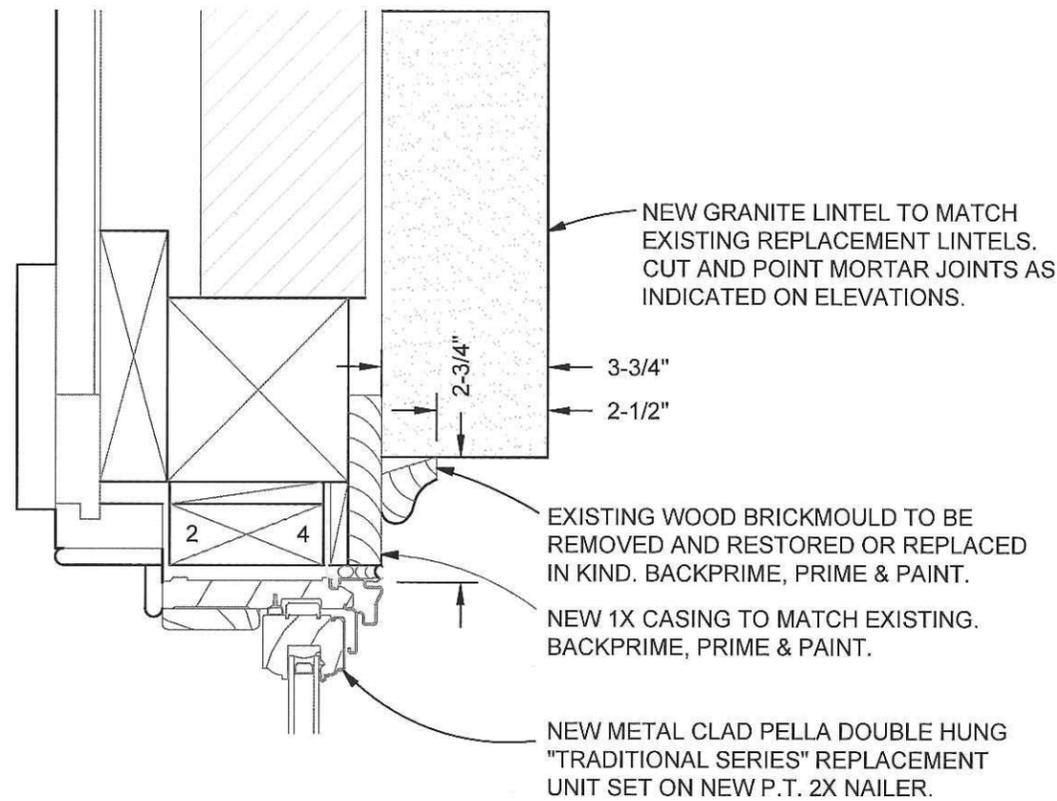
1 PROPOSED REPLACEMENT WINDOW HEAD CONDITION
A1.5 3" = 1'-0" (ON 22 X 34 SHEET)

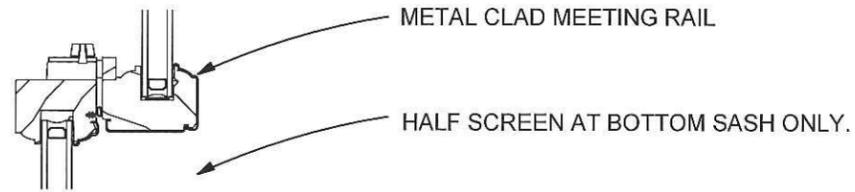
2 PROPOSED REPLACEMENT MEETING RAIL CONDITION
A1.5 3" = 1'-0" (ON 22 X 34 SHEET)

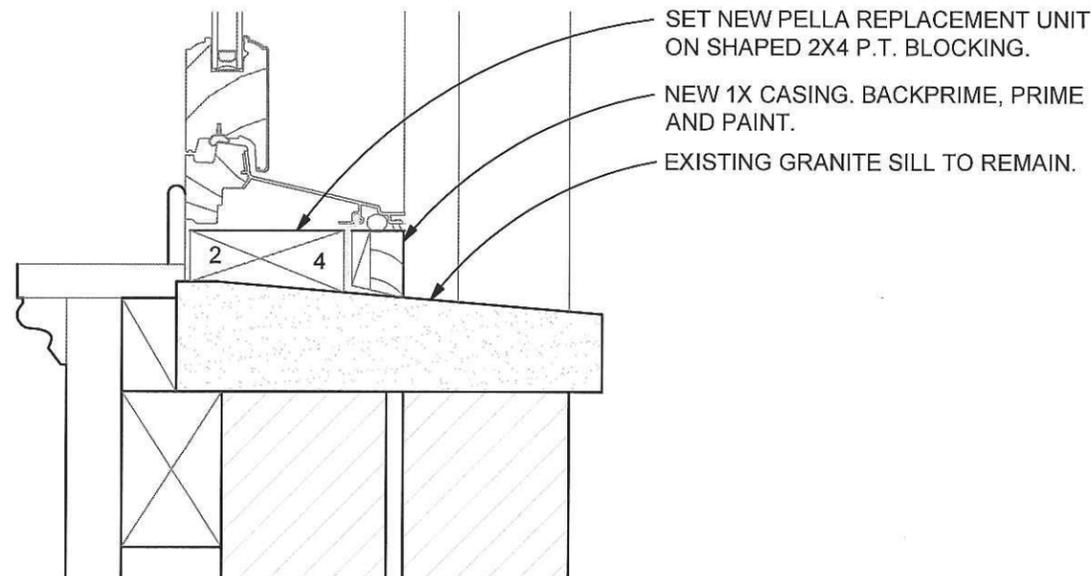
3 PROPOSED REPLACEMENT WINDOW SILL CONDITION
A1.5 3" = 1'-0" (ON 22 X 34 SHEET)

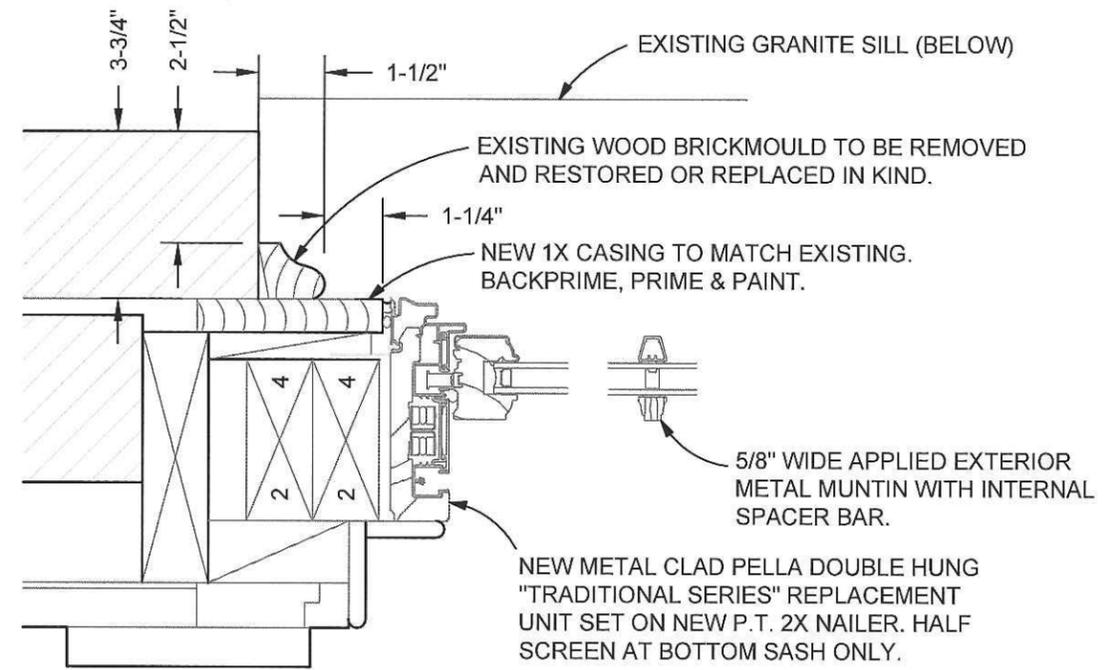
4 PROPOSED REPLACEMENT WINDOW JAMB CONDITION
A1.5 3" = 1'-0" (ON 22 X 34 SHEET)

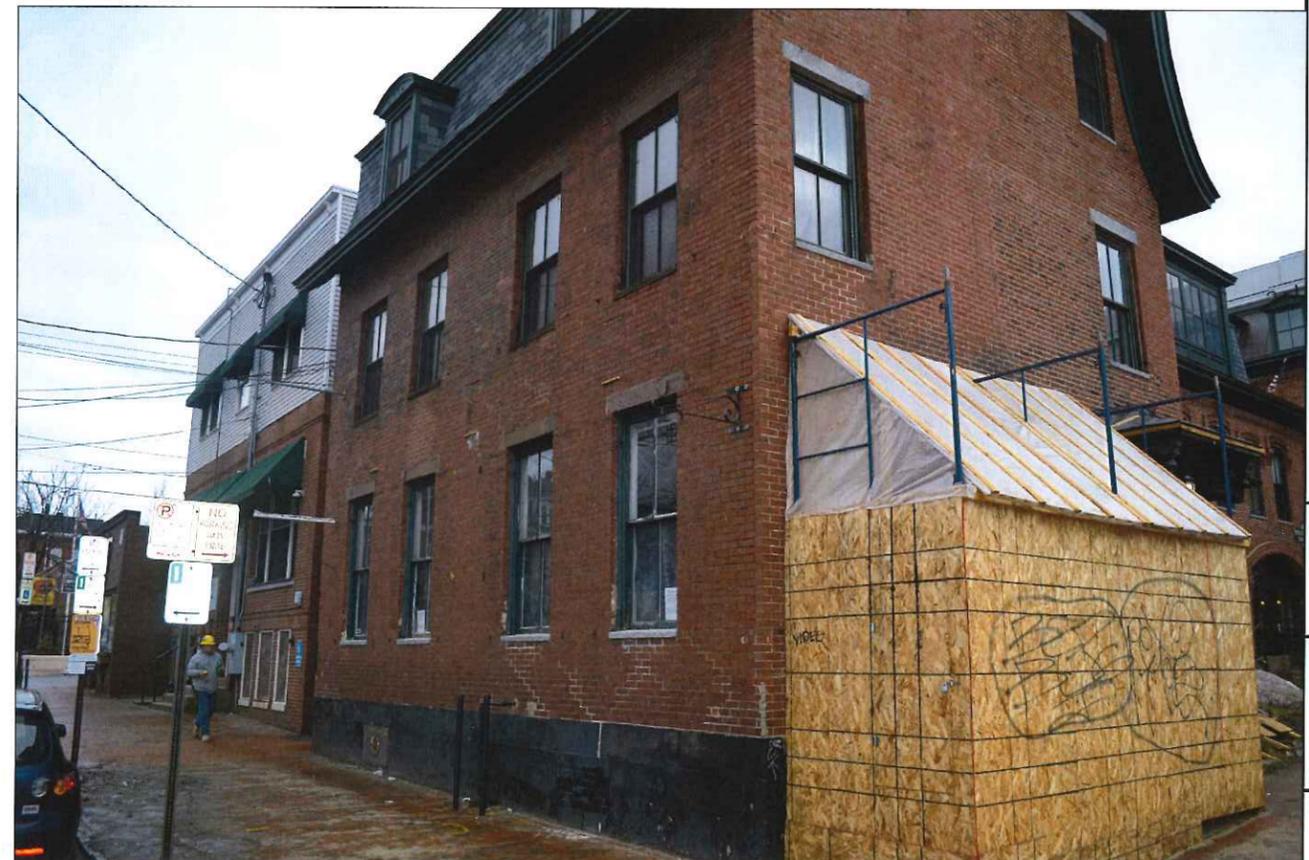
20 SIDE SHOWING GRANITE LINTEL

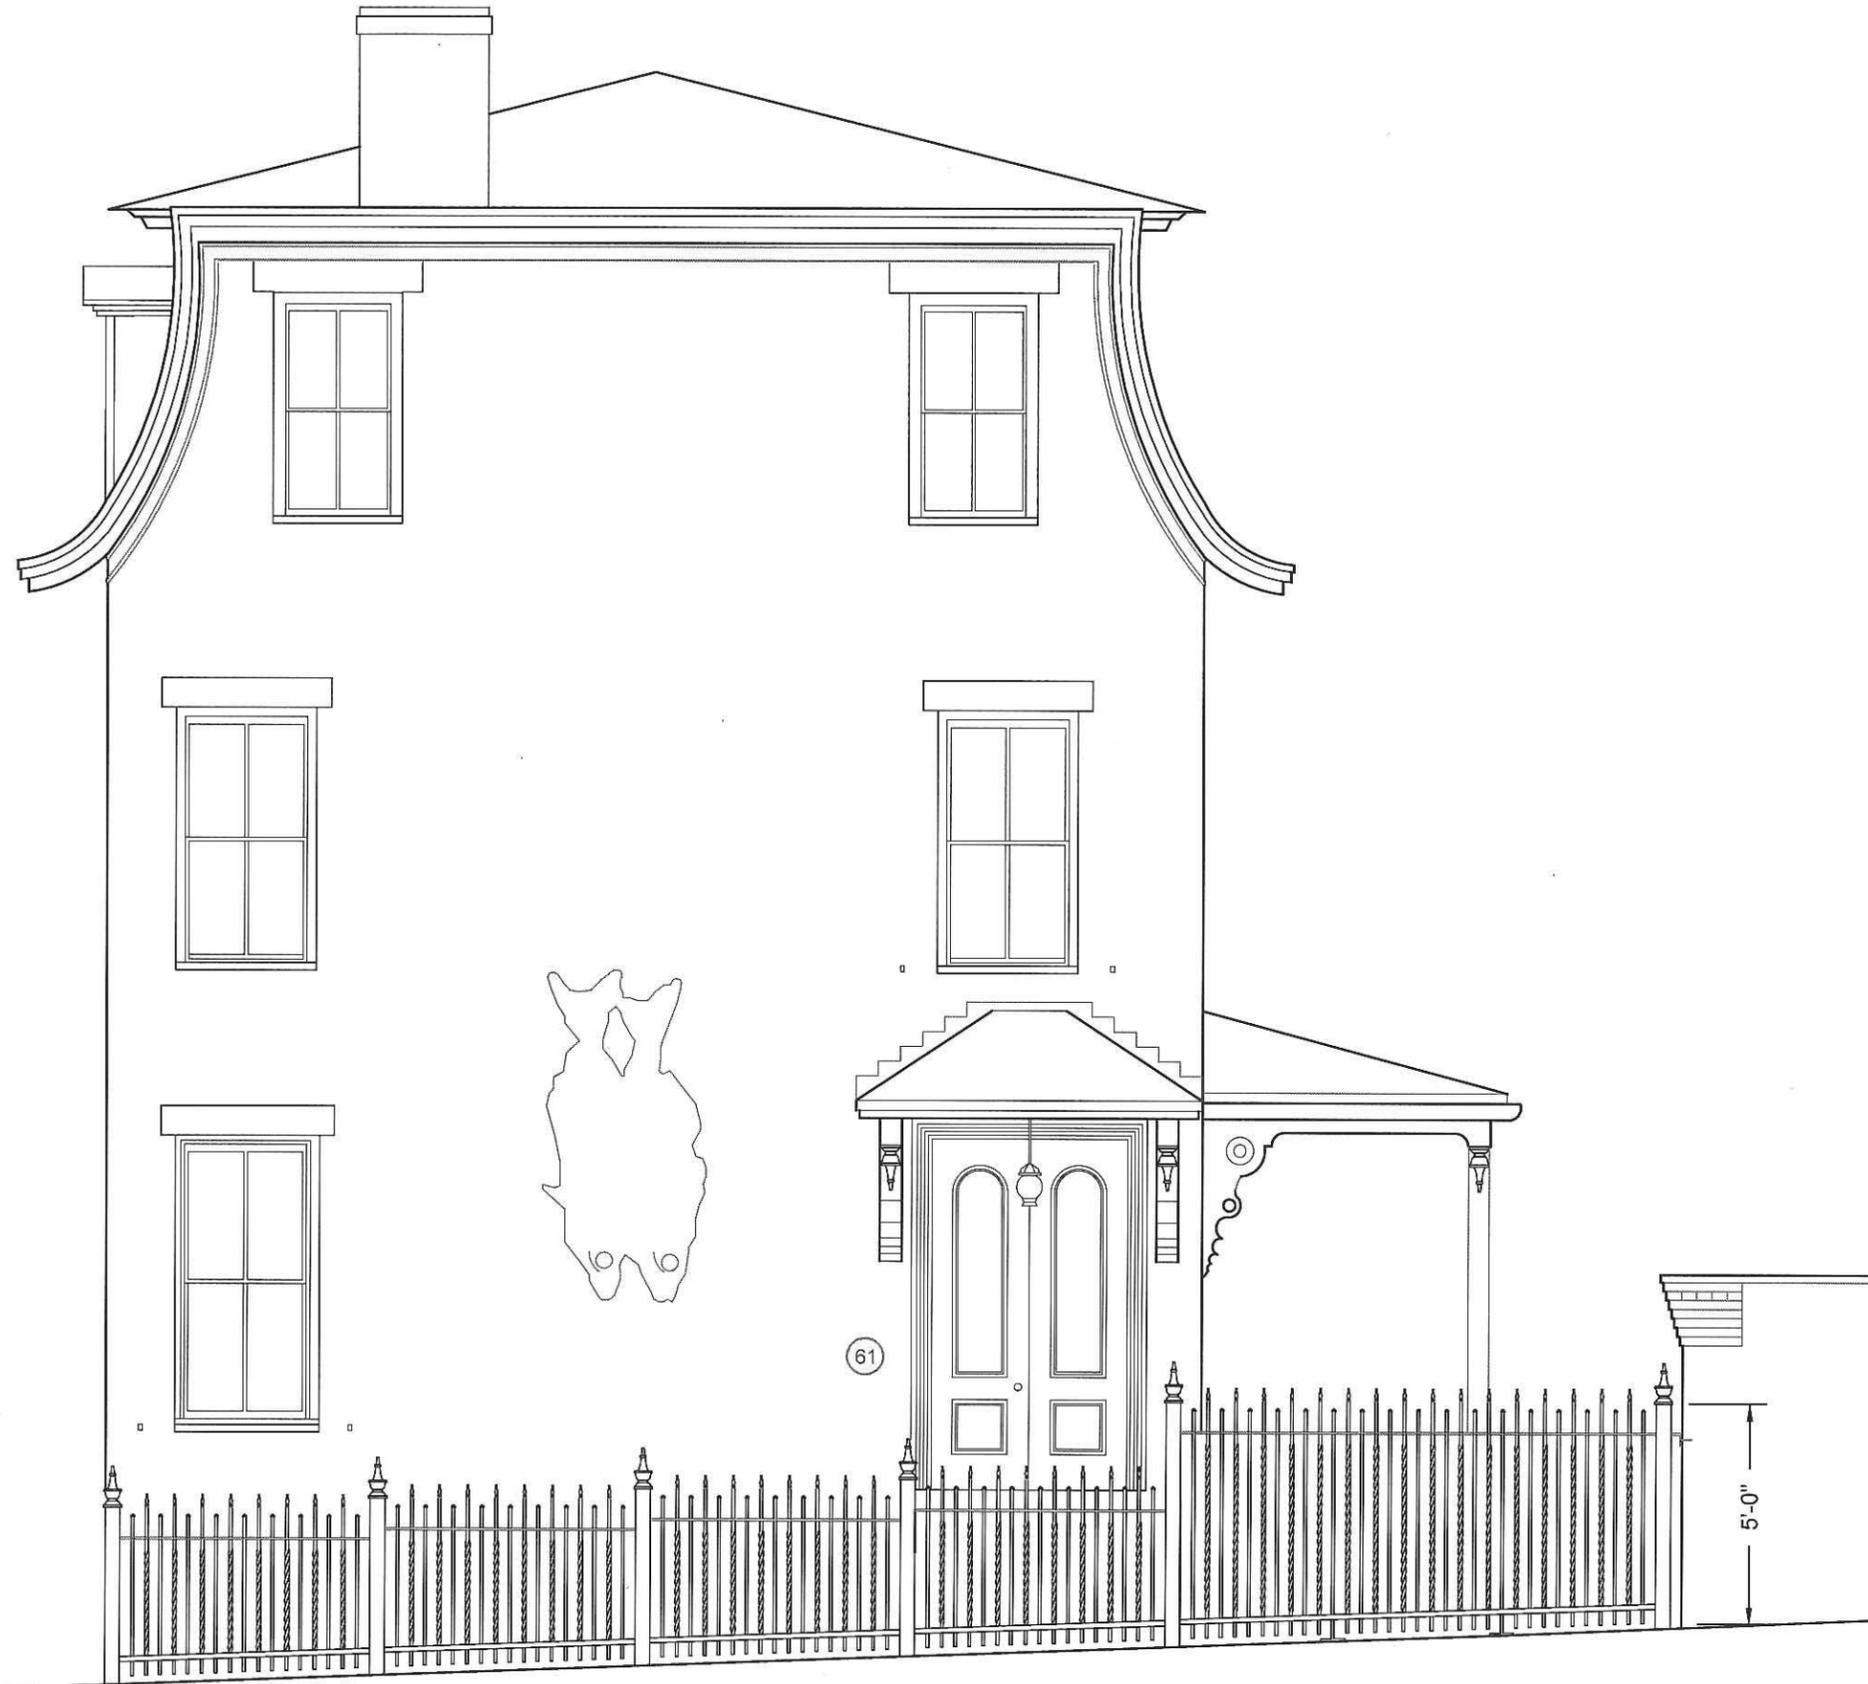
1 SIDE FACADE SHOWING PROPOSED IRON FENCE
A-1.3 1/4" = 1'-0" (ON 11" X 17" SHEET)

The proposal calls for installing a powder-coated decorative steel picket fence to fully enclose the front courtyard of the property. The fence would extend 16 feet from the corner of the main building along the sidewalk edge to the southeastern corner of the property, then return along the property line toward an existing brick half wall that encloses the rear portion of the courtyard—see Sheet A-1.1 An iron gate with a 9’3” opening would provide access into the courtyard. The gate would include an active and passive leaf, providing pedestrian access during regular business hours.

At the sidewalk, the fencing would run level across the entire frontage. Along the side property line the fence would be stepped to accommodate the change in grade.

The height of the fencing itself is about 4 ½’ and the posts are just under 5’. The design of the fence has drawn, in part, from decorative elements found on the entry porch of the main house. Note that the post tops replicate the inverted finials or pendants on the porch. The pickets vary in height and design. Some pickets are twisted, others not; some pickets have terminating finials, others not.

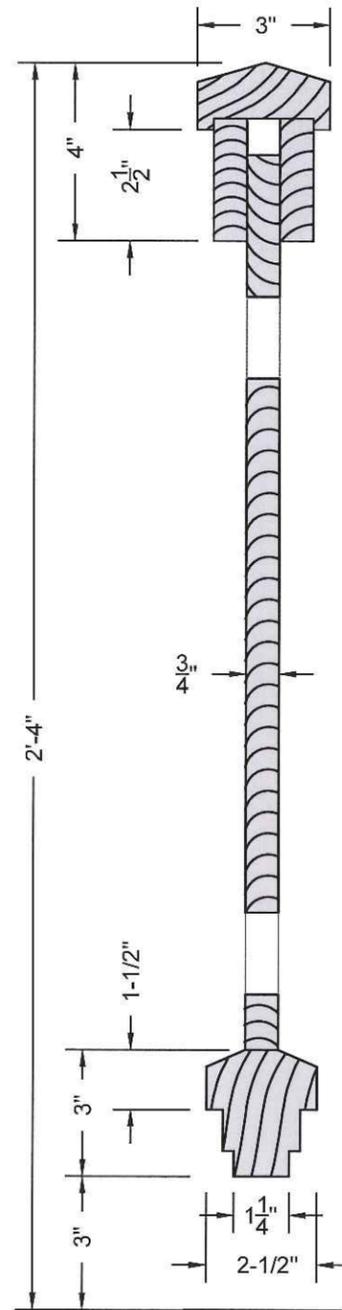
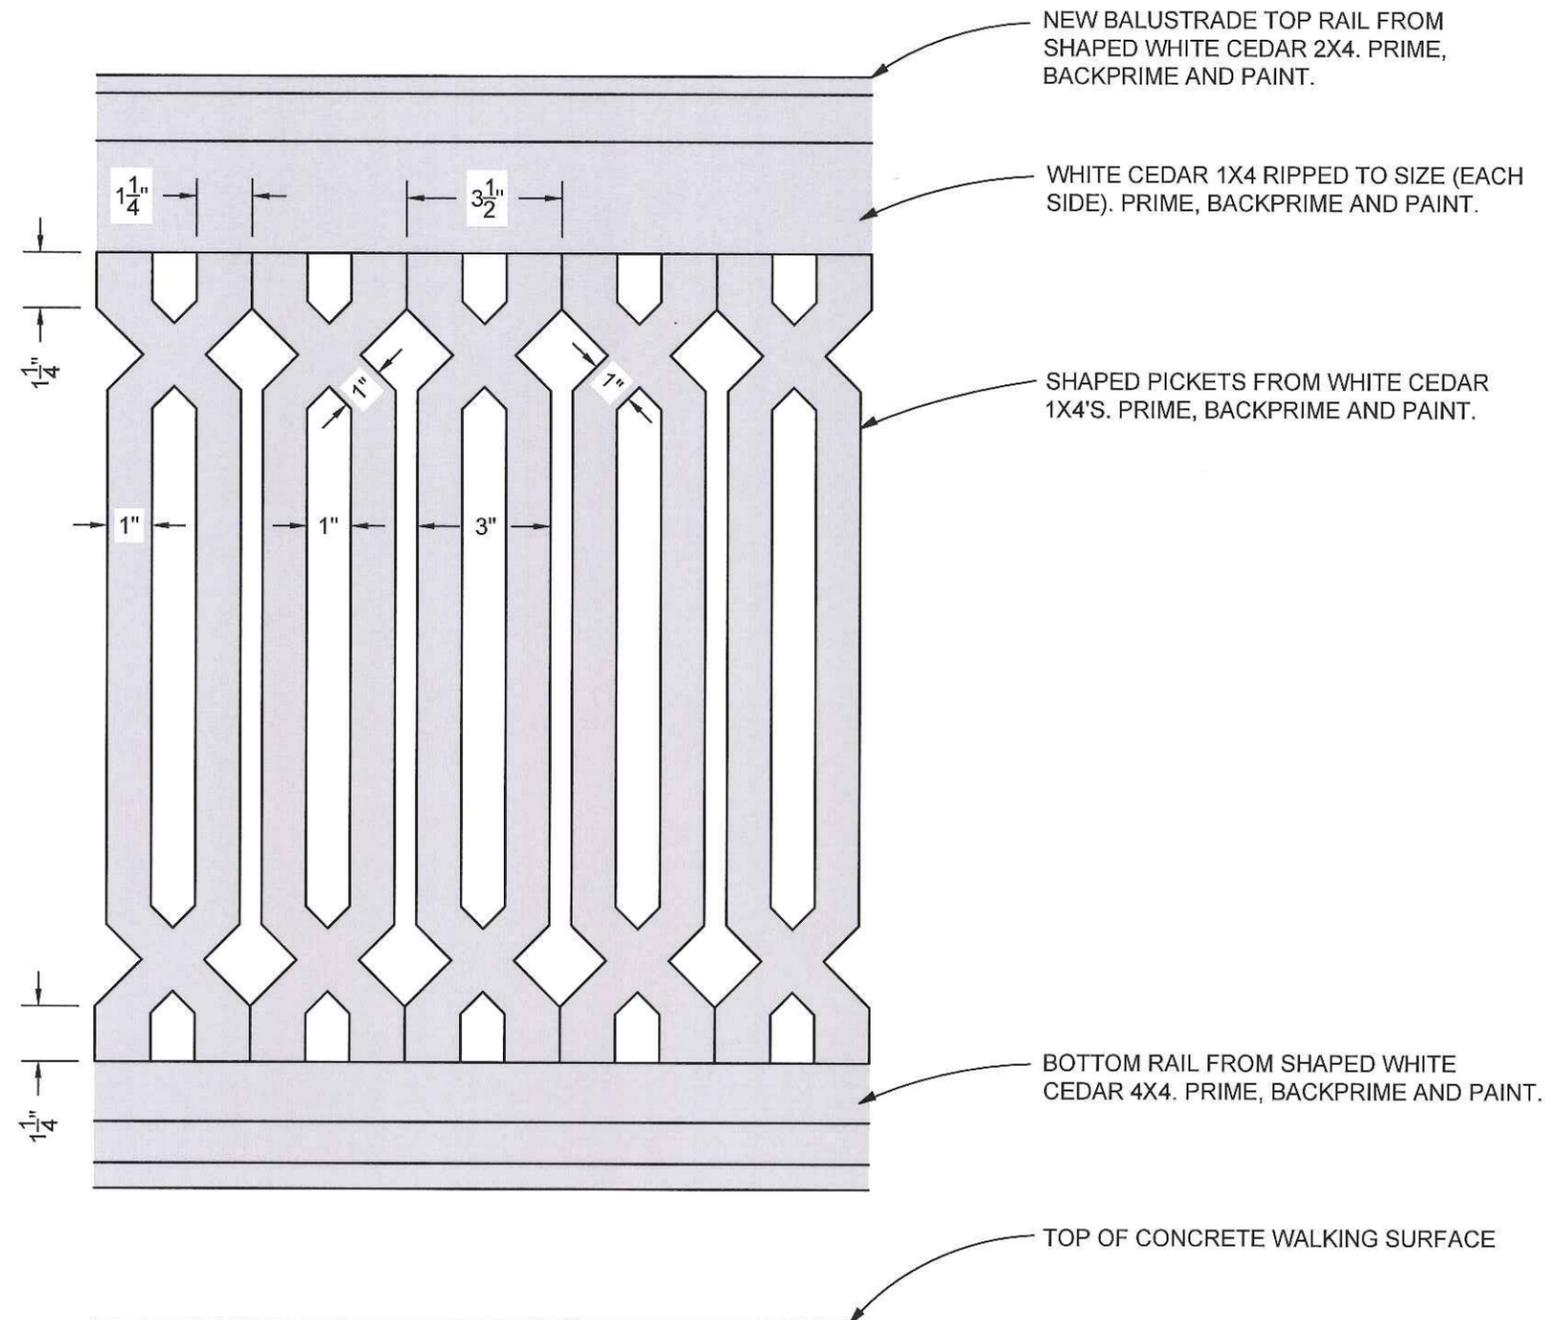
NEW BALUSTRADE TOP RAIL FROM SHAPED WHITE CEDAR 2X4. PRIME, BACKPRIME AND PAINT.

WHITE CEDAR 1X4 RIPPED TO SIZE (EACH SIDE). PRIME, BACKPRIME AND PAINT.

Recently, Mr. Reynolds commissioned John Turk to design supporting posts for the porch as well as a balustrade. Although there was no photograph or other documentation on which to base the design, the proposed design solution is patterned after porch elements from other buildings of this architectural style and era.

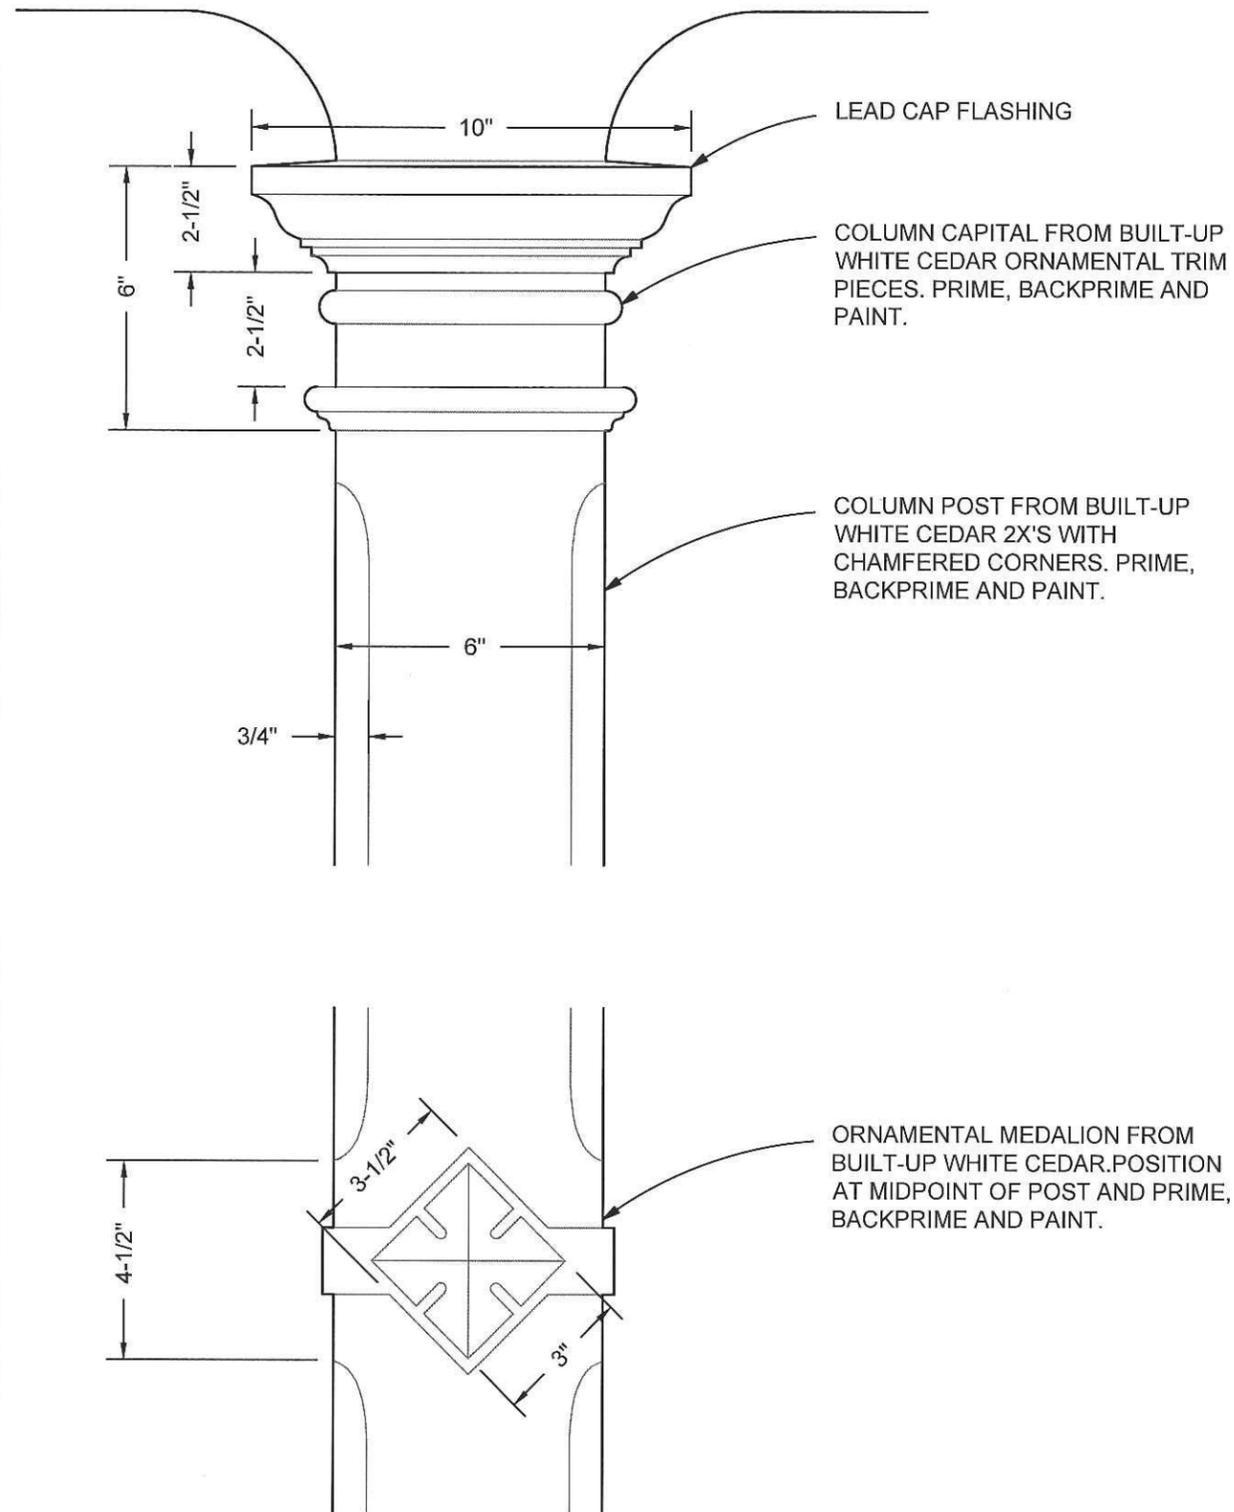
1 ELEVATION DETAIL AT NEW PAINTED WOOD COLUMN
A-1.6 3" = 1'-0" (ON 11" X 17" SHEET)
