CITY OF PORTLAND, MAINE
HISTORIC PRESERVATION BOARD

HISTORIC PRESERVATION BOARD AGENDA
April 4, 2018 at 5:00 p.m.
Room 209, City Hall, 389 Congress Street

**PUBLIC HEARING
61 INDIA STREET**

61 INDIA STREET - PORTLAND, MAINE MASONRY REPAIR, REPLACEMENT WINDOWS AND PROPOSED SIGNAGE MASTER PLAN

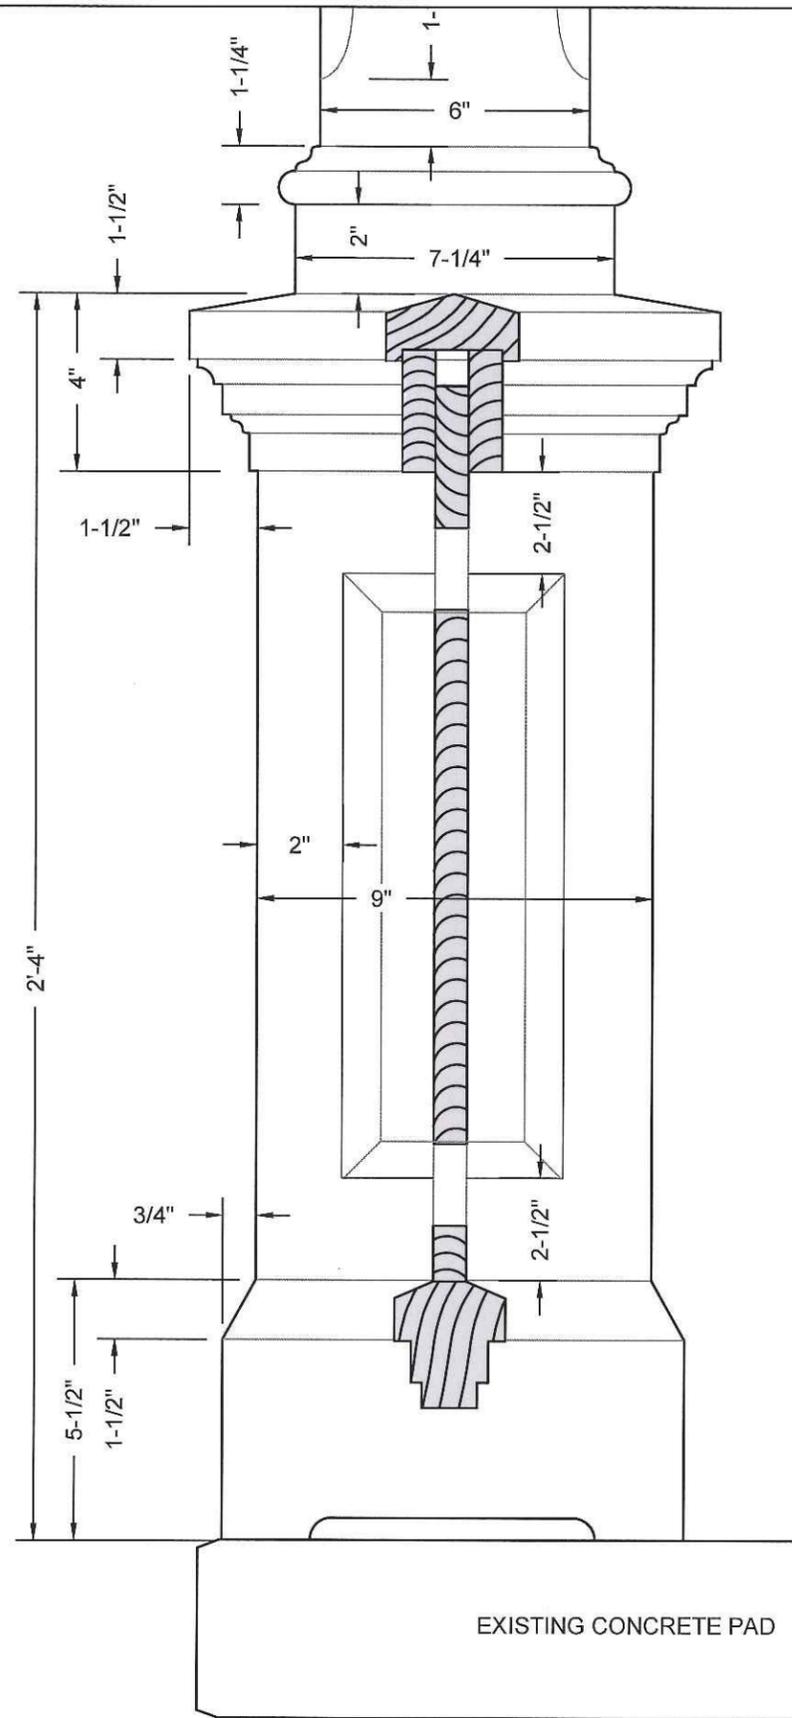
2 ELEVATION DETAIL AT NEW PAINTED WOOD COLUMN PIER
A-1.6 3" = 1'-0" (ON 11" X 17" SHEET)
