MASTER PLAN
FOR
WESTERN CEMETERY
PORTLAND, MAINE
DRAFT
PORTLAND
DEPARTMENT OF PARKS AND REC
WALKER KLUESING DESIGN GROUP

A MASTER PLAN

WESTERN CEMETERY
PORTLAND, MAINE

JANUARY 2001

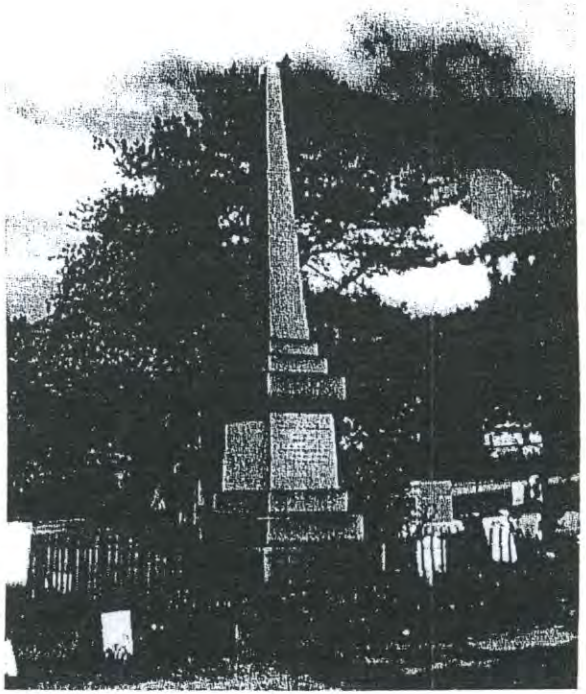
Eroding inscription on Jackson monument

The granite Jackson obelisk consists of large dressed stones arranged as a base, pedestal and shaft. The stones are tightly fitted without mortar joints. There does not appear to be any settlement or relative displacement among the dressed stones although the foundation is exposed from adjacent earth settlement and appears to be loose rubble. However, the surrounding curb stones have displaced horizontally and embedded iron corner posts have broken while also breaking and cracking the stone where they were embedded.

Clean the Mellen monument and Jackson obelisk with water and a stiff natural bristle brush. Remove remaining stains with ProSoCo's Marble & Limestone Cleaner, used according to manufacturer's specifications.

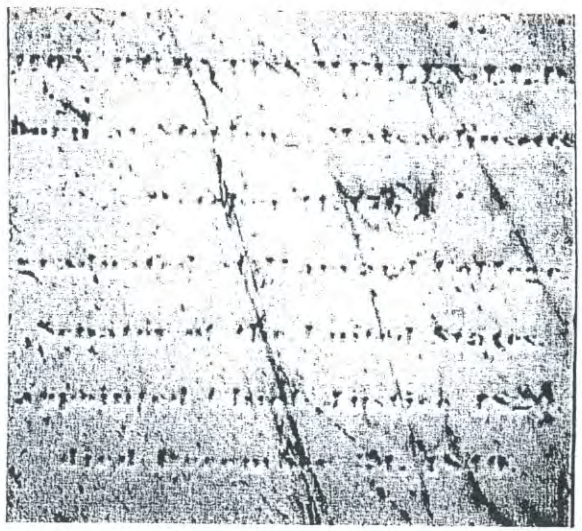
Eroding inscription on Mellen monument

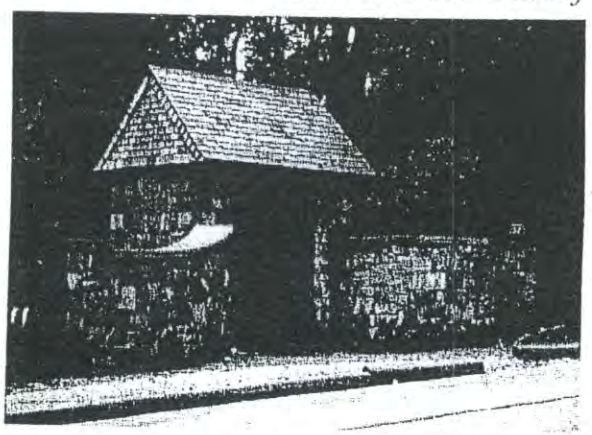
Daveis Memorial Gateway

Since that time some work has been performed on the memorial gateway. The stone work was restored in 1953 and a new wrought iron gate was added. Restoration of the slate roof and gateway structure commenced in 1998.

The Daveis Memorial Gate consists of curving stone wing walls that meet the sideways of a roofed passage from Vaughan Street into the cemetery. Iron gates close the entrance through the passageway. The wing walls and the gate house side walls have face wythes consisting of 3" thick, dressed stone units laid up in mortar beds. The space between the face wythes is filled with rubble and mortar.

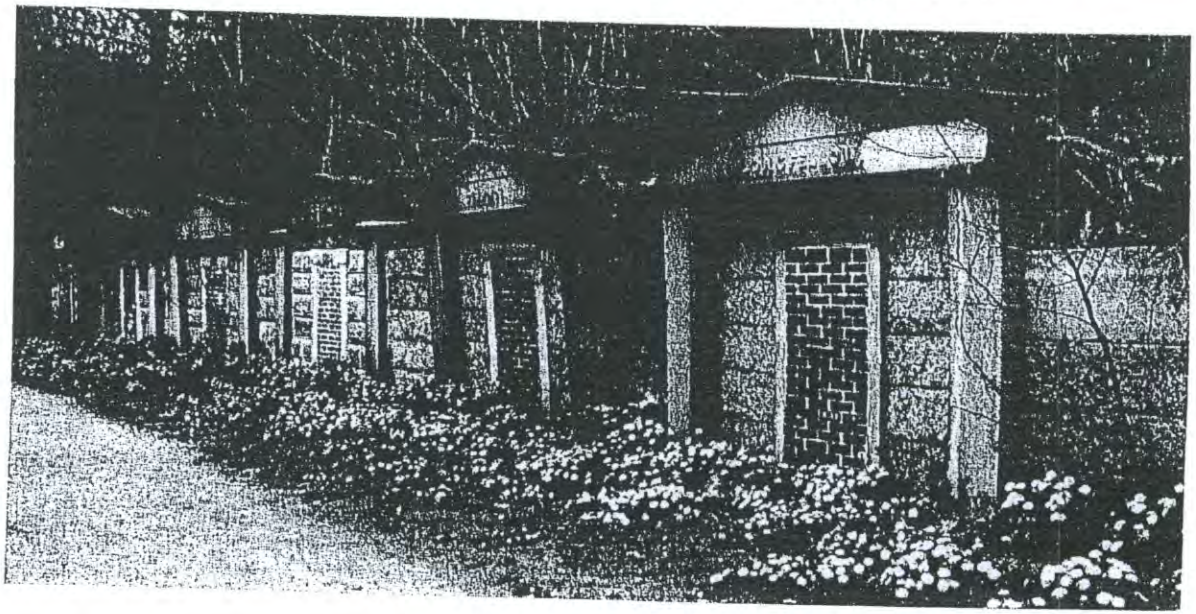
Connecting retaining wall: The top stone has shifted and should be reset.

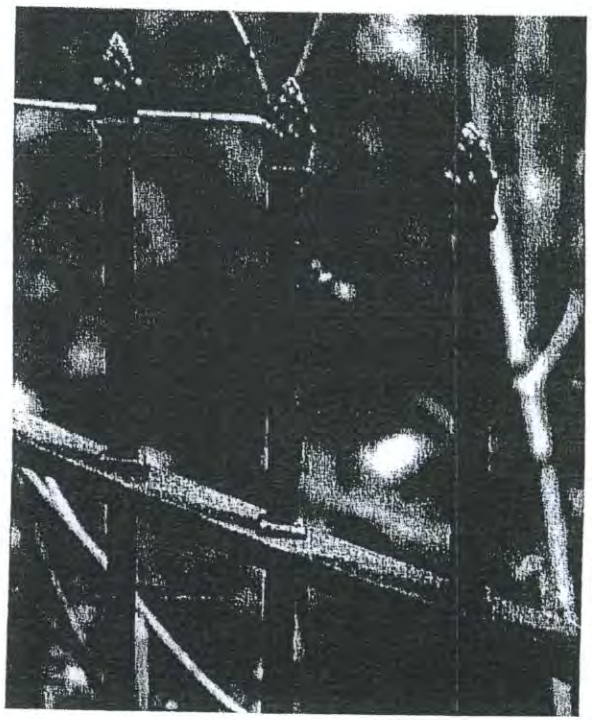
Iron fence at northwest corner

Removed for the WWII war effort, only 4 panels, about 32', are left. It was 5' high with 8' long panels set on concrete posts 4' oc and 4' into ground. Support posts were 3/4" square and back braced. Pickets, 5/8" square with acorn tops, were set @ 45 degrees and spaced at 4-1/4" oc. The fence had 2 horizontal channel rails, 1-1/2" wide by 1/2" high. Now missing, there were a pair of entrance gates with a 9.5' opening, and a 4.5' wide gate left of the entry near Bowdoin Street. Today, the remaining iron fence is rusted and pitted.

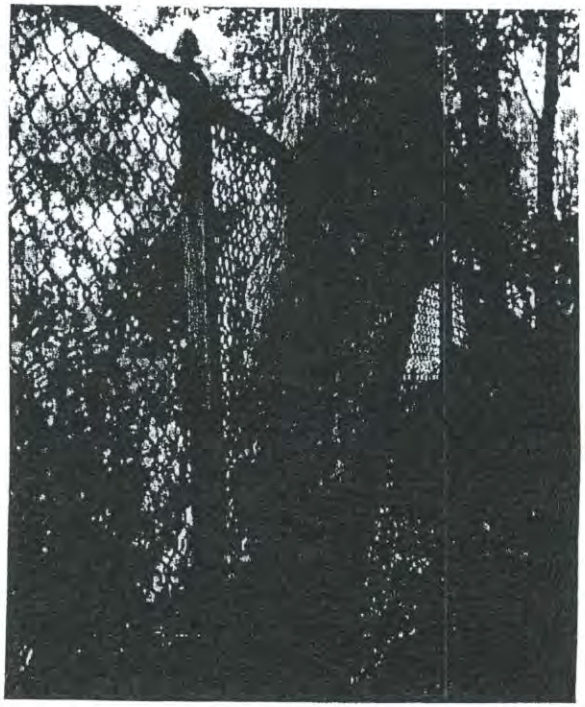
Chain Link Fence along north edge

Fences and Gates
Retain the existing remaining iron perimeter fence and restore it. Replicate it and extend it along the Western Promenade edge. Install a modified version of that fence along the Vaughan Street edge. Maintain the existing chain link fence until it is replaced.

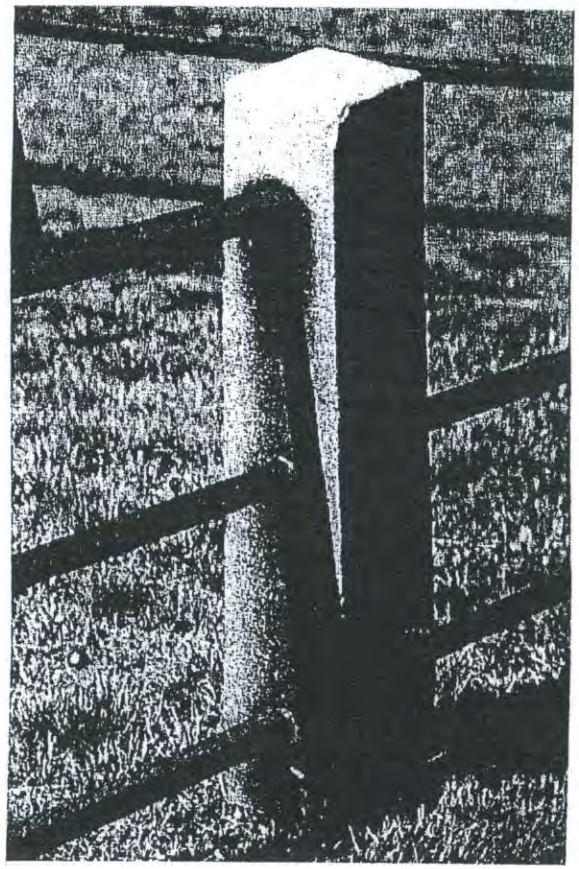
Iron fence at family plot

Granite post and iron fence at family plot

Those that are not to be restored should be left in situ until such point that they become a public safety hazard. Clean granite posts of rust and black stains. Reset them straight and true.

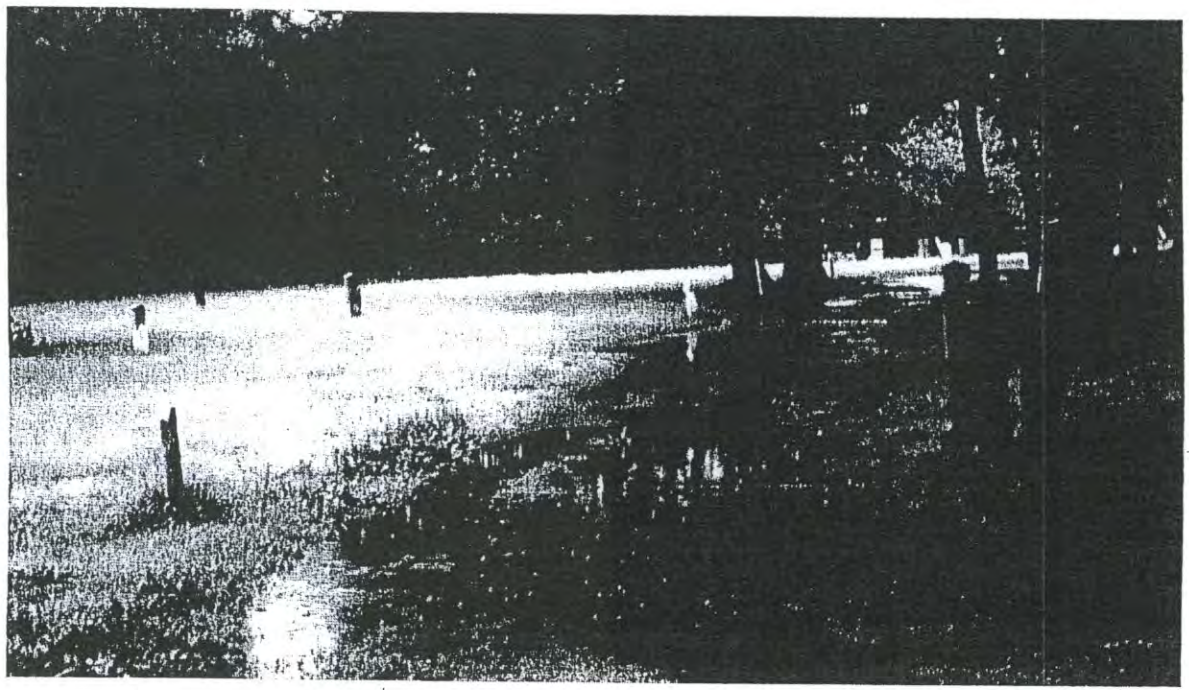
Erosion on southwest perimeter avenue

Ponding on southeast perimeter avenue

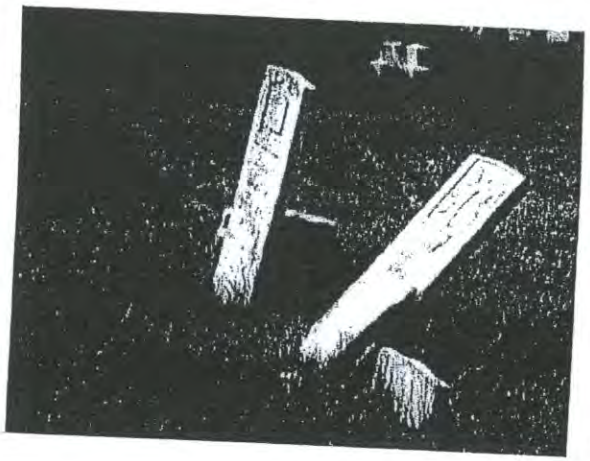
Laening marble markers

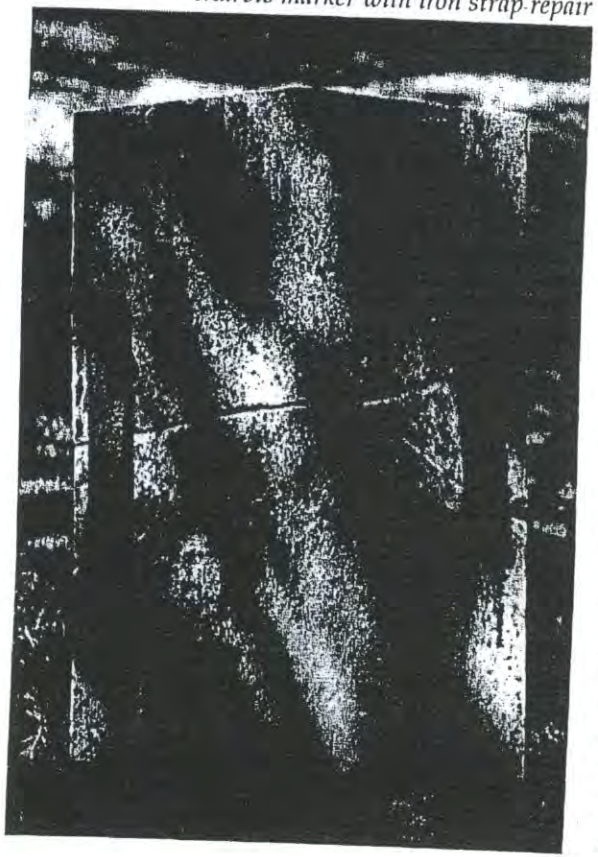
Marble marker with iron strap repair

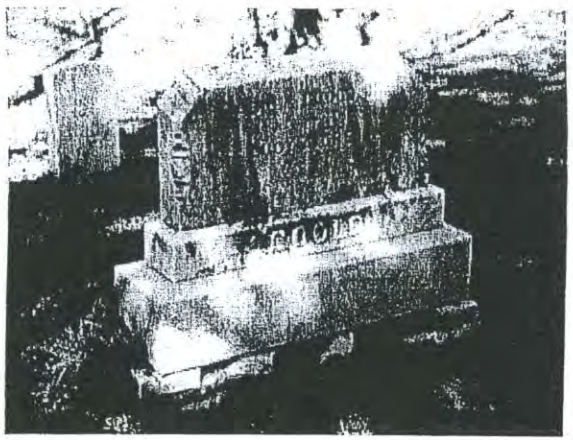
Marble marker with exposed foundation

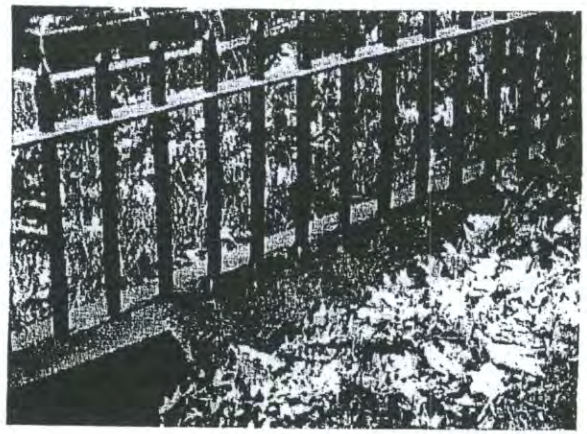
Rust jacking damage at family plot edging
