PORTLAND COMPANY COMPLEX GENERAL BUILDING CONDITION REPORT

PERFORMED FOR
CITY OF PORTLAND, MAINE PLANNING DEPARTMENT
389 CONGRESS STREET
PORTLAND, ME 04101

MARCH 26, 2015
SUPERSEDES REPORT DATED MARCH 11, 2015

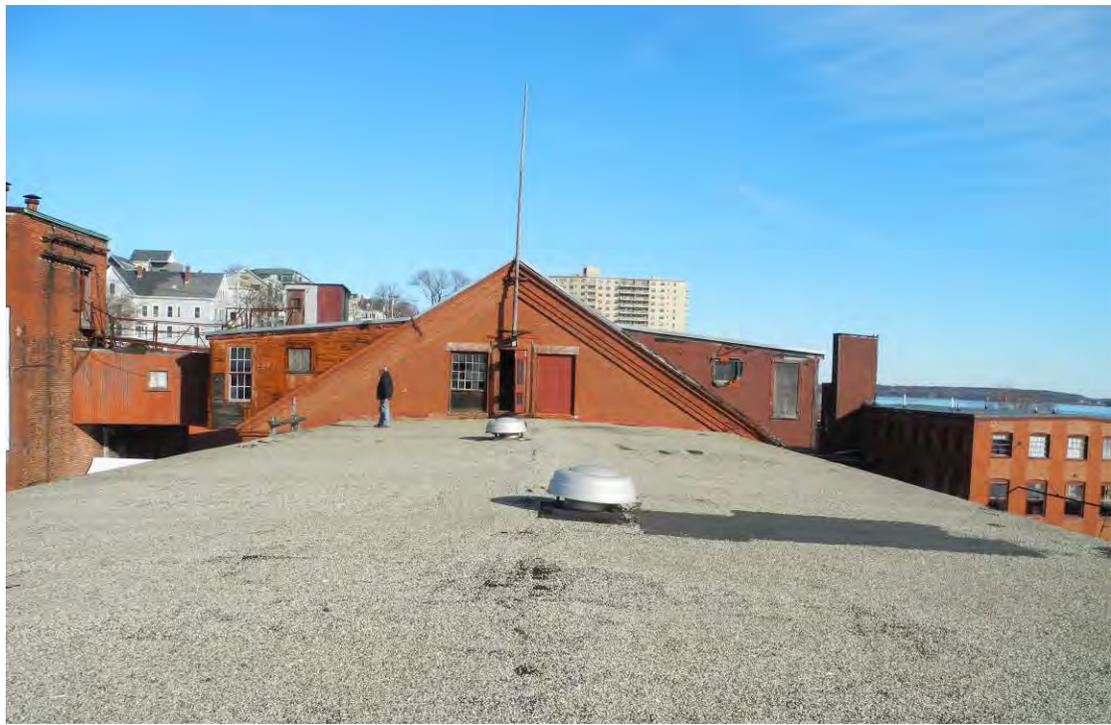
PHOTO
1.3
A 30 86.jpg

- Upper roof surfacing consists of ballasted rolled asphalt, in good to fair condition (Photo #1.3). On lower roofs, a membrane surface covers the roof. We could not determine if it was insulated, or to what extent. Insulation would likely be required on the roofs, especially if there is a goal to retain the visible structure inside the building.

Building 1: View from west end of upper roof, showing felt and gravel surface. Lower side roof levels, not visible, consist of rubber membrane on south side and possibly felt on the north side. Building 2 gable roof visible in background.

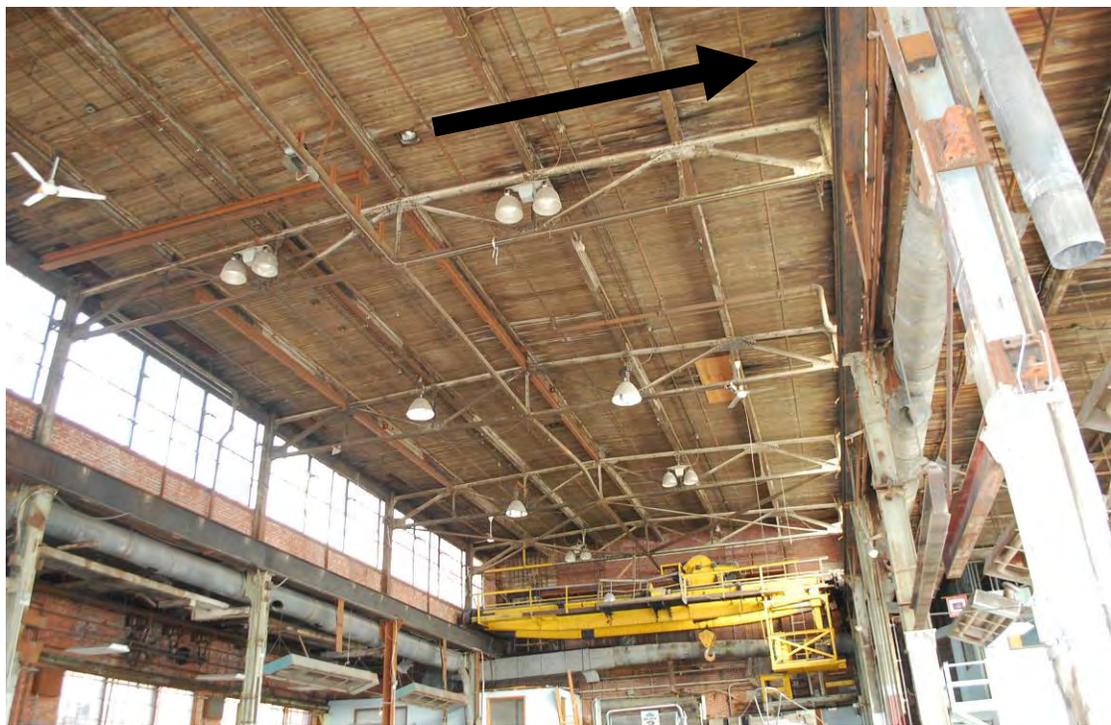
PHOTO
1.4
R 17.jpg

- Roof framing consists of steel trusses and intermediate beams at the clerestory (Photo #1.4). The beams and trusses will need to be analyzed for snow load capacity, and the decking above the beams will need to be replaced at deteriorated areas. The existing board sheathing is a combination of edge bead and edge-and-center bead. We were not able to measure the sheathing thickness. The sheathing does not provide an adequate diaphragm to transfer lateral loads, and it likely does not have sufficient nailing to resist code-required wind uplift forces.

Building 1: Interior view of upper roof framing, showing flat Warren trusses, I-beam purlins, and edge and center-bead roof decking. Note rotted decking areas (arrow) and steel-framed clerestory windows.

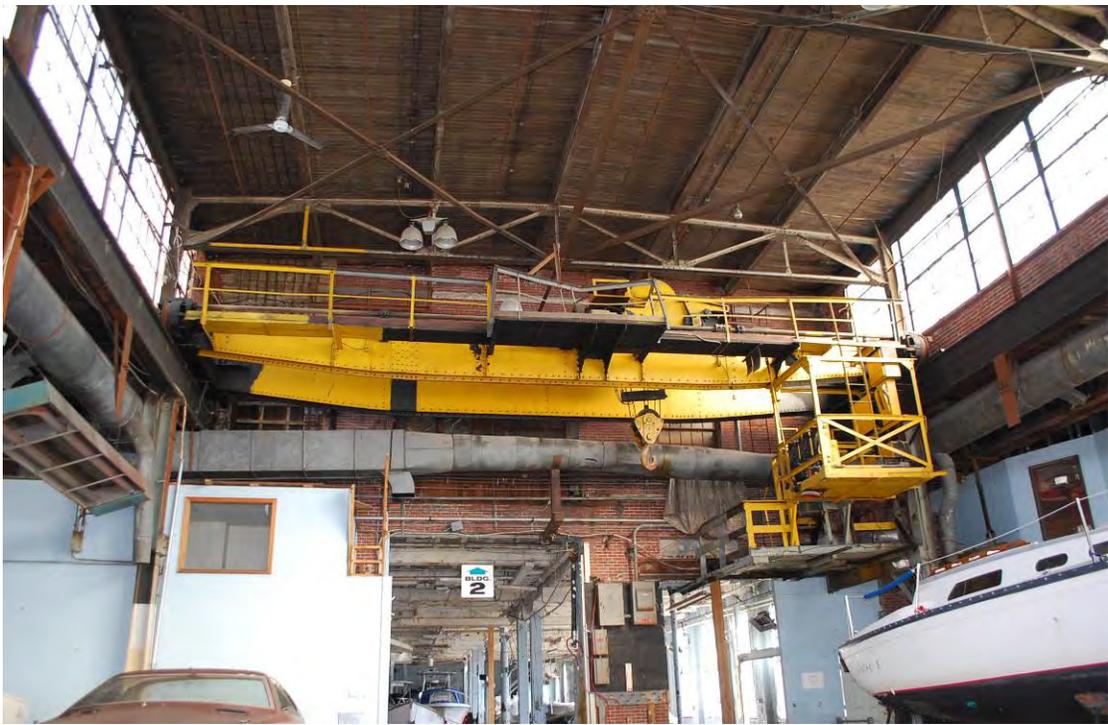
PHOTO
#1.5
R 37.jpg

Building 1: Existing rail crane is supported by girders spanning the length of the building. Rail cranes in mill buildings require offset framing at columns in order to support low roofs and upper roof framing. Note horizontal angle bracing at high roof.

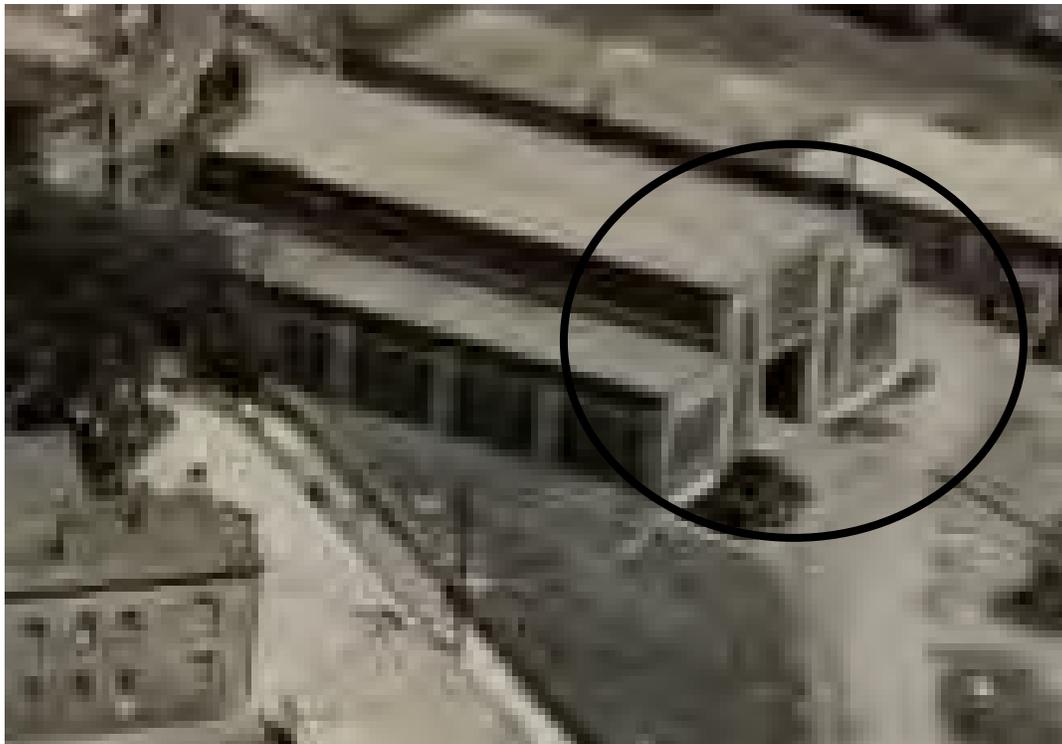
PHOTO
#1.8
 maine memory
 ntwk

- Space is relatively straightforward to subdivide. Subdividing the space could also improve the lateral rigidity of the structure.
- Reconstruction of the west elevation to its original appearance (Photo #1.8) would address identified deficiencies in the masonry and improve the overall lateral stability of the building.

Building 1: 1938 aerial photo shows smaller-scale door opening and symmetrical windows. Rebuilding west wall to a similar configuration could strengthen wall and return elevation to its period of significance.

- Rebuild the west elevation, wrapping around to the north and south elevations, to match period of historic significance and to strengthen lateral capacity of west end wall.
- Provide shear wall at east end of building as necessary.
- Provide lateral bracing as required to resist code-required lateral loads.

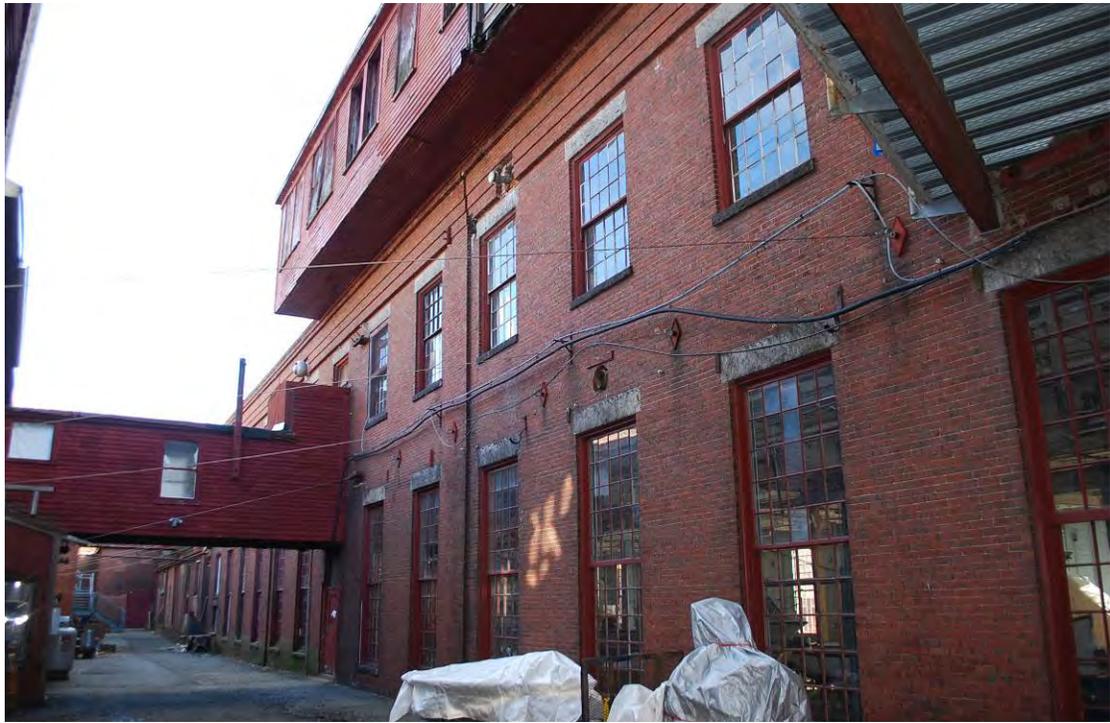
PHOTO
#2.1
R 26.jpg

- 11,300 square foot footprint, three stories with overhanging third floor added in 1905 (above).
- Third floor overhangs for nearly the entire building length on the south side, and approximately half the building length on the north side. Cantilevered floor has little backspan.

Building 2: View from southeast. Note third floor (added in 1905) cantilevered over original building cornice. Walkway to Building 6 was not assessed as part of this study.

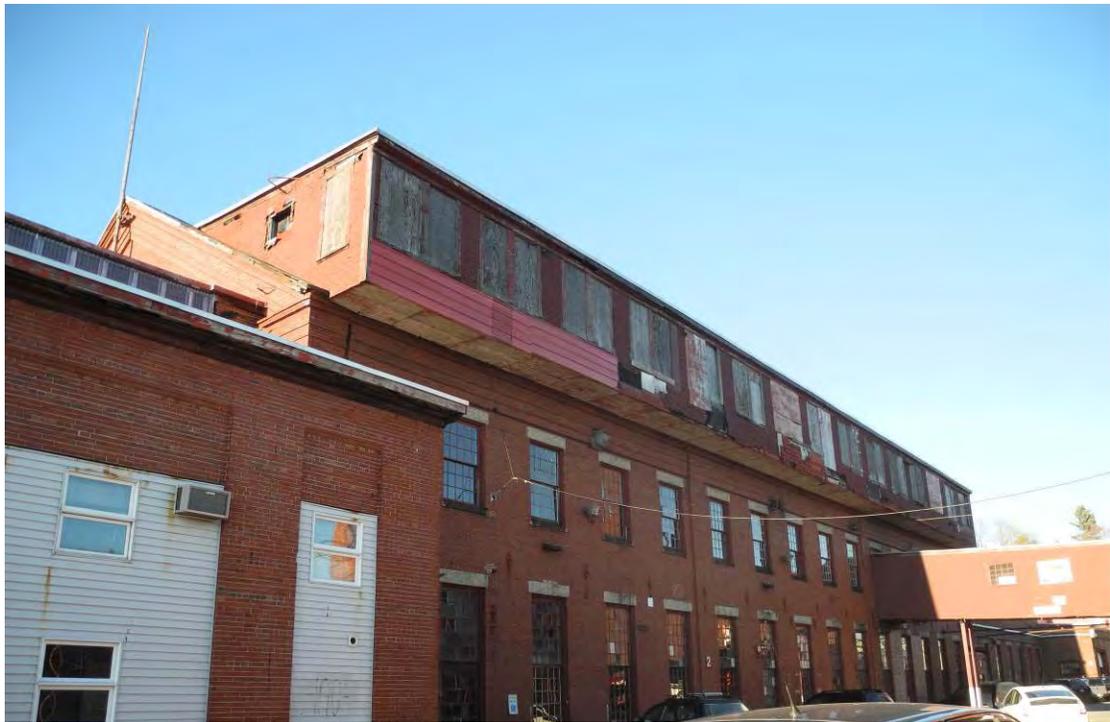
PHOTO
#2.2
A P 5.jpg

Building 2: View from southwest showing continuous third-floor shed dormer cantilevered over original roof cornice.

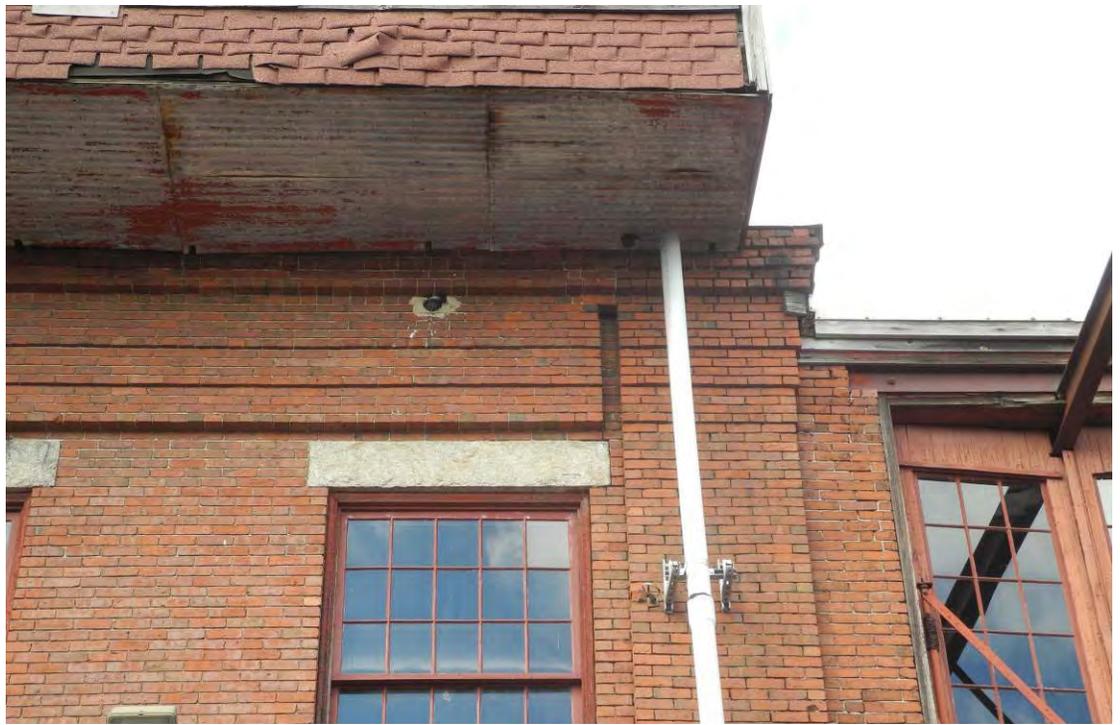
PHOTO
#2.3
A 29 14.jpg

- Building may have originally had gutters and downspouts (Photo #2.3), which were rendered obsolete when the third floor was added.
- Building has fifteen window bays and structural bays. Other supplemental columns, girders, and trusses have been added, likely to provide additional upper-floor and roof support as the third floor was added and the building responded to additional loads.

Building 2: View of southeast corner of building, looking up at cantilevered dormer. Note relief in brick cornice above window. A downspout likely descended from that location before the addition was built.

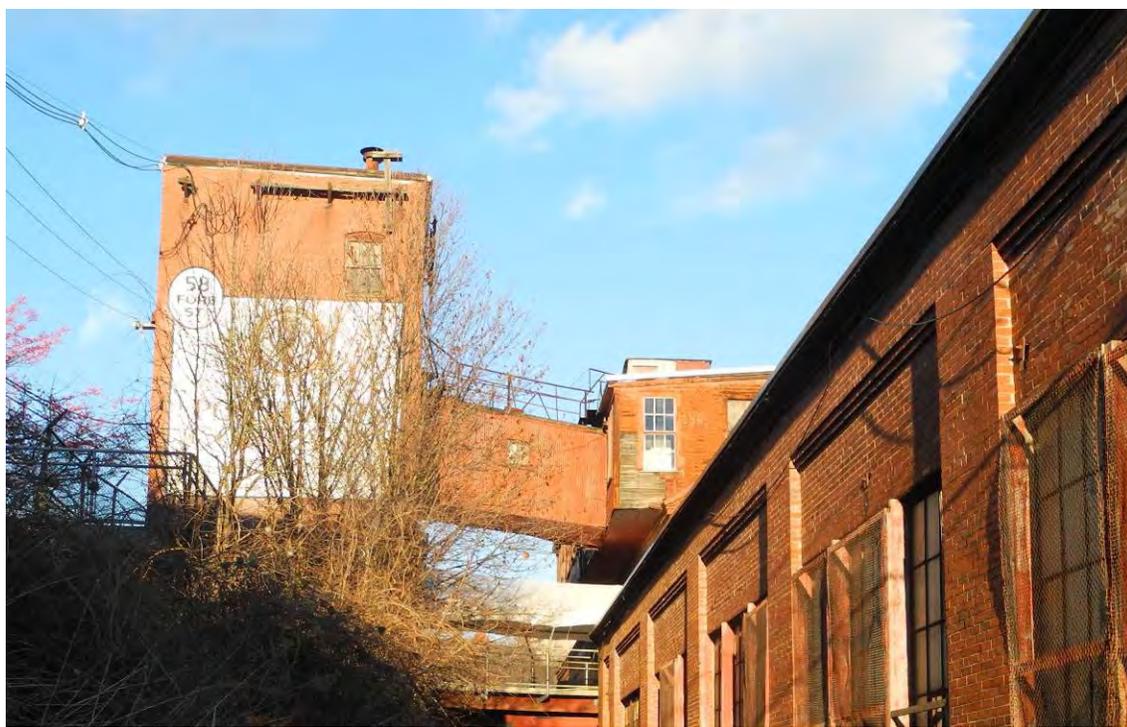
PHOTO
#2.4
A 29 107.jpg

Building 2: Walkway from third-floor drafting room to plan vault. Walkway was not assessed as part of this project.

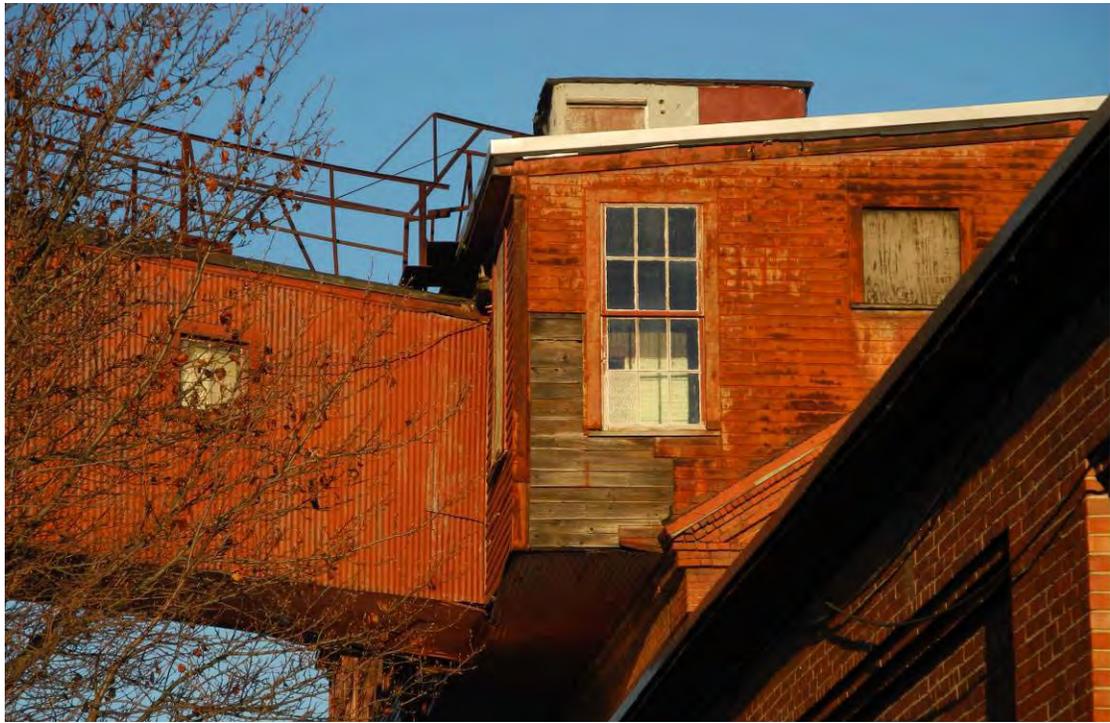
PHOTO
#2.5
ah 1 x 0.jpg

Building 2: Metal-clad walkway extending from Building 24 (vault storage) to drafting office allowed quick access to drawings in progress and drawings from archives, without exposing drawings or draftsmen to weather conditions.

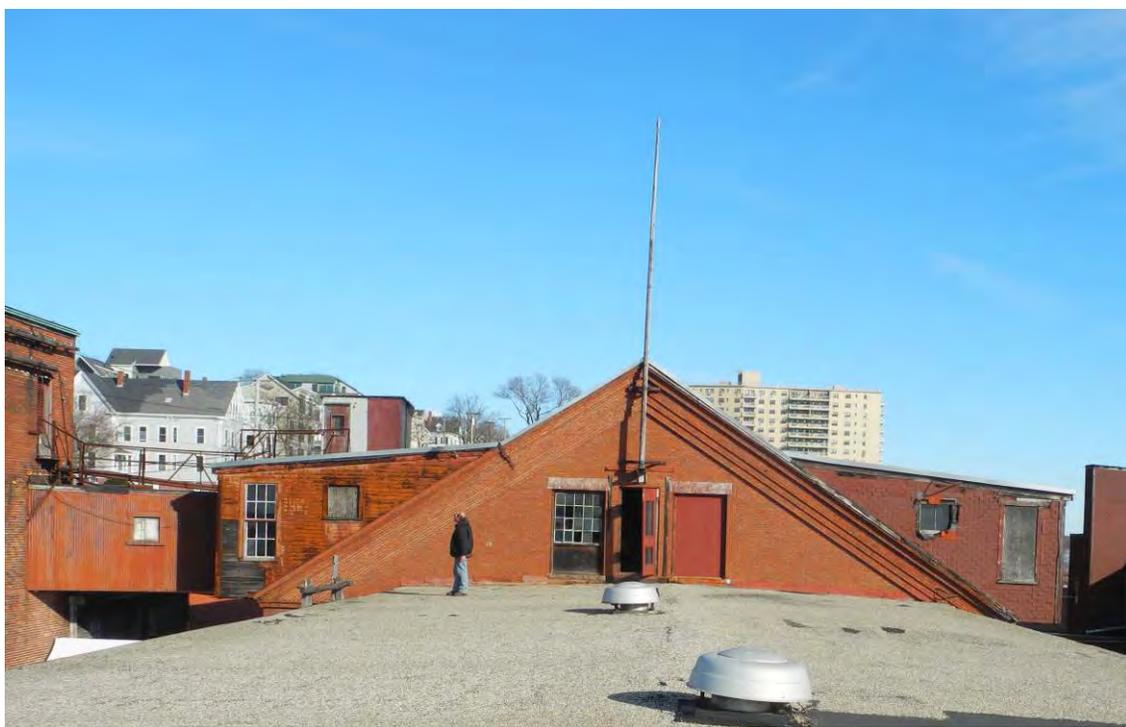
PHOTO
#2.6
A 30 86.jpg

- Third-floor shed dormer cladding at north elevation consists of stamped metal sheeting in a clapboard pattern (Photo #2.6), while red rolled asphalt clads the South dormer. Areas of missing cladding exist all along the dormers.

Building 2: West gable viewed from West end of Building 1. Third floor dormers extending from each side of gable require strengthening to ensure integrity of cantilevered structure. Note different dormer cladding materials.

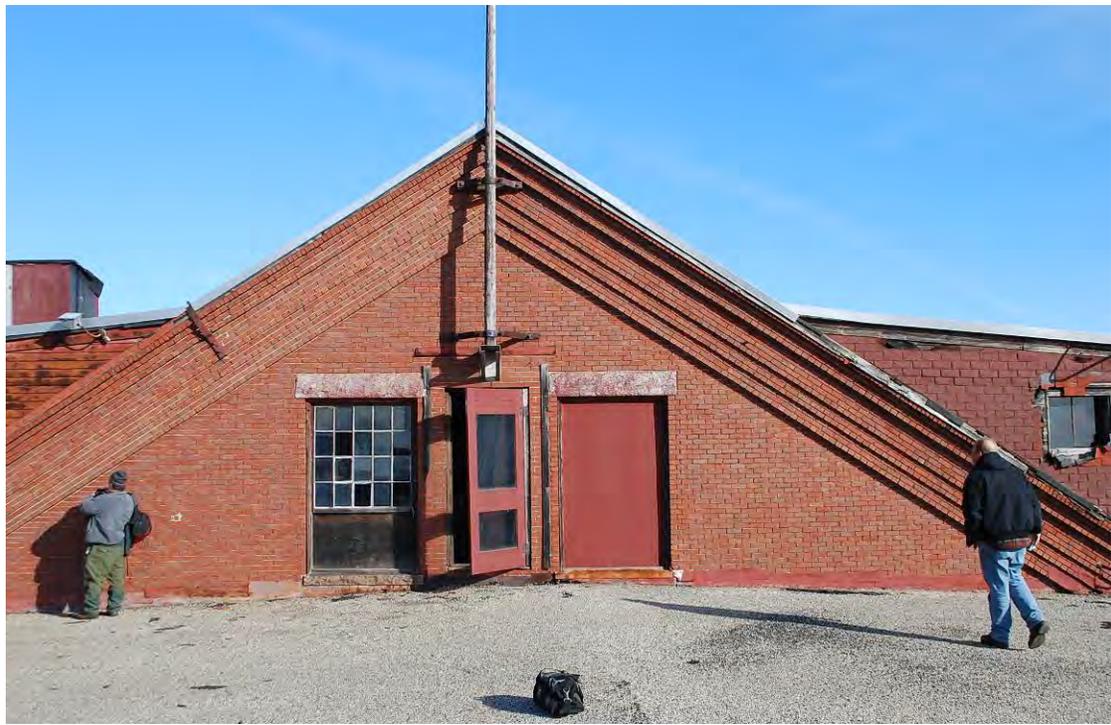
PHOTO
#2.7
R 179.jpg

Building 2: Gable end rake viewed from Building 1 roof. With proper safety precautions, much of the rake and gable peak can be repointed without extensive scaffolding.

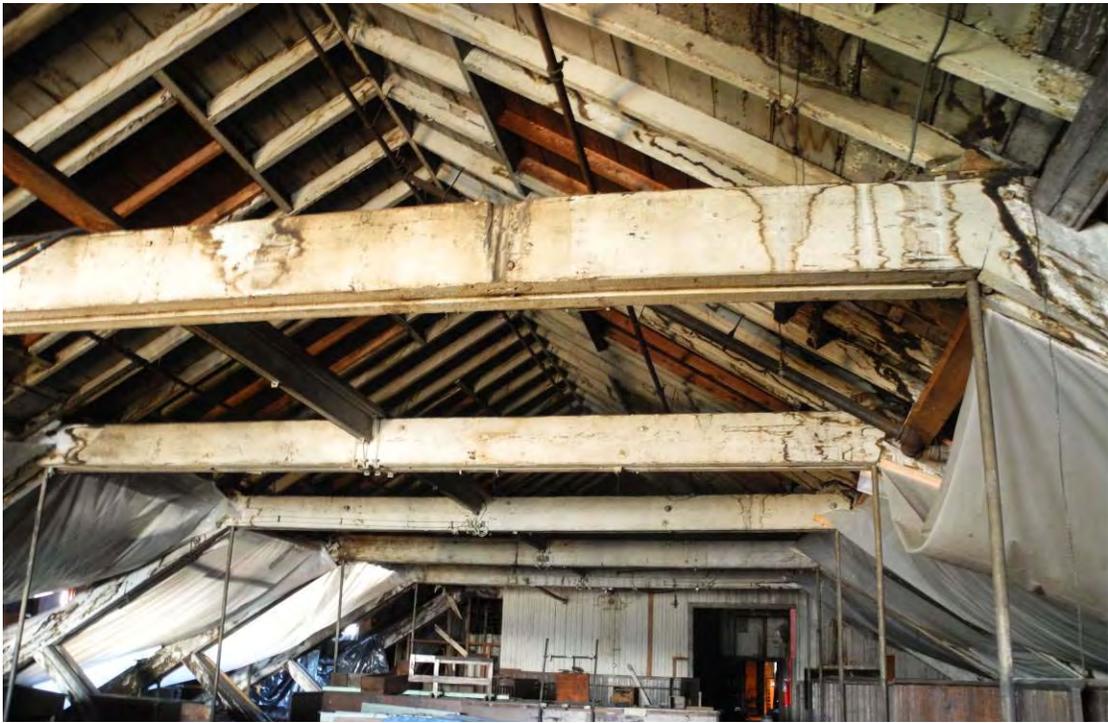
PHOTO
#2.11
A 30 100.jpg

Building 2: 3rd floor drafting office viewed from west wall. Queen rod trusses support roof structure, and lower half of roof extends out as low-slope shed dormers, not visible in this photo.

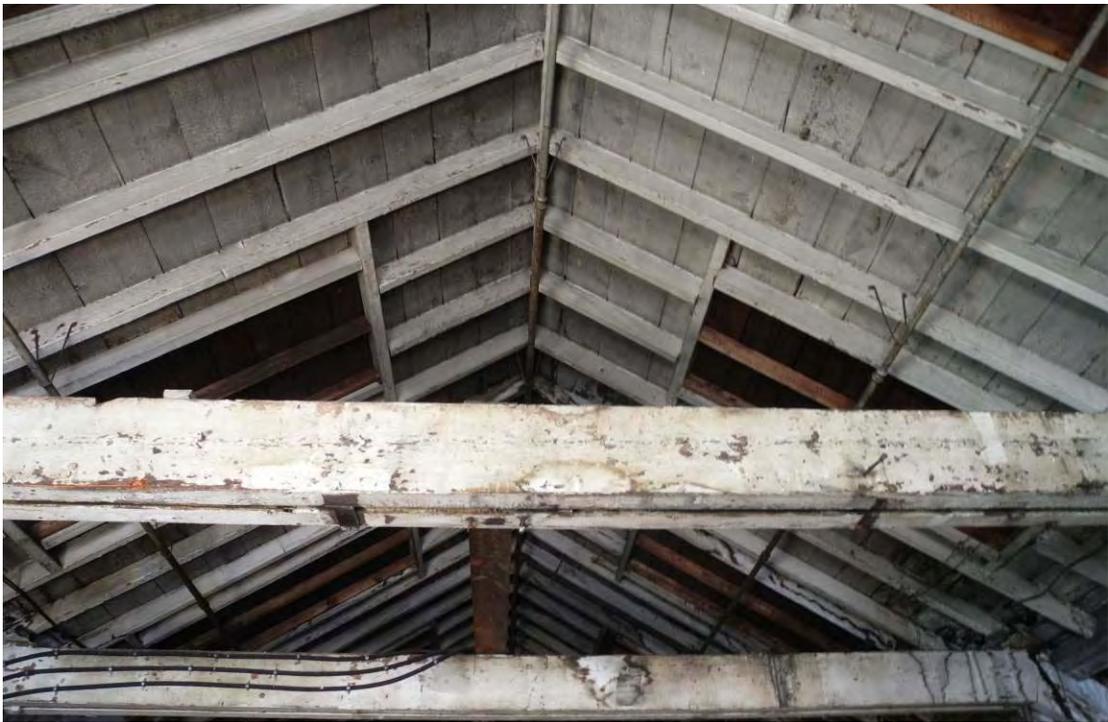
PHOTO
#2.12
A 30 55.jpg

Building 2 upper roof: Note skylights previously located along roof.

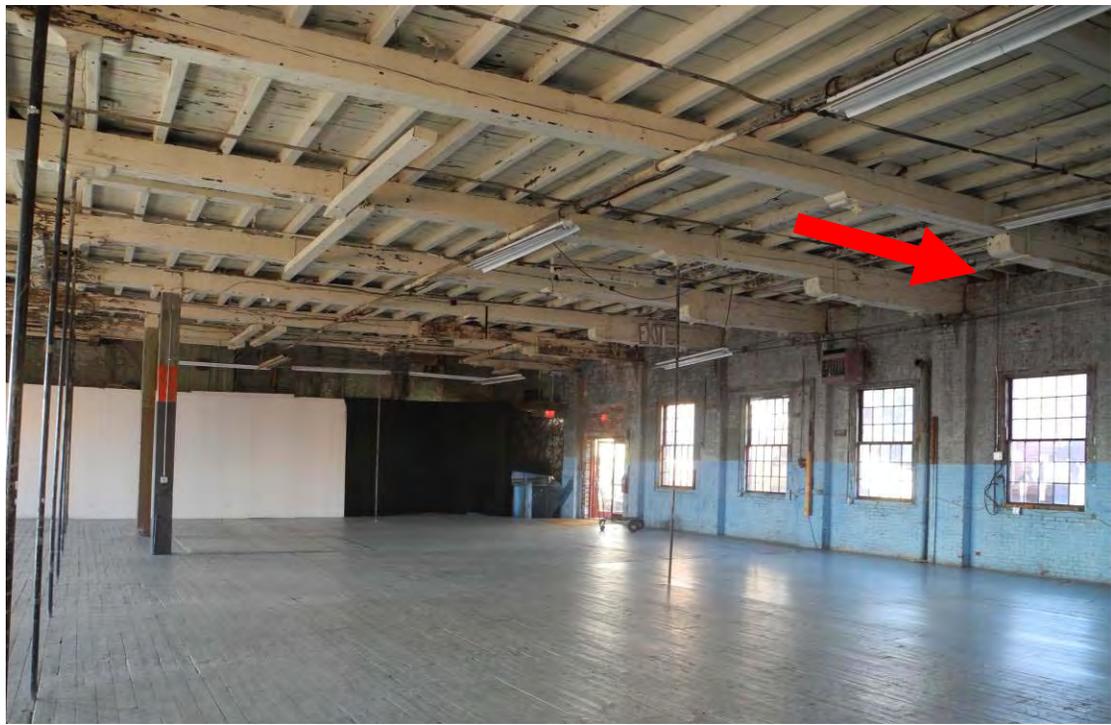
PHOTO
#2.13
A 29 58.jpg

Second floor assembly area, supported below by additional cast iron and timber posts. Iron rods were used to suspend the floor from the roof trusses. Dormer cantilever floor framing has very little backspan (arrow).

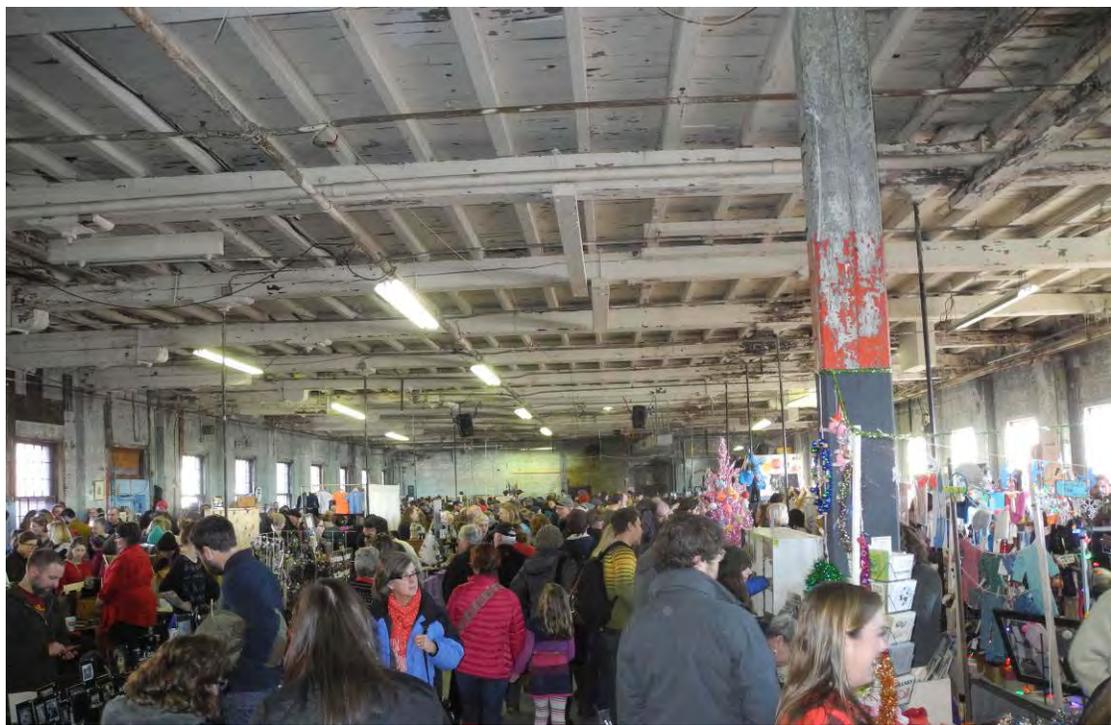
PHOTO
#2.14
A P 1.jpg

Second floor assembly area: In use as assembly facility, December 2014.

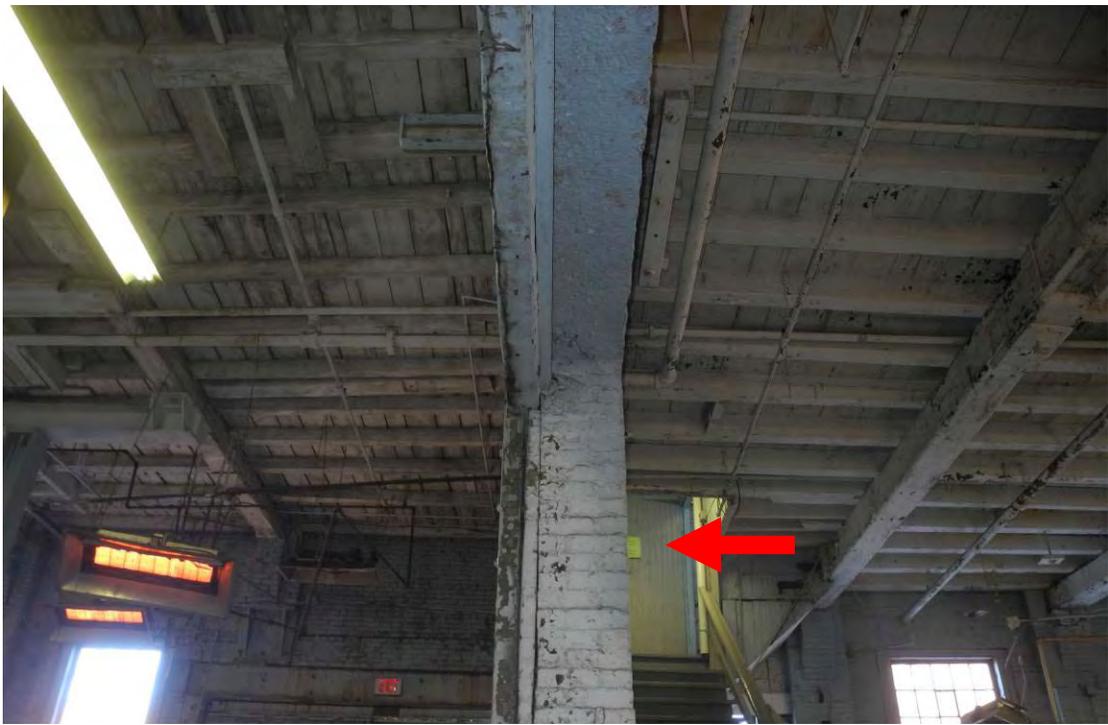
PHOTO
#2.15
A 3 23.jpg

Building 2 (right side of wall) and Building 3 (left side of wall) share a common partition that consists primarily of 12-inch (3 wythe) brick masonry. Arrow indicates point of view from stair landing shown in Photo 2.24 below.

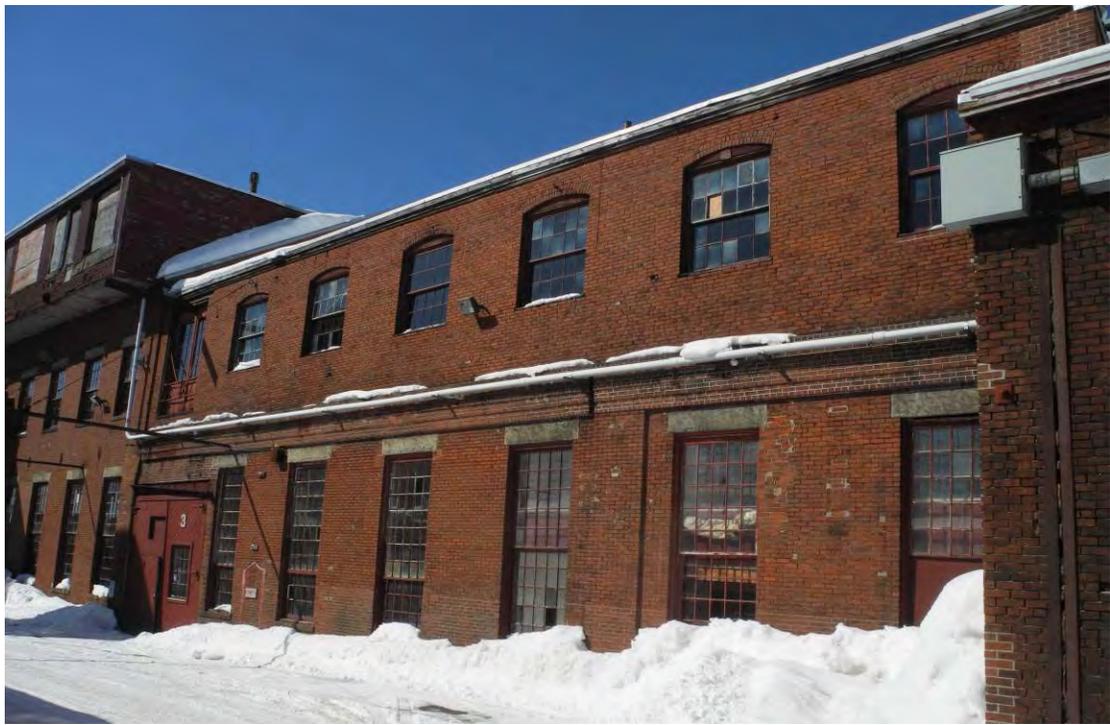
PHOTO
#3.1
A 2 78.jpg

Building 3: View from southeast. Second floor added sometime around 1895. Unlike level added at Building 2 (at left) second floor wall consists of loadbearing brick masonry in alignment with the first-floor masonry wall.

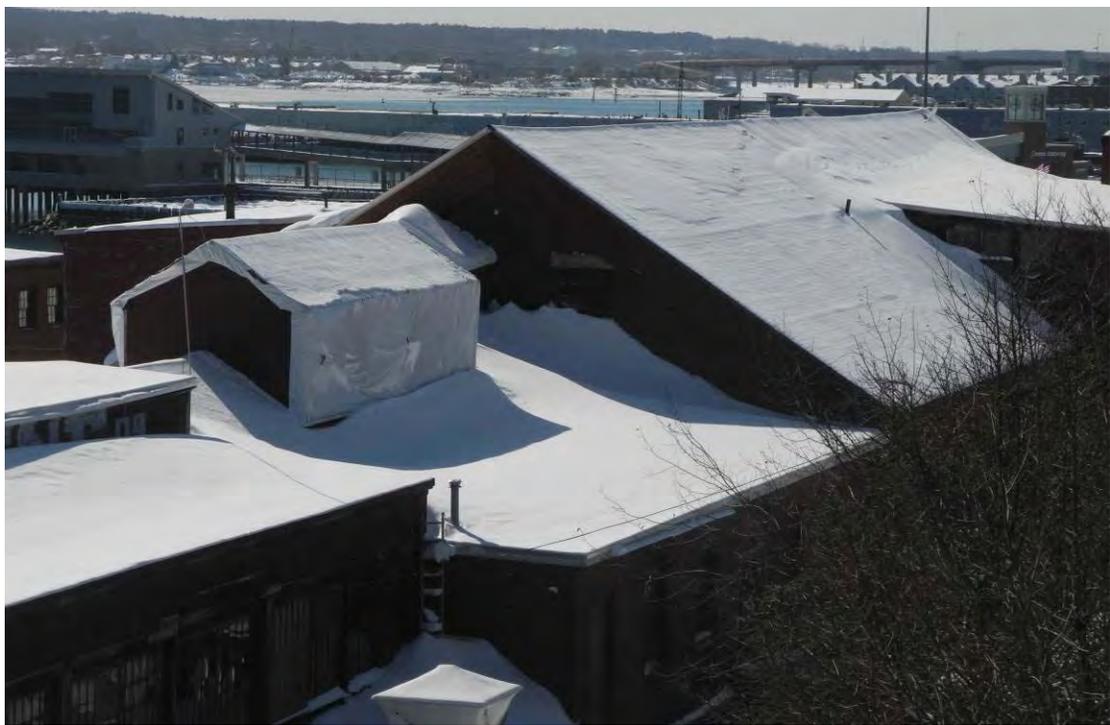
PHOTO
#3.2
A 2 73.jpg

Building 3: View from northeast showing original monitor roof extending above clerestory roof now covered in snow. Note drifting patterns developing around various roof intersections.

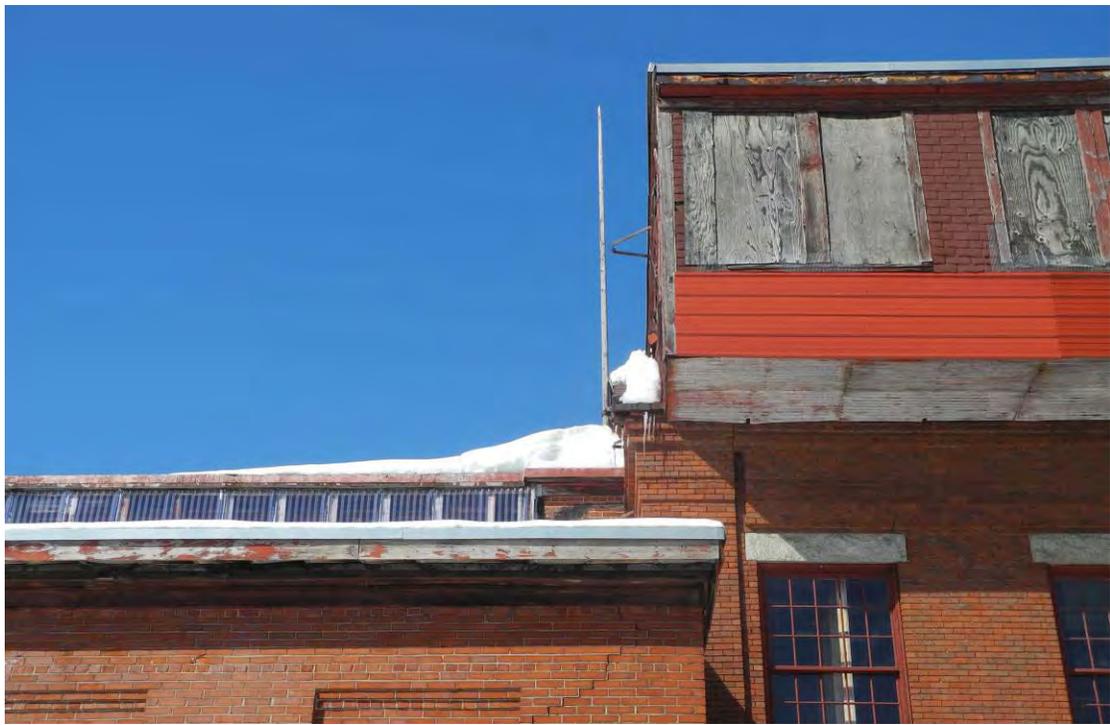
PHOTO
#3.3
A 2 107.jpg

Building 3: View of northwest corner of building, looking up at cantilevered dormer of Building 2 (right) and clerestory of Building 3 (left).

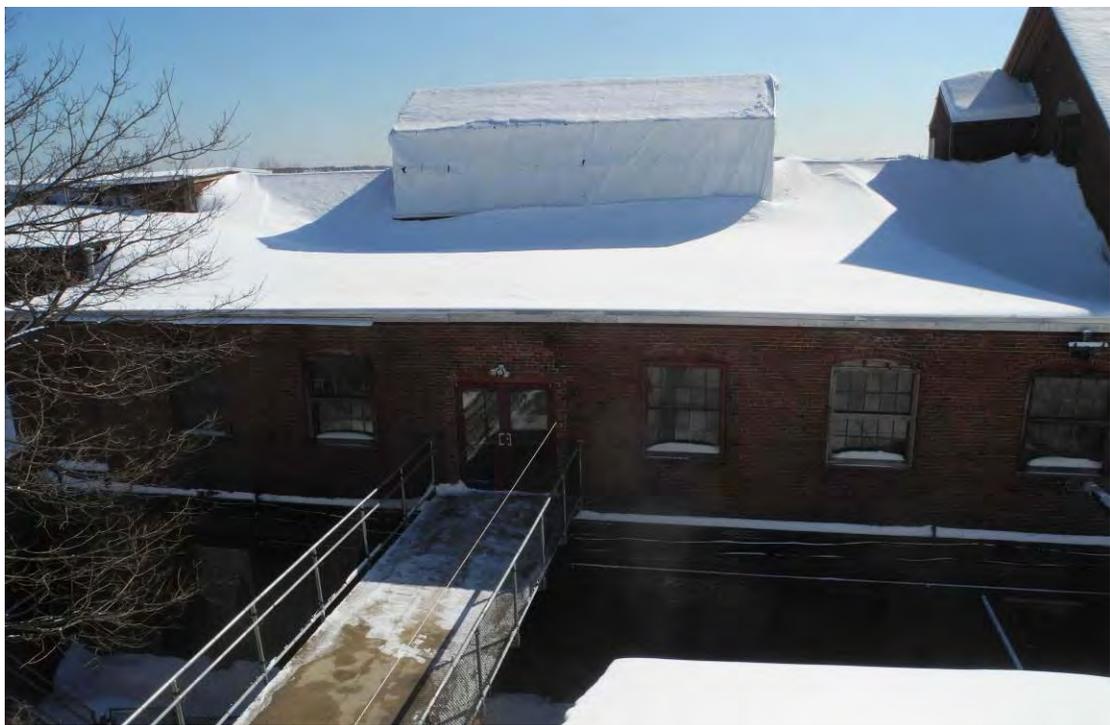
PHOTO
#3.4
A 2 63.jpg

Building 3: Walkway from second-floor space to stair landing leading to Fore Street. Walkway was not assessed as part of this project.

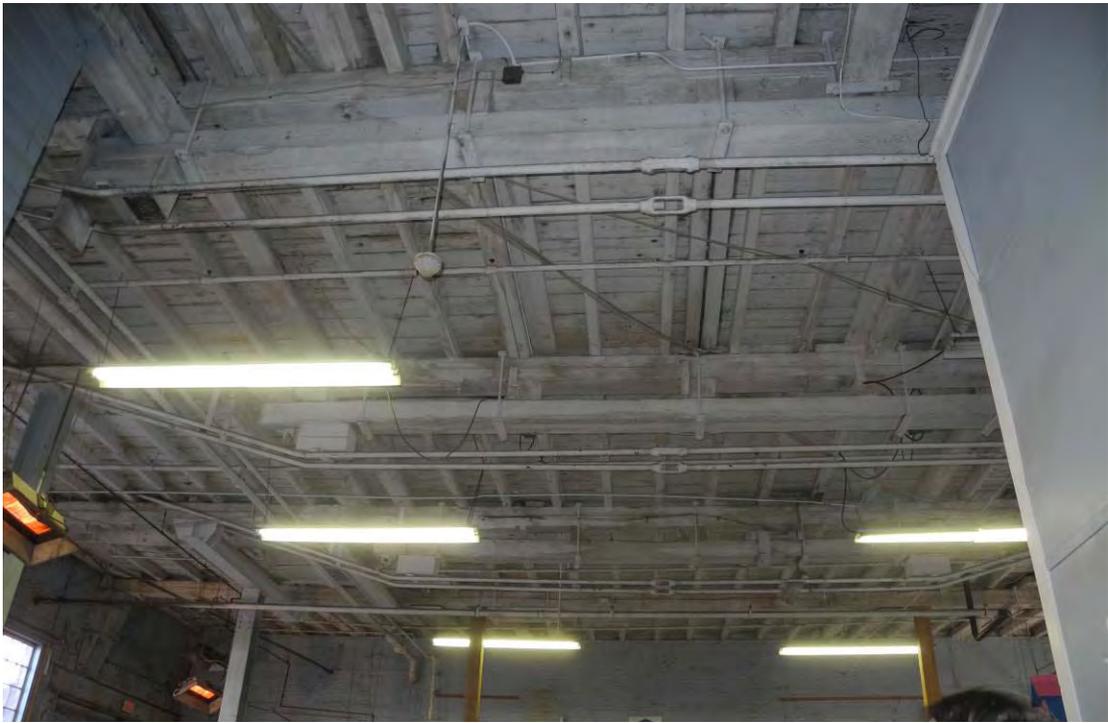
PHOTO
#3.5
A 3 20.jpg

- Building has seven window bays and six interior structural bays. Supplemental columns, girders, and trusses have been added, likely to provide additional upper-floor and roof support as the second floor was added and the building responded to additional loads (Photo #3.5, Photo #3.6).

Building 3: Second floor framing viewed from east. Added rods and turnbuckles create double-strut trussed beams that also serve as the bottom chord of the roof trusses.

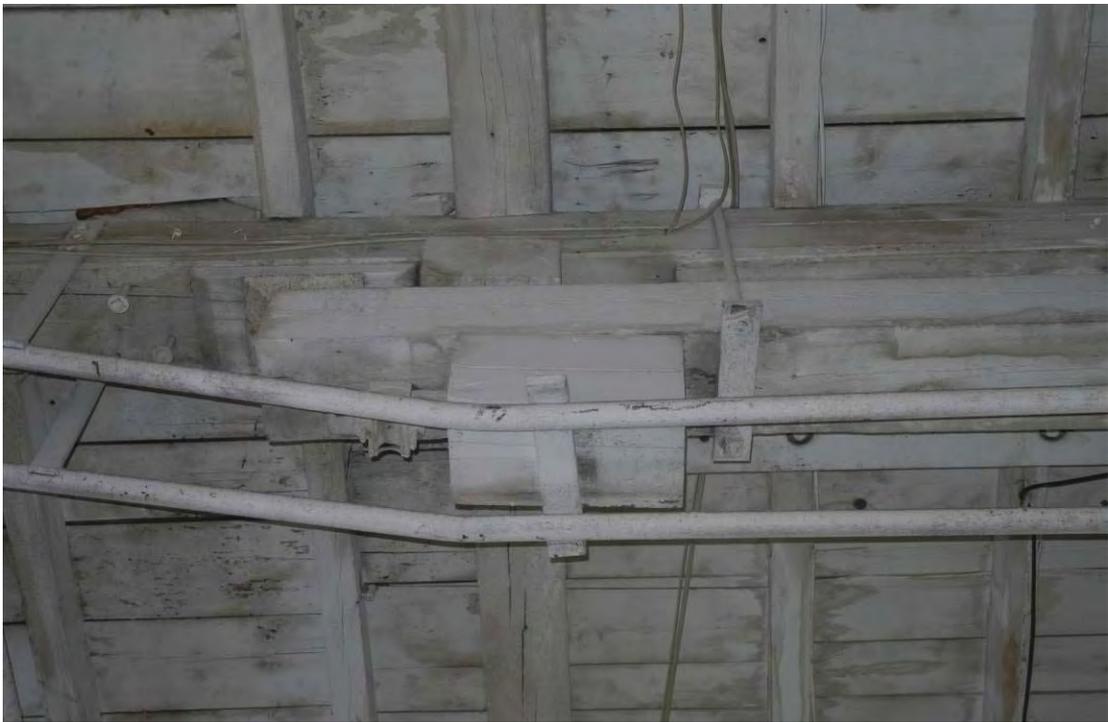
PHOTO
#3.6
A 3 21.jpg

Building 3: Detail looking up at reinforced bottom chord of underhung queen rod truss/trussed girder. Further inspection is necessary to better understand the load path of this framing system.

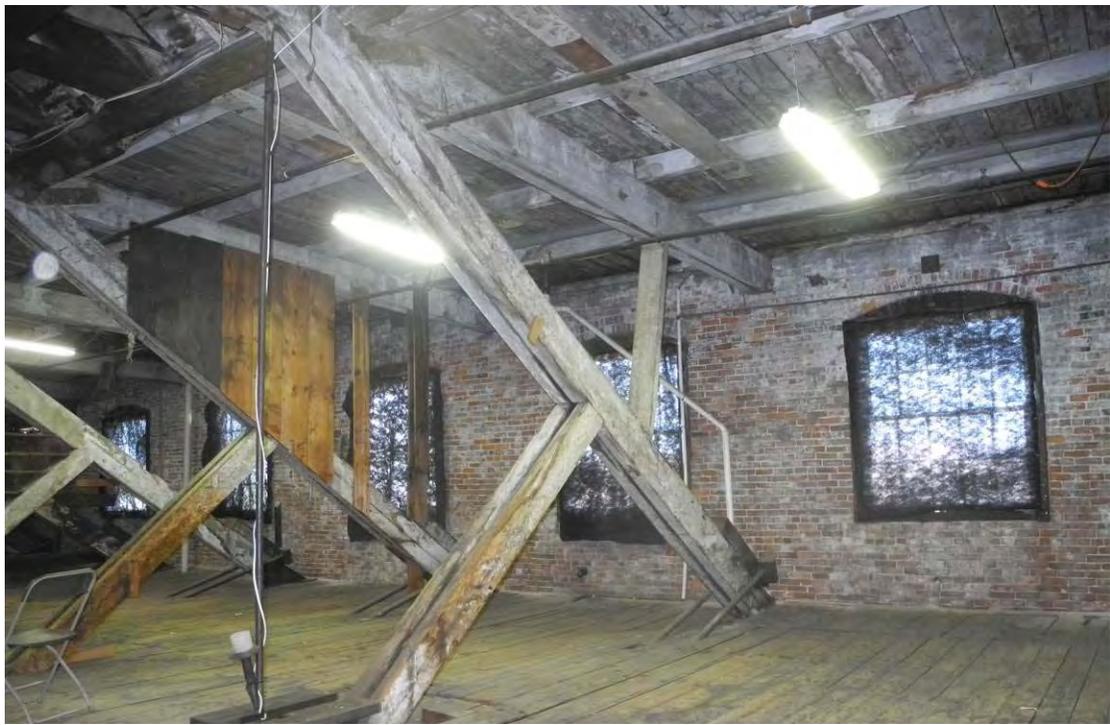
PHOTO
#3.7
A 3 29.jpg

- 4,900+/- square foot footprint, two stories with second floor added sometime around 1895, according to the SCC report.
- Second floor walls constructed of multi-wythe brick masonry, and roof trusses supplemented with additional framing to create shallow pitched continuous shed dormers while maintaining the original monitor roof (Photo #3.7).

Building 3: Original roof truss modified to create third-floor dormer. View taken looking toward south facing wall.

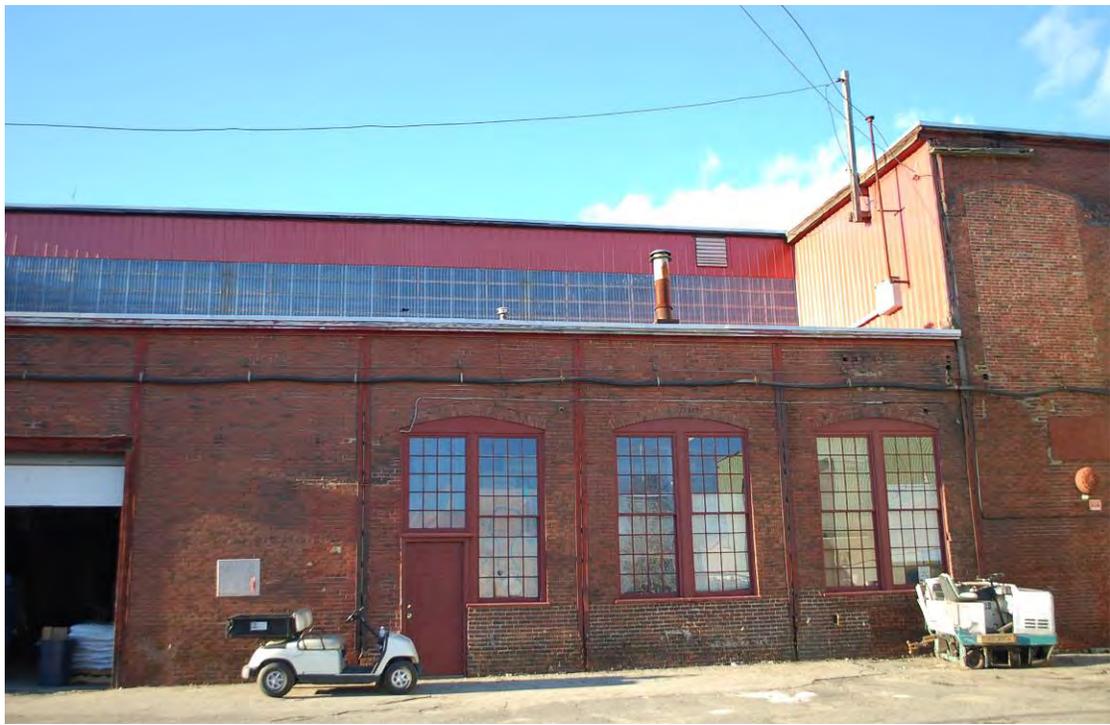
PHOTO
#4.3
R 79.jpg

Building 4: View looking north. Construction date of taller two-story structure at right is unknown but reportedly dates to original construction.

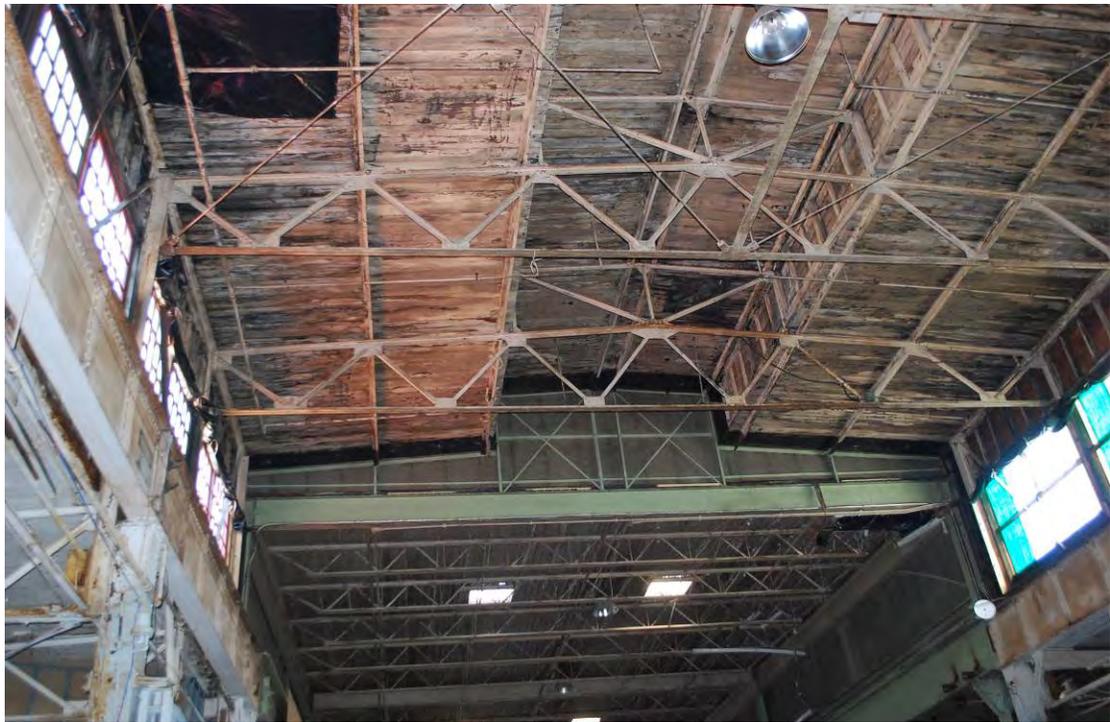
PHOTO
#4.4
R 89.jpg

Building 4: View toward east, where new roof structure of Building 5 spans across the building width with contemporary steel roof joists.
