PORTLAND COMPANY COMPLEX GENERAL BUILDING CONDITION REPORT

PERFORMED FOR
CITY OF PORTLAND, MAINE PLANNING DEPARTMENT
389 CONGRESS STREET
PORTLAND, ME 04101

MARCH 26, 2015
SUPERSEDES REPORT DATED MARCH 11, 2015

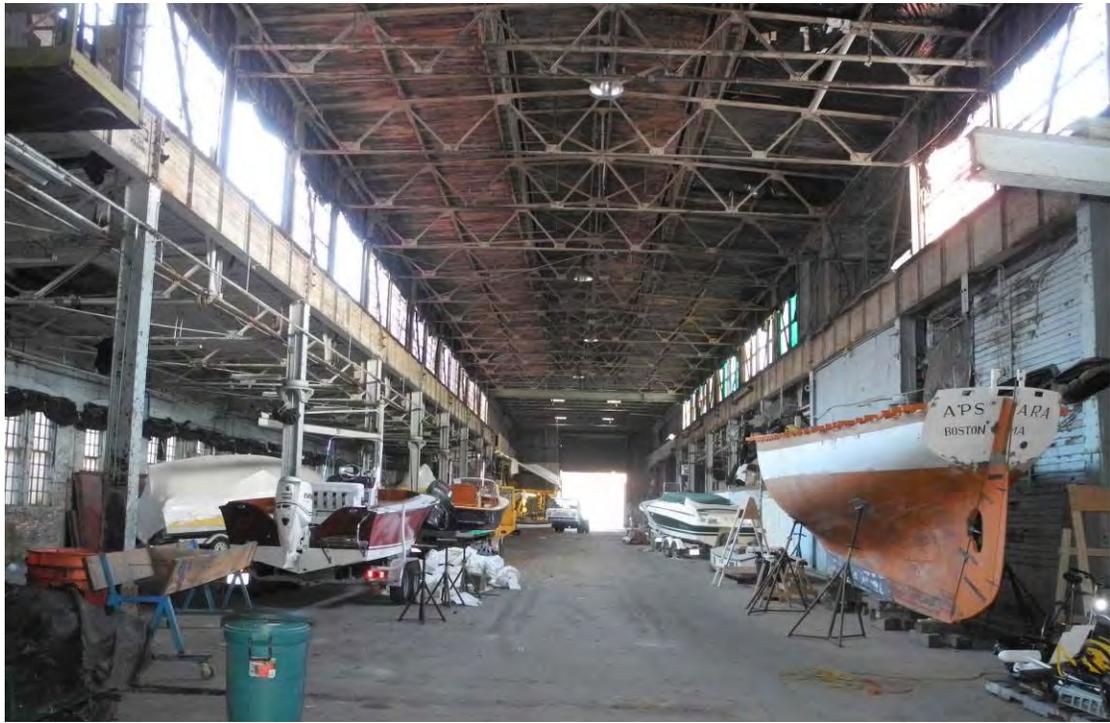
PHOTO
#4.5
A 29 63.jpg

Building 4: Expansive open space and high ceiling provides natural light, unless monitor windows are covered. East end of Building 4 ties into surrounding Building 5, eliminating the pattern of structure and light.

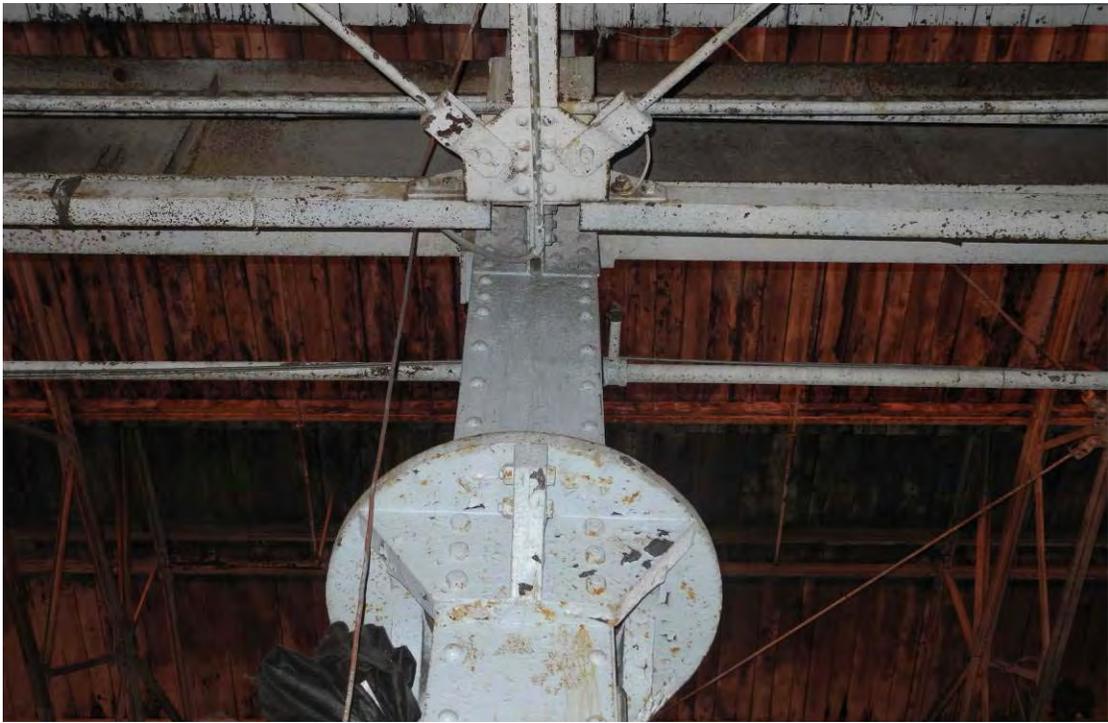
PHOTO
#4.6
A 29 64.jpg

Building 4: Monitor roof at center of photo supported by small steel truss framed onto clerestory truss.

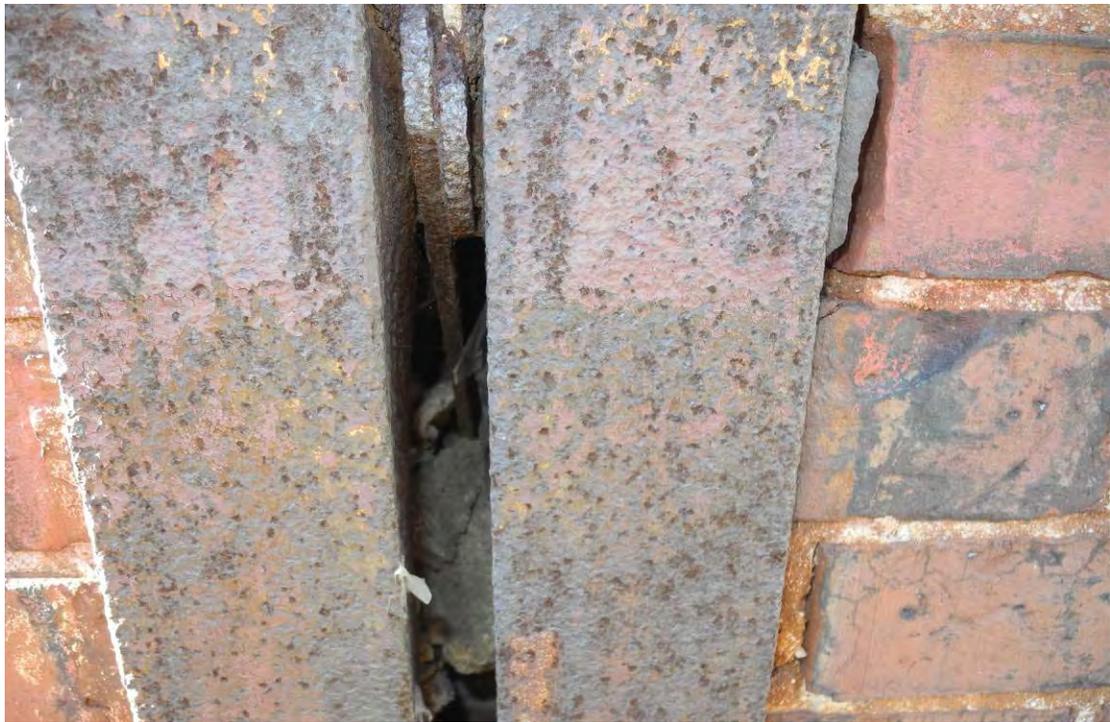
PHOTO
#4.11
A 29 49.jpg

Building 4: Significantly deteriorated built-up angle column. Constant exposure to a shoreline environment, along with inherent construction flaw, caused failure of these columns for several feet above the base.

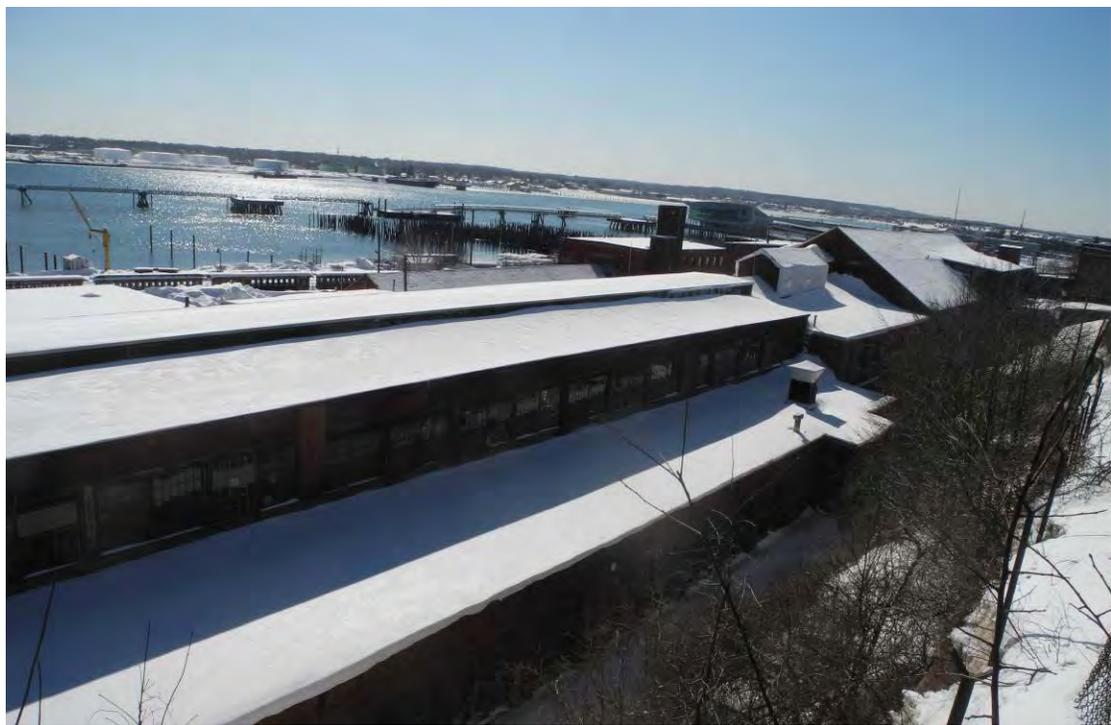
PHOTO
#4.13
A 2 81.jpg

Building 4: South elevation, with more recent steel structure attached. A concrete masonry bearing wall picks up the primary load from the new roof, and new steel columns support the upper south wall and roof.

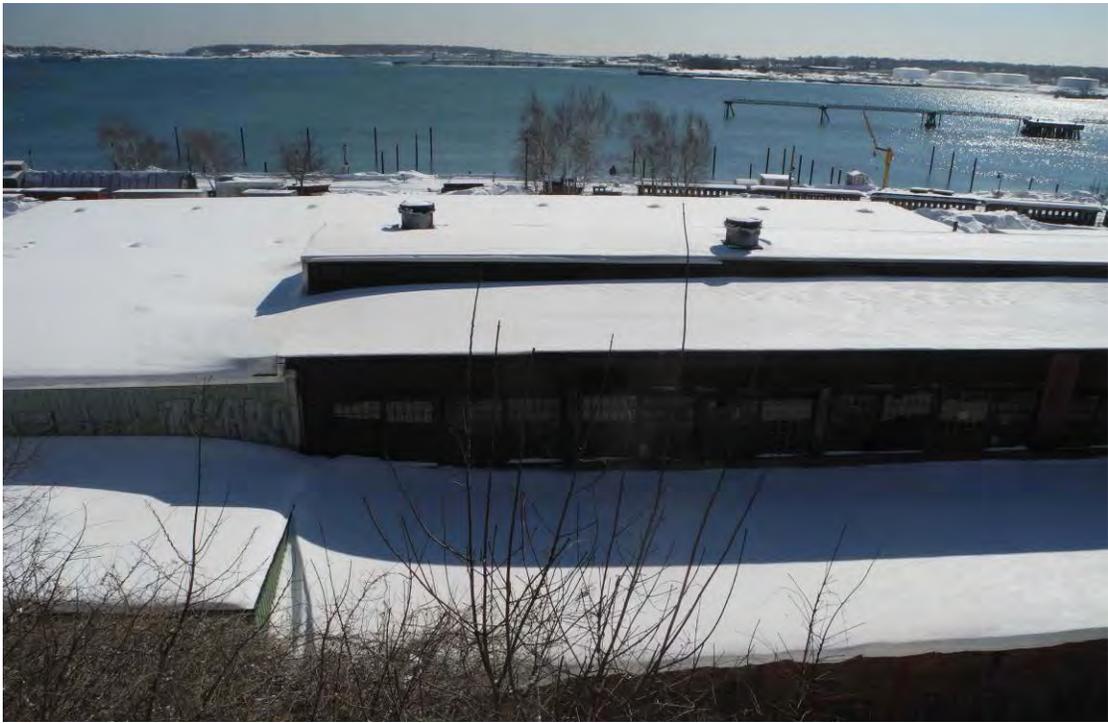
PHOTO
#4.14
A 2 70.jpg

Building 4, looking Southwest along upper roofs. Note tall clerestory roof and smaller upper monitor roof at clerestory roof ridge.

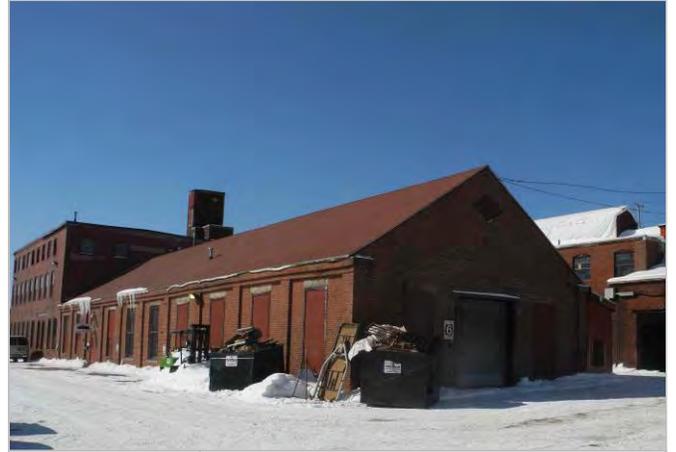
PHOTO #6B.1
A 2 35.jpg

Building 6B: View from southwest. Building 6A is at far left of photo. Building has relatively steep pitched roof in comparison with most buildings on site.

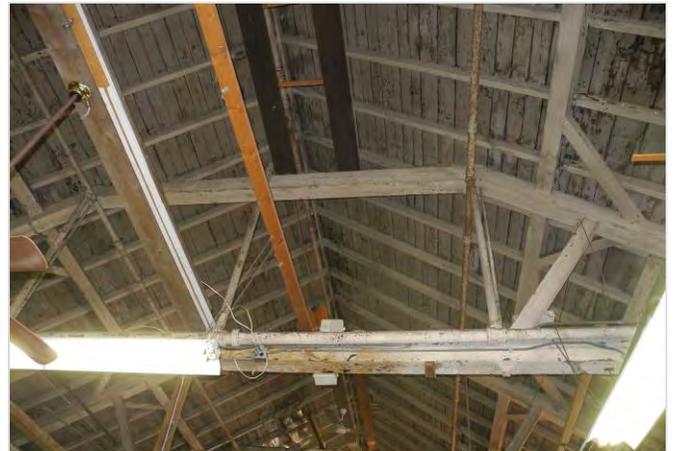
PHOTO #6B.3
A 30 06.jpg

Building #6B: East wall interior elevation. Attic space above ceiling served as storage.

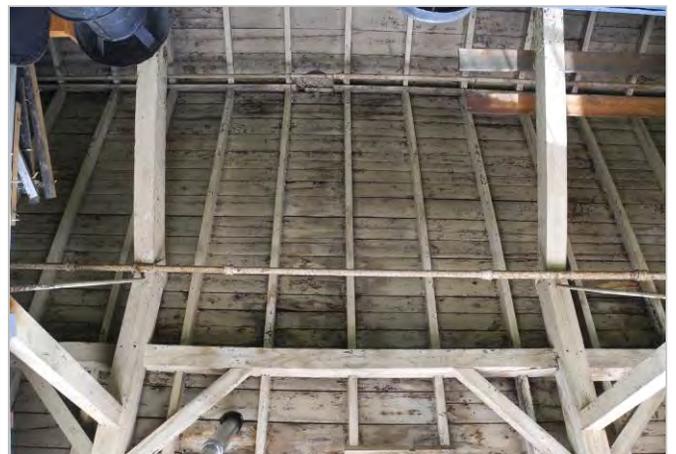
PHOTO #6B.5
A 30 02.jpg

Building #6B west end roof truss: Deteriorated south end of roof truss. Building #6A second floor visible at right. Provide temporary shoring beneath truss.

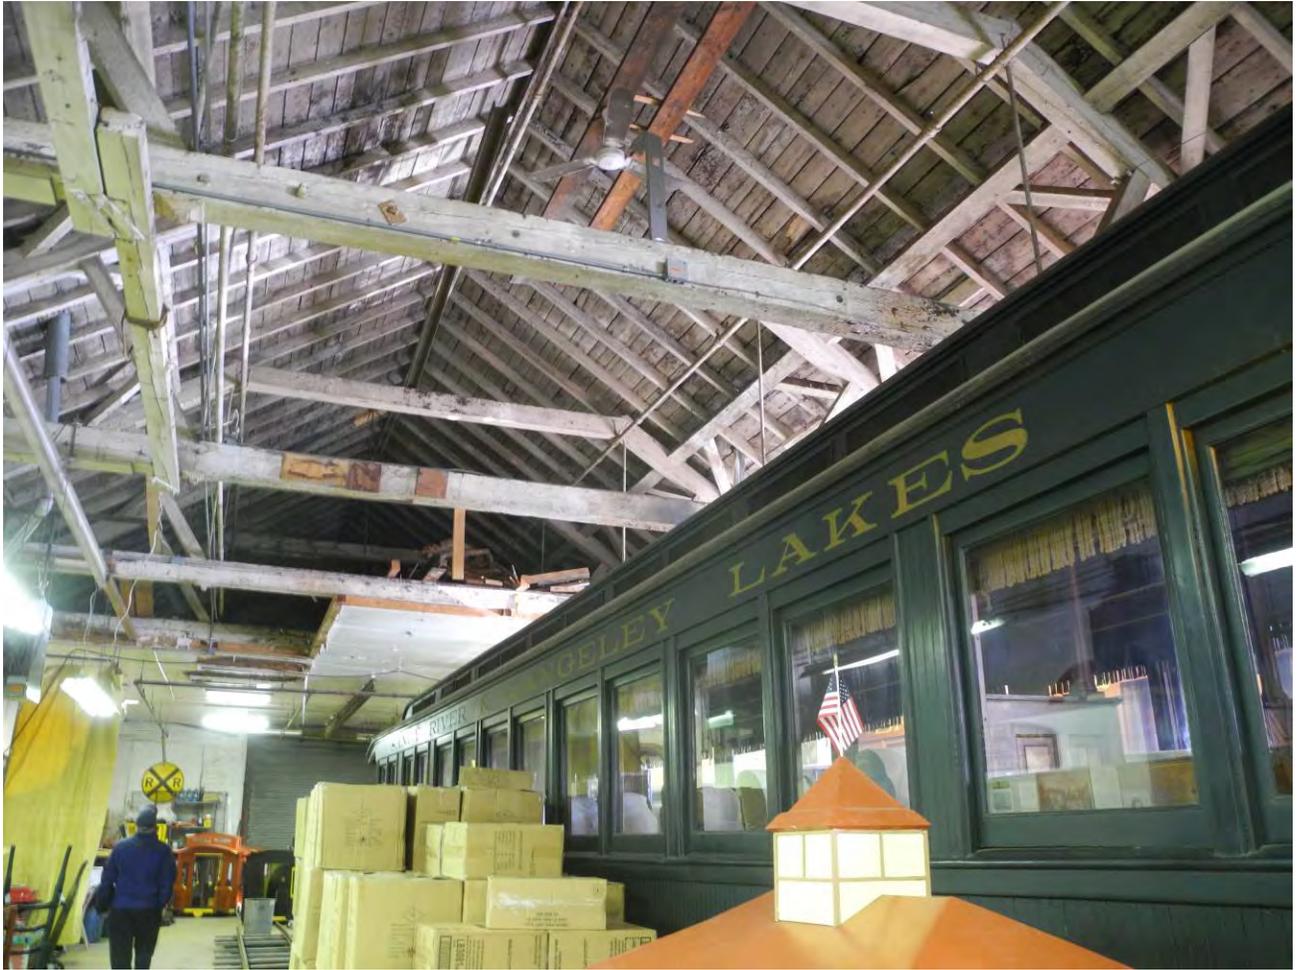
PHOTO #6B.6
A 30 13.jpg

Typical framing bay: Rafters extend from center purlin up to ridge. Knee braces serve to provide lateral stability in the longitudinal direction of roof.

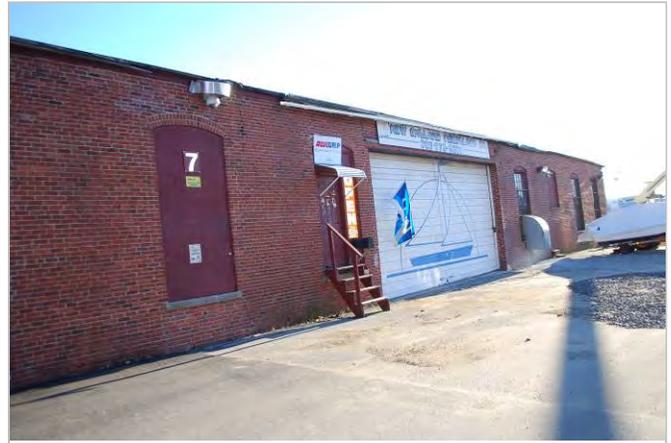
PHOTO #7.1
R 101.jpg

- The building appears to have been originally a long rectangular structure (Photo #7.1 and Photo #7.2), supplemented later on by a shed addition on the south side (Photo #7.5). We did not access the south side addition, which apparently served as a lumber shed.

Building 7: View from northwest showing large overhead door openings cut into masonry bearing wall.

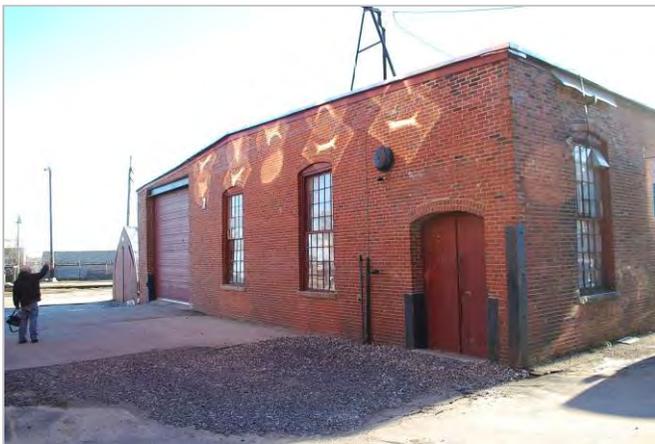
PHOTO #7.2
R 102.jpg

Building 7: North elevation, looking west. Many changes have been made to the building facades, weakening existing walls and diminishing original fabric.

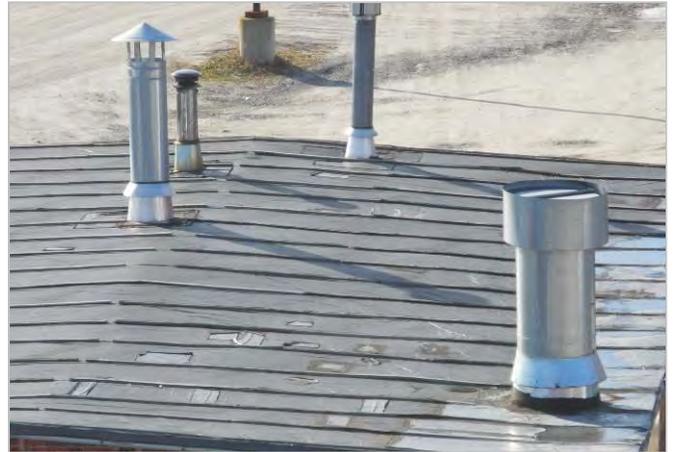
PHOTO # 10.1
A30 87.jpg

Building 10: View from Building 1 Roof showing Building 10 roof and East elevation. Note very low slope roof with surface partially covered by battens.

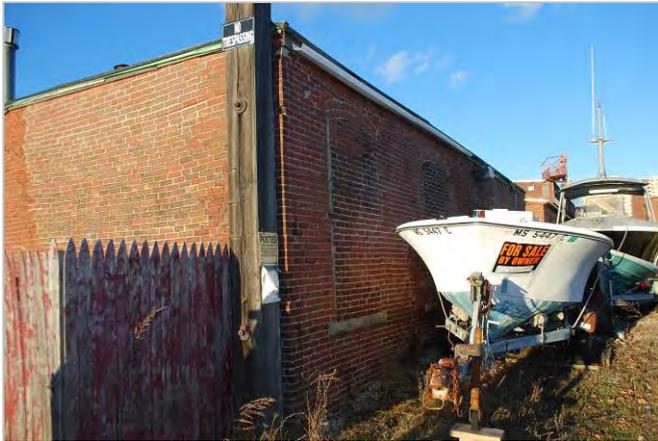
PHOTO # 10.6
R 129.jpg

East elevation (detail): Contemporary door infill. Note badly deteriorated mortar visible at left side of door and along upper roof (arrow).

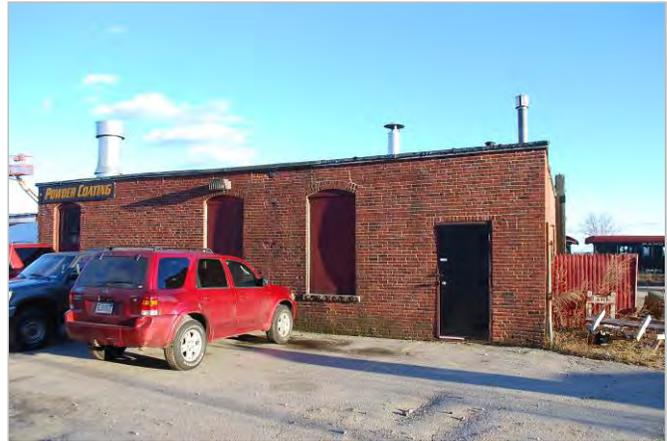
**PHOTO
10.7**
R 128.jpg

Building 10 south wall: Note infilled windows with granite sills and arched headers.

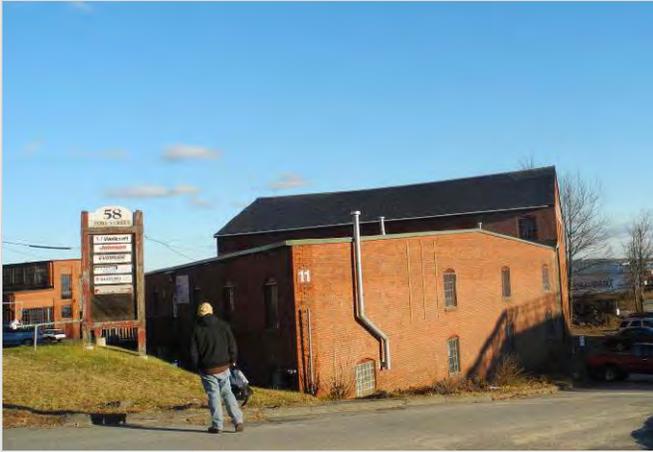
**PHOTO
10.9**
A 3 5.jpg

West elevation, viewed from south: Significantly bowed masonry at south half of wall is unstable. Upper masonry at north half of wall is in poor condition (see Photo #10.5) We concur with the BSE report that the building should not be occupied.

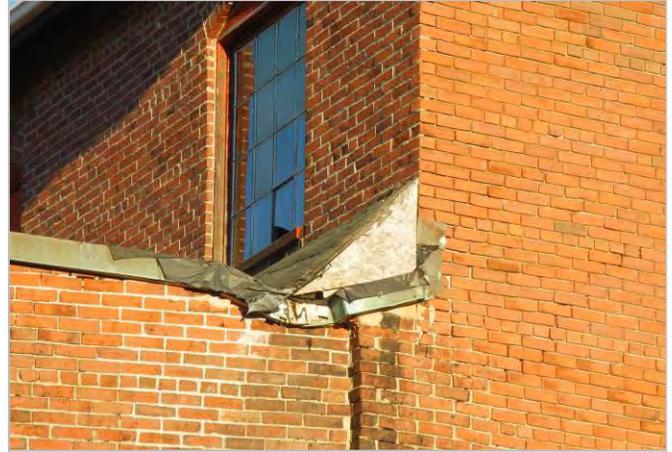
PHOTO #11.1
A 29 103.jpg

- The high roof of building 12 presents a significant potential for snow drifting (Photo #11.1, #11.2) Runoff from both roofs drains from the wall at the building junction (Photo #11.2). Previous masonry repointing repairs attempted to solve the problem, but only temporarily eliminated the symptoms.

Building 11: West and north elevations viewed from northwest on Fore Street. Note roof taper back toward Building 12, and relative lack of windows.

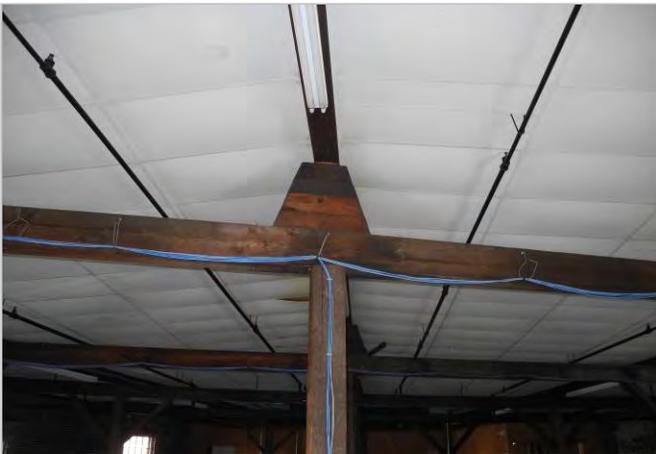
**PHOTO
#11.8**
A 30 45.jpg

- We observed active roof leaking into barrels placed on the second floor (Photo #11.8).
- The bottom masonry on the north side of the building is in poor condition due to raised grade and likely saturation from snow accumulation, rising damp, and poor site drainage.

Second floor assembly space, east end: Barrels beneath multiple active roof leaks.

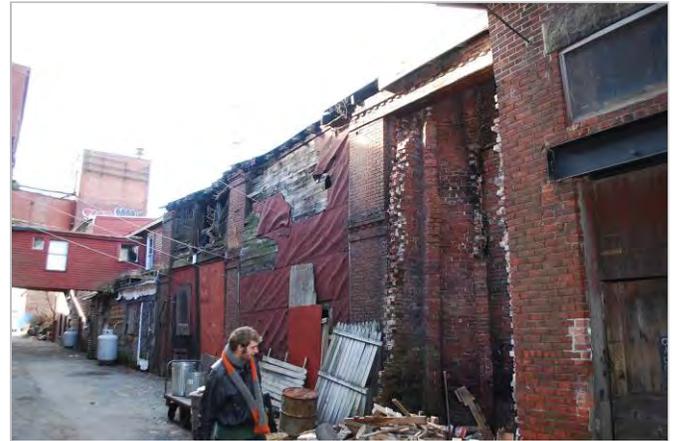
PHOTO #16.1
R 57.jpg

Building 16: View from southeast from alleyway. Note masonry wall return cracks on east elevation (arrow).

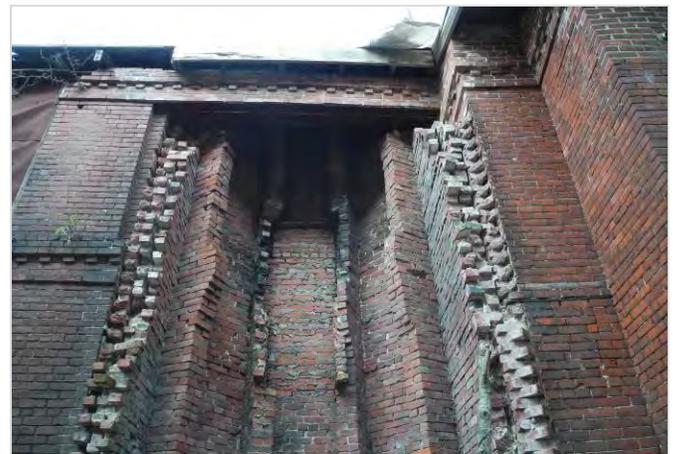
PHOTO #16.3
a f 93.jpg

Building 16: Enlarged opening in south elevation wall. Entire south wall requires repointing, repair, and anchoring into east wall.

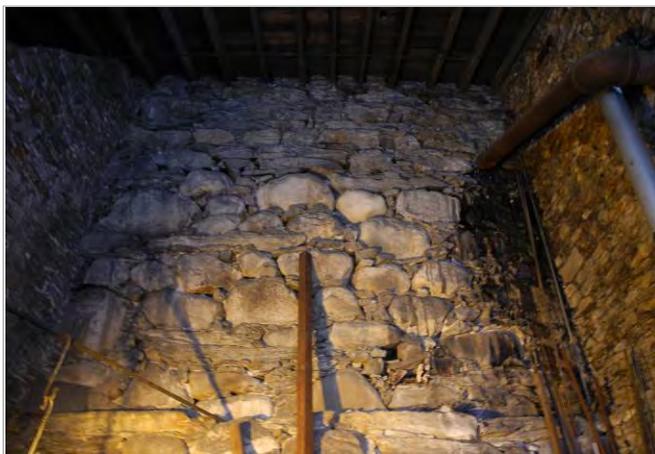
PHOTO #16.4
P 23.jpg

Building 15/16: Remnants of boiler house chimney stack between Buildings 15 and 16.
